Catchment Management Plan

REPORT

Bega Valley Shire Council

11 August 2016 PROJECT REFERENCE: JN15115

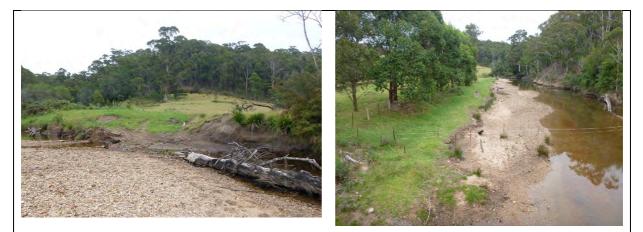
Figure B2 Section of degraded bank where stock cross Nelson Creek to access grazing areas (*left image*). Stock are occasionally provided access the streamside zone and enter Nelson Creek upstream of the Tathra-Bermagui Road bridge (*right image*).

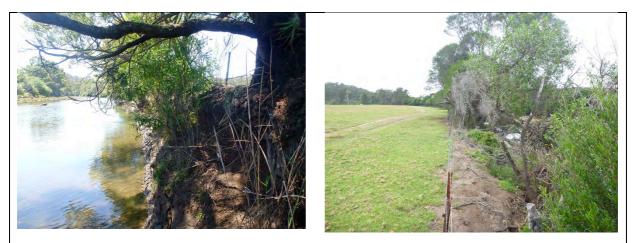
Figure B3 Example of steep bank and narrow strip of riparian vegetation with a large black wattle perched at the bank edge (*left image*). View downstream along left bank showing the narrow band of riparian vegetation (*right image*). It is recommended that the riparian buffer be expanded as much as possible to mitigate against further degradation of the stream bank and loss of alluvial flats.

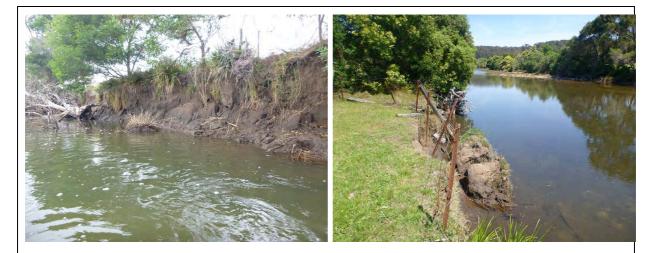
Figure B4 Example of moderate to severe bank slumping of Nelson Creek in upper estuary reaches (*left image*). Recent severe bank slumping along an un-vegetated section of the stream bank (*right image*). It is recommended that bank toe protection works be undertaken and the riparian buffer be expanded as much as possible to mitigate against further degradation of the stream bank and loss of alluvial flats.

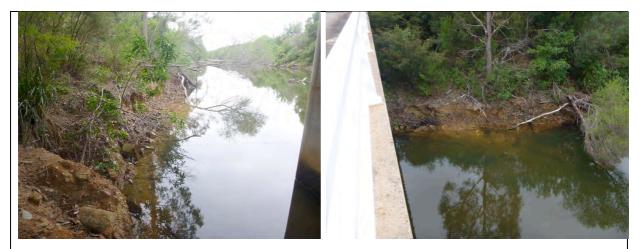
Figure B5 Minor erosion evident to the bridge abutments on the left bank (*left image*). View of erosion to left bank from above (*right image*).

- Recommend removal of excess loose sediment from affected area and construct a small sediment detention basin/trap to prevent sediment from entering watercourse.
- Batter eroding bank to a minimum slope as specified by geotechnical engineer and treat as provided in guidance for Group A erosion control measures (DECCW 2008).

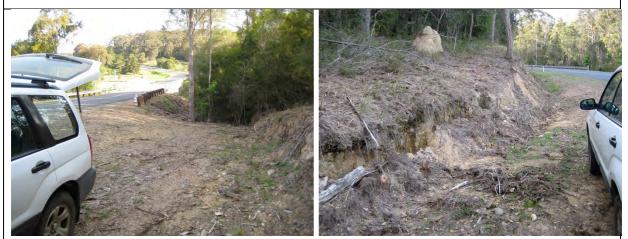
Figure B6 The western side of Tathra-Bermagui Road where surface road runoff drains to Nelson Creek (*left image*). Example of an area of eroding roadside embankment that could be improved through appropriate battering (*right image*).

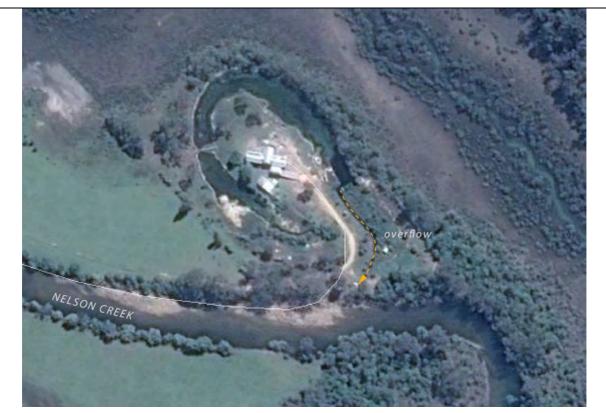
Figure B7 Unknown water quality of private canal waterbody in close proximity to residence and associated OSM system represents a potential risk to estuarine water quality.

• Recommend working with landholder to test canal waters annually for signs of faecal contamination that may indicate a potential failure of OSM.

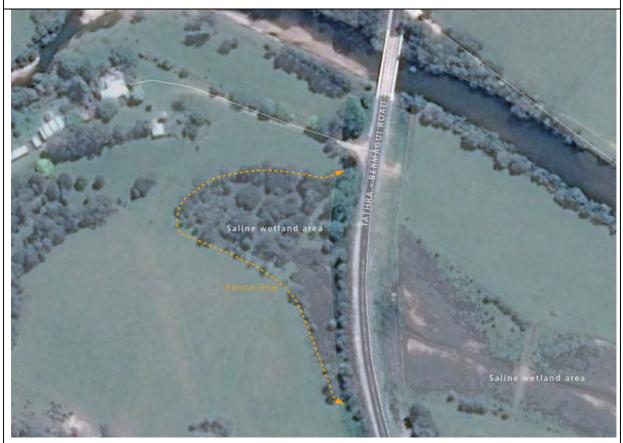
Figure B7 Inspect integrity of fence line enclosing saline wetland and undertake repairs where required to exclude stock access.

• Work with landholder to repair fencing where required excluding stock from sensitive wetland area.

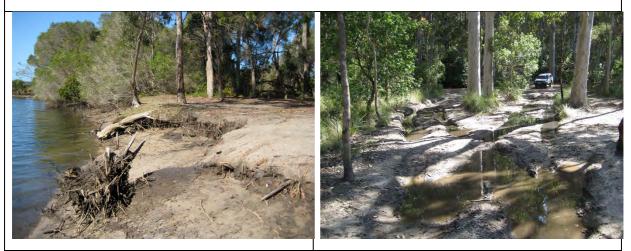
Figure B9 Degraded bank currently devoid of any regenerating vegetation (left image). Parts of the foreshore access road are in poor condition with deep wheel ruts and mud tracks (right image).

- Implement control fencing and or bollards to direct foreshore access to a single area.
- Improve site amenity by addressing the poor road condition and consider closing access road during wet conditions.

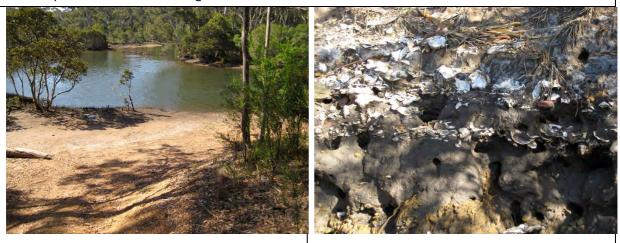
Figure B10. Informal boat ramp located at the western end of the foreshore access road (left image). A shell bed layer with potential cultural heritage values is present at the site and warrants further assessment to determine its significance (right image).

- Consult with Bega LALC to investigate the potential cultural heritage values of site. ٠
- Develop signage and install bollards to limit vehicle damage to foreshore vegetation and potential cultural heritage values.

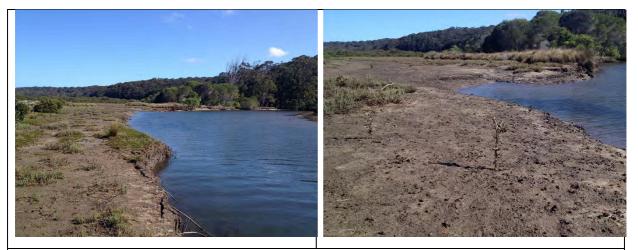
Figure B11. Regenerating saltmarsh community following exclusion of vehicles to the area by a previous conservation project by SR CMA (*left image*). Minor erosion of foreshore adjacent to saltmarsh community (*right image*).

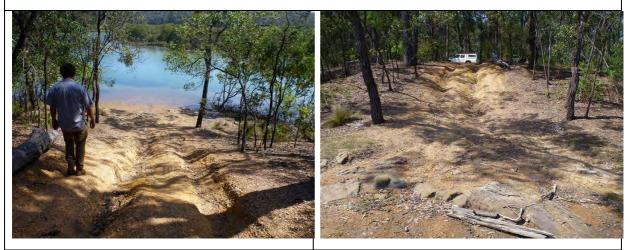
Figure B12. Vehicle access to the foreshore from Cowdroys road with moderate erosion and wheel rutting evident (*left image*). Current road condition is relatively stable with majority of dispersible sediment already eroded (*right image*).

- Consult with NPWS to determine whether foreshore access at this location is to be maintained.
- Monitor road condition and implement repair should road condition deteriorate further.

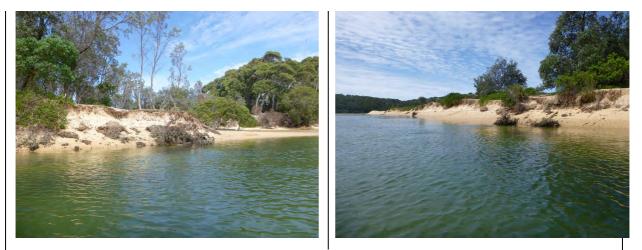
Figure B15 Example of eroding sand banks and impacts to dune vegetation associated with uncontrolled pedestrian foot traffic and trampling.

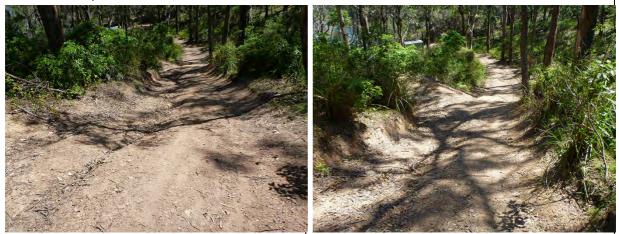
Figure B16 Foreshore access to northern side of Nelson lagoon from Cowdroys Road (*left image*). Existing surface runoff controls require maintenance and could be improved with addition of siltation fences to further minimise potential sediment inputs to estuary (*right image*).

• Improve road surface runoff controls including maintenance (*i.e.* removal of leaf litter and excess sediments), use siltation curtains to minimise potential sediment inputs to the estuary.

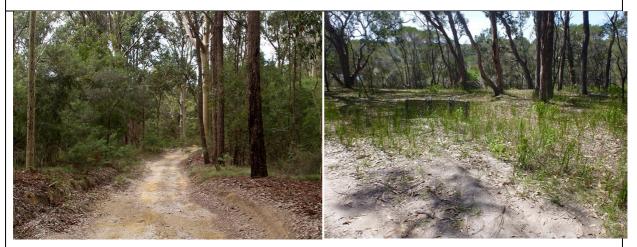
Figure B18 Cowdroys Road showing the original road surface - orange clay, supplemented with three decades of crushed oyster shell - white color (*left image*). Example of a siltation barrier constructed by oyster grower to minimise sediment inputs to lagoon basin (*right image*).

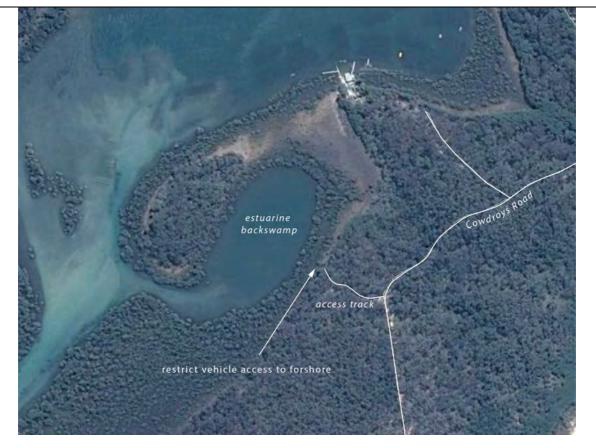
Figure B19 Overview of issue 4.2 showing the foreshore location where bollards or logs could be installed to prevent vehicle access to foreshore.

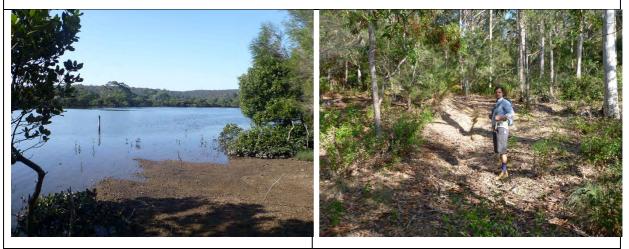
Figure B21 Deposition of hill slope sediments at the margin of estuary back lagoon due to erosion of old foreshore access track (*left image*). Example of erosion affecting the foreshore access track (*right image*).

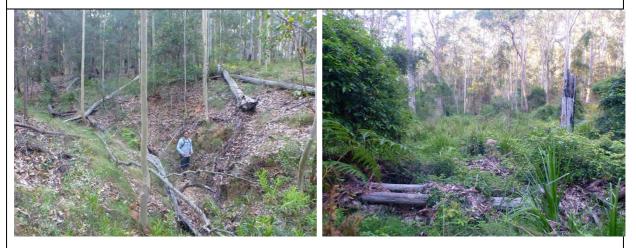
Figure B22 Deeply incised gully formation along drainage line of a minor stream (*left image*). Example of downstream channel where majority of gully sediments have been deposited and colonised by vegetation that provides stability to the streambed (*right image*).

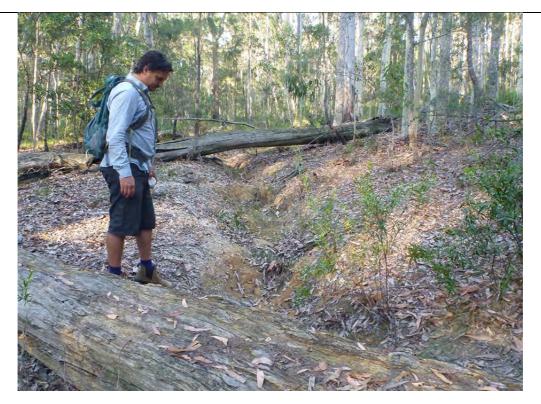
Figure B23 Example of rill erosion on the hill slope of management area 5 caused by disturbance of the soil surface likely due to historical logging operations. This issue can be treated by constructing several log berms to disperse surface runoff, trap sediments and encourage colonisation of vegetation.

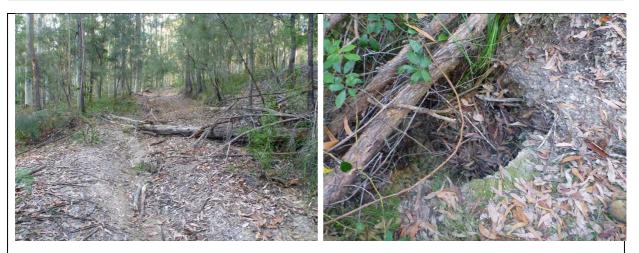
Figure B24 Example of NPWS management track showing minor to moderate erosion (*left image*). Localised areas of road erosion include nick-points with potential to develop into gullies if left unaddressed (*right image*).
