6 DATA COLLECTION AND REVIEW

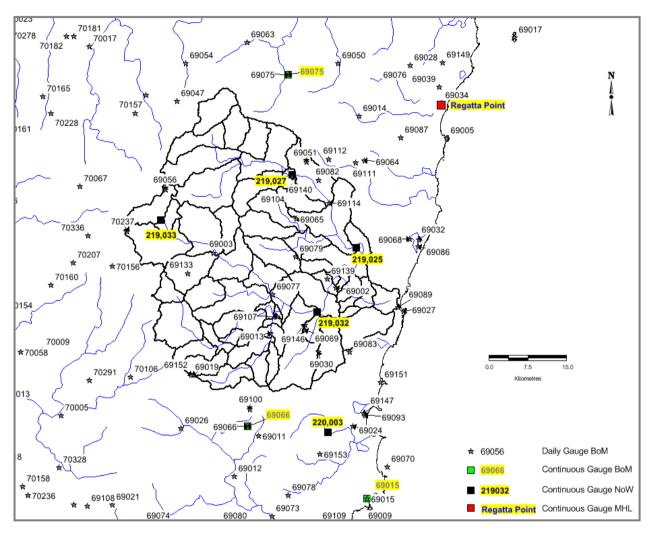
Locations of daily rainfall and pluviograph records were obtained from the Bureau of Meteorology and NSW Office of Water's Pinneena DVD and are shown in Figure 6.1. While there are several daily rainfall stations situated throughout the catchment the number is still limited particularly in the mid to upper parts of the catchment where there can be significant orographic effects impacting on rainfall. Many of these stations were not operational for all of the events used during the calibration.

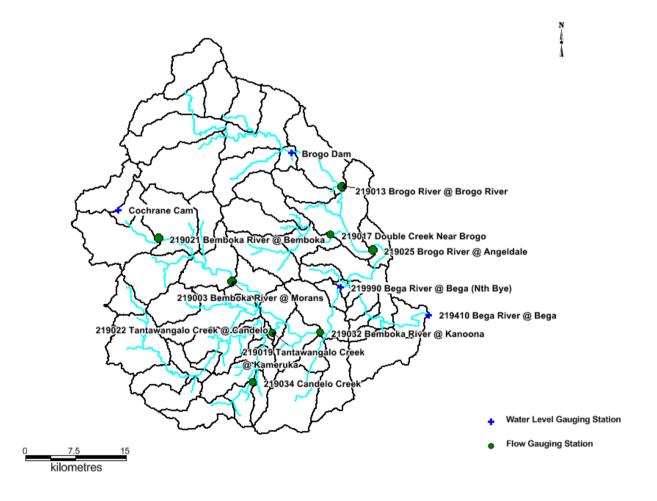
Figure 6.2: Flow and Water Level Gauges Map

The locations of the streamflow gauging stations were obtained from the NSW Office of Water based on records held in their database (Pinneena DVD). In addition to flow gauging sites, water level measuring sites at Brogo Dam, Cochrane Dam, the North Bega site in the town of Bega, and Bega (Live) site at Mogareeka were also used. The Bega (Live) site at Mogareeka is sourced from OEH data obtained from the Manly Hydraulics Laboratory. The locations of these gauging sites are shown in Figure 6.2.

The gauging stations shown in Figure 6.2 were chosen for modelling to provide a level of detail and maximise the reliability of the calibration. Lower gauging station sites with larger cumulative flows were supplemented with additional gauges upstream to enhance the level of detail in the calibration by representing variations in hydrology throughout the catchment. Not all of the gauging stations were operating for all flood events modelled.

Table 6.1 shows the years of continuous water level records at the abovementioned gauging stations. The levels at Brogo and Cochrane Dams are used to record reservoir water levels and storage volumes. The other stations convert the water levels to observed streamflow discharges, using developed rating curves specific to each site.

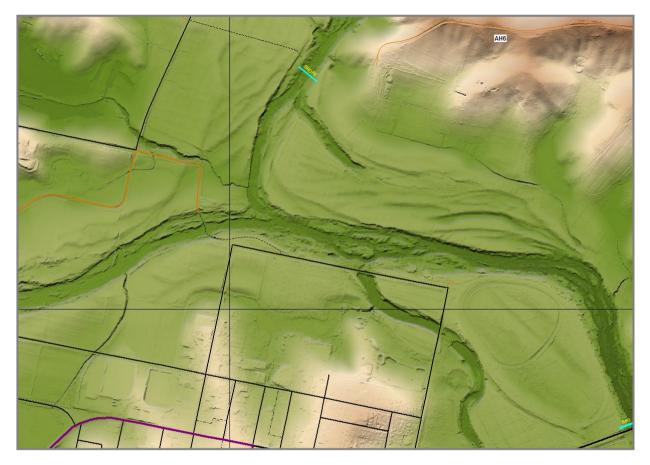
Figure 6.3: DTM Representation of the Confluence of Brogo and Bega Rivers North of Bega Based on the Council's LIDAR Survey Data

For the purpose of the detailed hydraulic modelling from Bega to Mogareeka, Council's detailed LIDAR survey was used. Digital Elevation Models (DEM) were produced by Terranean Mapping Technologies using the LIDAR data flown at 800m above sea level, at a point density of approximately 1.5 points per square metre. The data was captured between January and March 2008 and has an accuracy at the 95% confidence level of 0.33m.

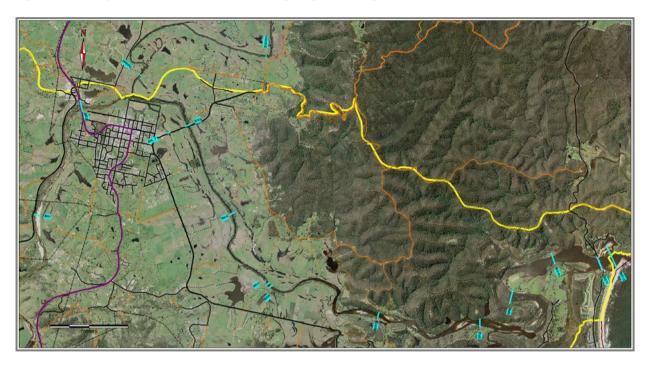
Figure 6.4: Surveyed Control Cross-Sections Along Bega and Brogo Rivers

As Council's LIDAR survey did not extend to Candelo, the topographic survey of the Candelo Creek was undertaken by Caddey Searle & Jarman Consulting Surveyors and included the creek bed and floodplain area. Generally, the survey provided a high level of detail to adequately supplement the existing survey data and define the topography of the study area and hydraulic structures required for modelling. Figures 6.4 and 6.5 show the locations of cross sections surveyed by ground survey at both project locations.

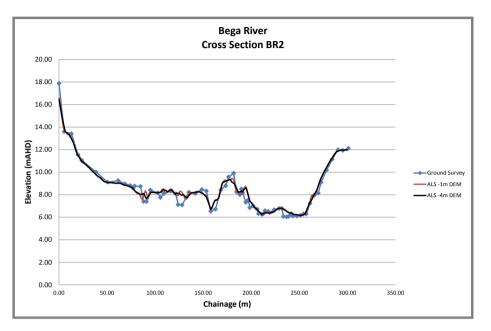
Figure 6.6: Example where LIDAR Adequately Represented Channel

An example of a review of the surveyed cross section where the LIDAR adequately represented the channel as typical in the upper reaches is shown in Figure 6.6 below.

The review of cross sections along Bega River indicated that the LIDAR data adequately represented the topography of the channel in the upper parts of the hydraulic modelling area from Jellat Jellat to the upstream end, but did not register the channel within the banks downstream of Jellat Jellat flats to Mogareeka. The

inconsistencies in lower reaches originate from LIDAR registering the water surface rather than the bottom of the channel.

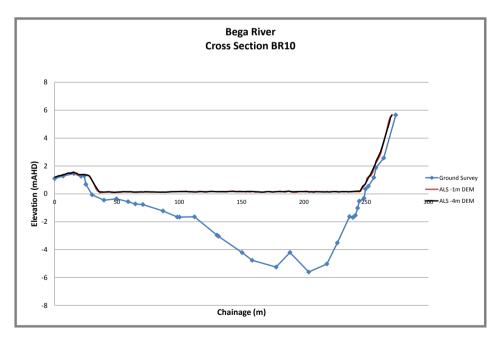
Figure 6.7: Example where LIDAR did not Adequately Represent Channel

An example of a review where the LIDAR did not adequately represent the channel, typical in the lower reaches, is presented in Figure 6.7 below. In such cases the ground/bathymetric survey was used in preference to the LIDAR data.

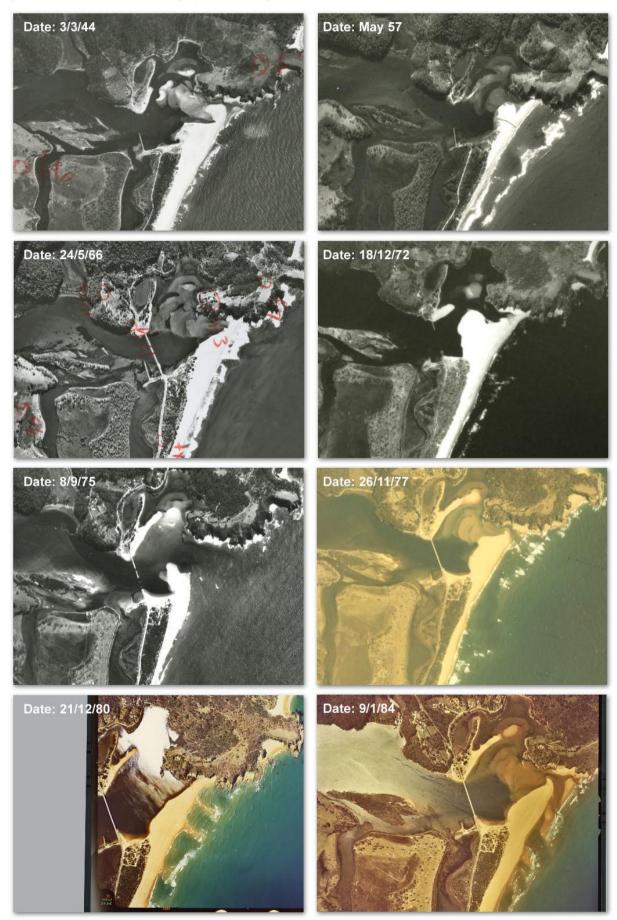
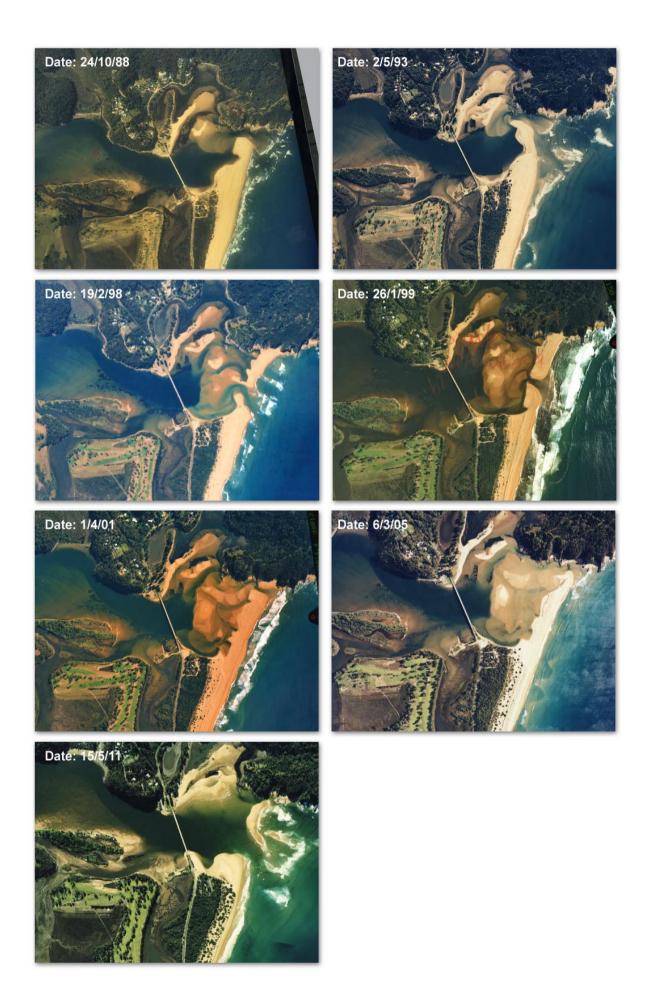
Figure 6.9: Historic Aerial Photographs near Mogareeka (Source OEH)

Aerial photography of the outlet at Mogareeka was provided by OEH and indicated that the berm changes over time. There were significant changes in location and shape at the outlet. Fifteen aerial photos of the inlet were provided, dating back to March 1944 to May 2011. These aerial photos are shown in Figure 6.9 below.

Changes noted in the aerial photos include:

- The width and shape of the berm
- The width of the opening
- The location of the opening
- Sediment build up between Tathra Bridge and the berm
- Changes to the Tathra bridge with part of the bridge being removed/ washed away (also noted in bridge drawings)
- Relatively minor changes to bathymetry upstream of the Tathra bridge (although difficult to associate from the plan views alone)
- Changes to development in the area
- Changes to the alignment of the road leading to Tathra bridge since May 1957
- Changes to the location of Tathra bridge since May 1957.
- Generally the opening of Bega River is situated at the northern end of the berm, however in the case of the Feb 1998, Jan 1999 and May 2011 photos the opening is situated more centrally between the berm's northern and southern ends.

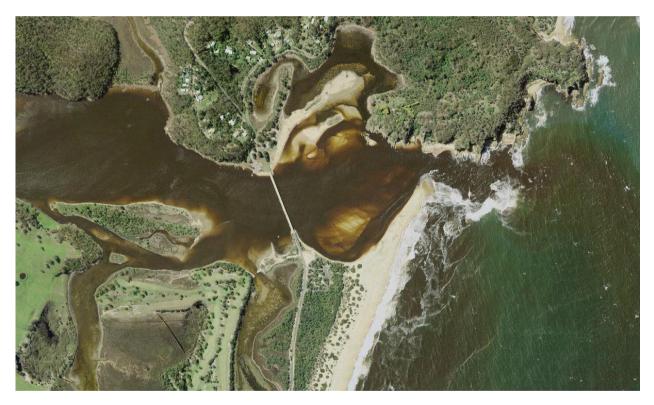
Figure 6.10: 2010 Aerial Photograph near Mogareeka (Source Council)

Figure 6.10 shows an image of the opening from the aerial photograph supplied by Council (dated 2010).
