Eden, Twofold Bay, Towamba River Flood Study

Draft Flood Study

Project Name: Eden, Twofold Bay and Towamba River Flood Study

Rhelm Reference: J1053_R04_Stage_4_Rev0

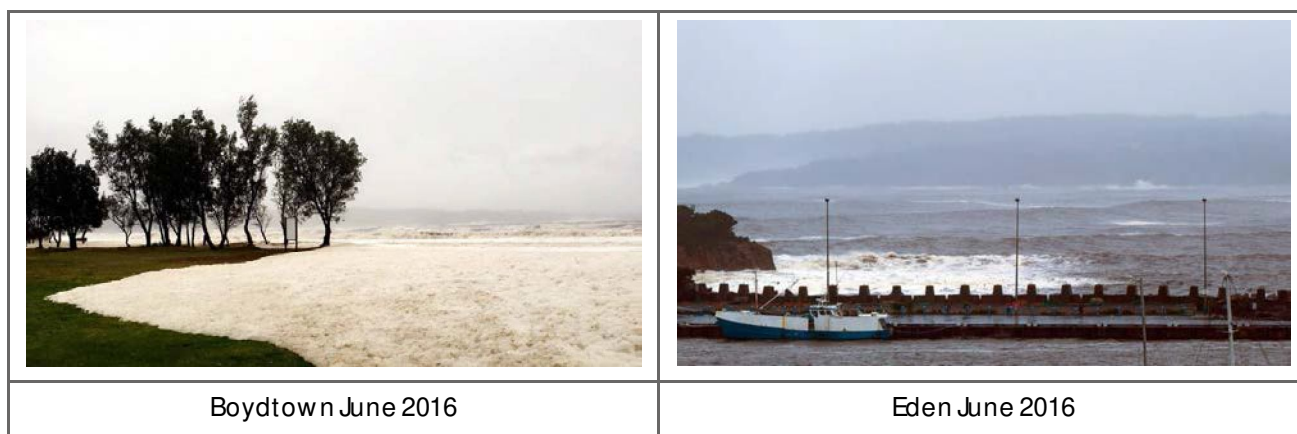
In June 2016, an East Coast Low event caused significant damage to wharf infrastructure at Allied Natural Wood Exports wharf at Jew’s Head and also nearby Tathra Wharf due to the prevailing wave direction. Photos of this event are shown in **Figure 2-1** and analysis of this event is provided in **Section 5.5**.

Figure 2-1 ECL June 2016 - Photos

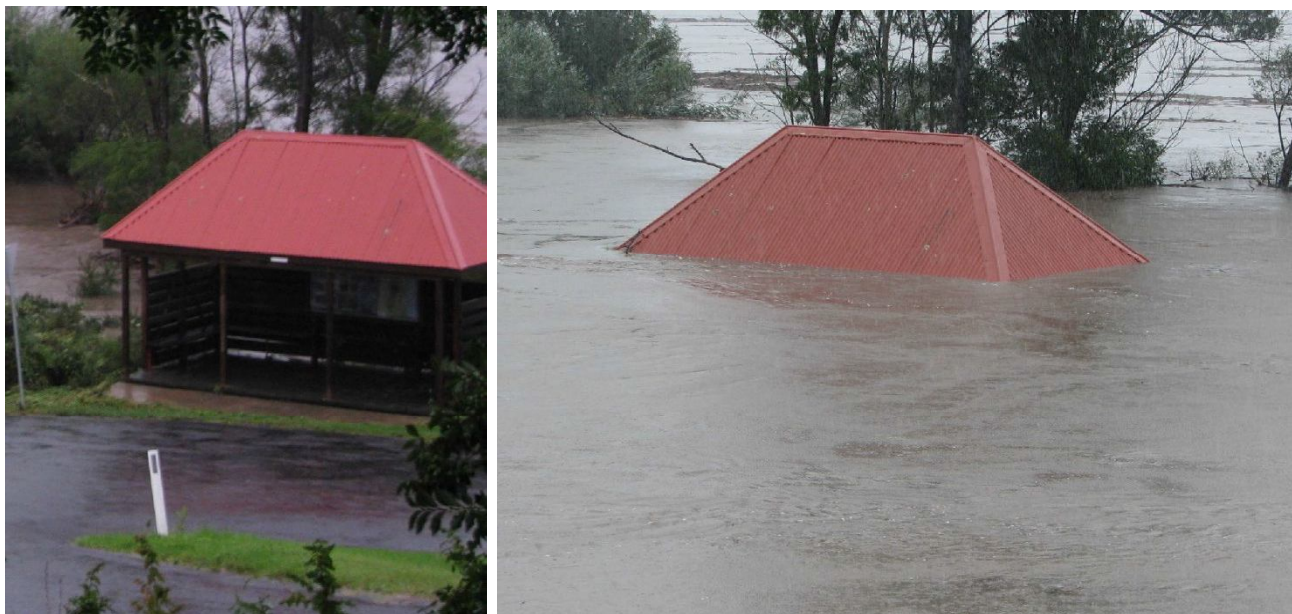
The flood level surveyed for the 1978 event was marked by a hacksaw on a post near the intersection of Yambulla Road and Towamba Street. The point was surveyed as being at 36.52m AHD. The model at this location has a level of 36.39m AHD, 0.13m lower than the survey mark.

Figure 5-3 Towamba Bus Shelter Flooding in 2011

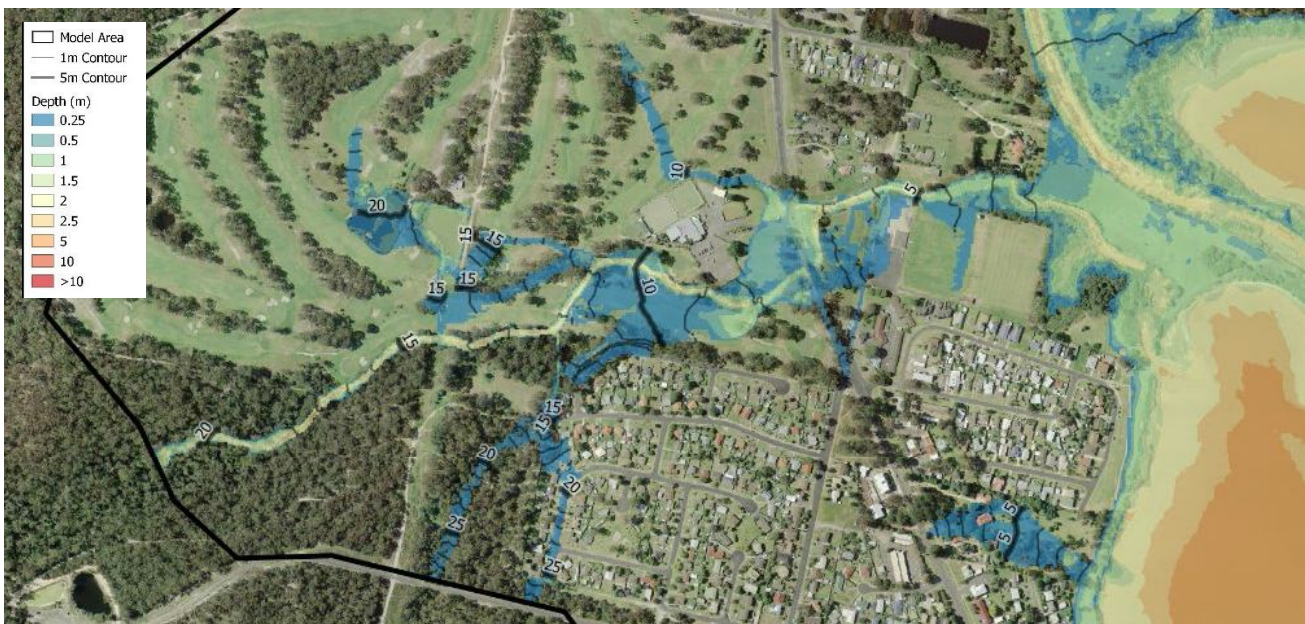
Figure 6-7 Lake Curalo Western Tributaries(with 1% AEP flooding)

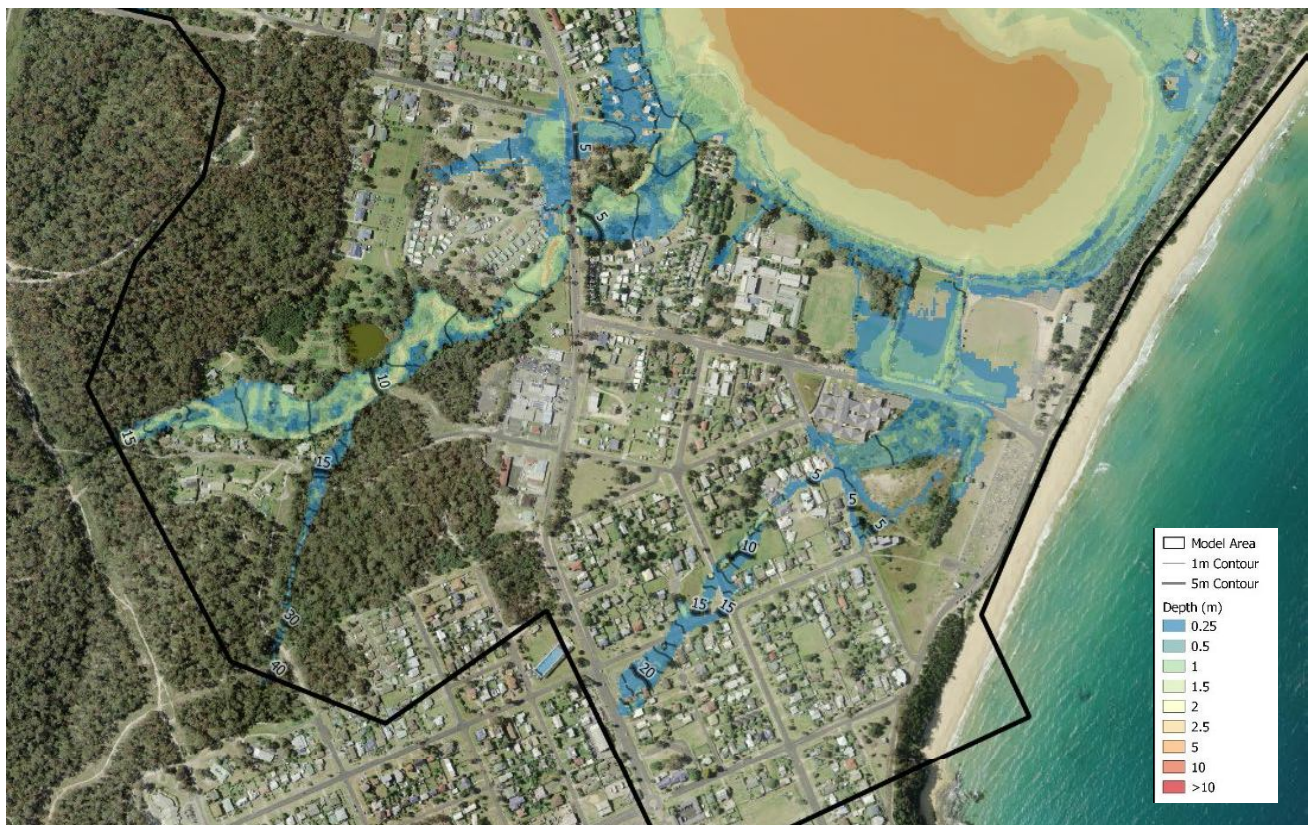
In the PMF however, driven by increased lake levels, a large region of residential development is inundated, including the Aged Care centre, and properties along Curalo Street and Dolphin Crescent, by depths of 0.5 to 1 metre.

Figure 6-8 Lake Curalo Southern Tributaries(with 1% AEP flooding)

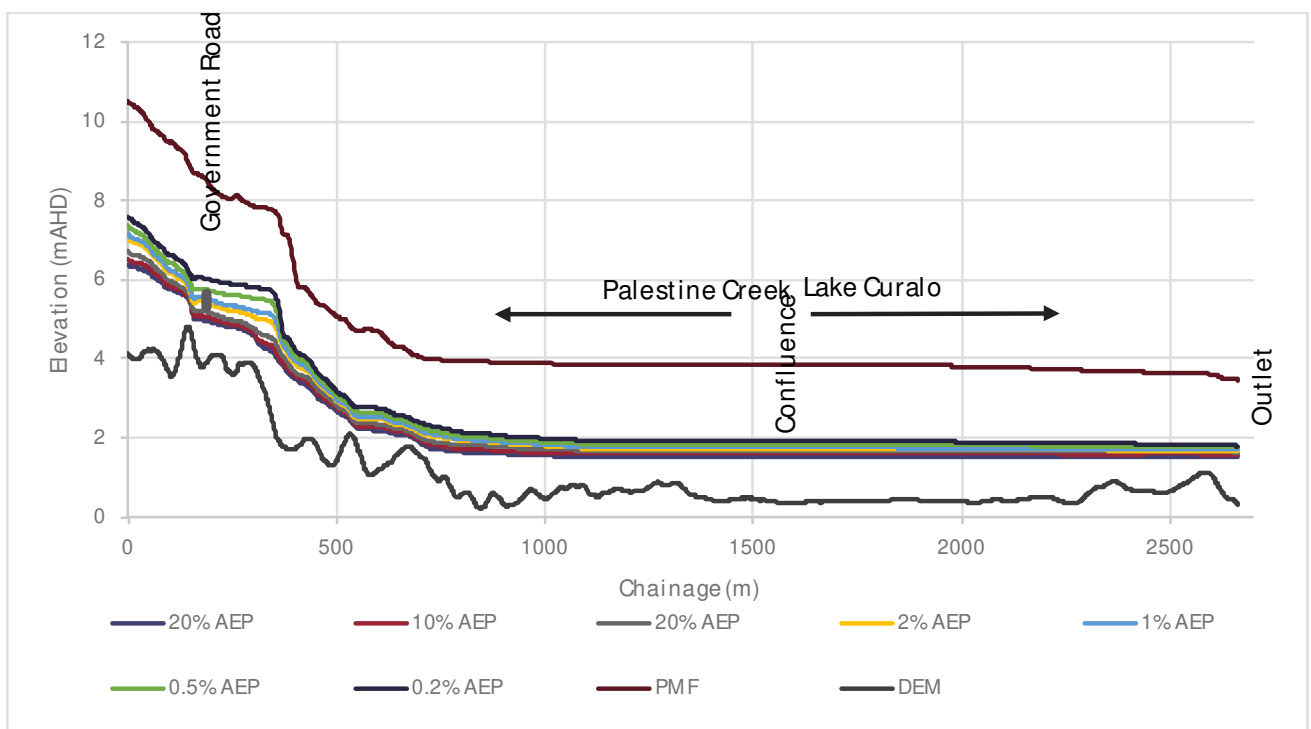
Figure 6-10 Lake Curalo Long Section

In the PM F event however, there is substantial overbank flow, largely driven by the increased lake levels (refer **Figure 6-10**) that results in inundation of the sports fields, and property flooding along Clare Crescent and Cook Drive. Lakeside Drive properties are also flooded in the PM F, but this is driven by lake levels, rather than catchment flow.

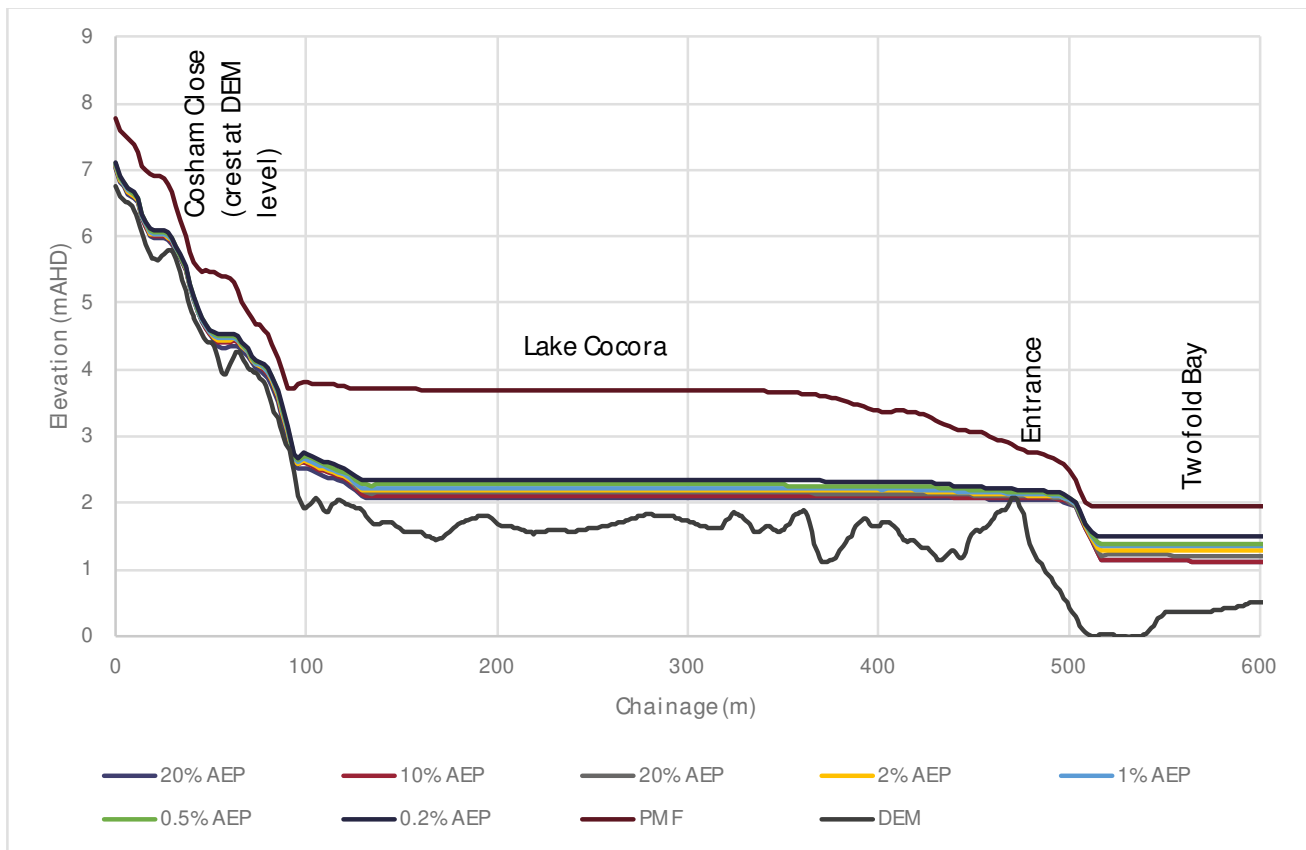
Figure 6-12 Lake Cocora Long Section

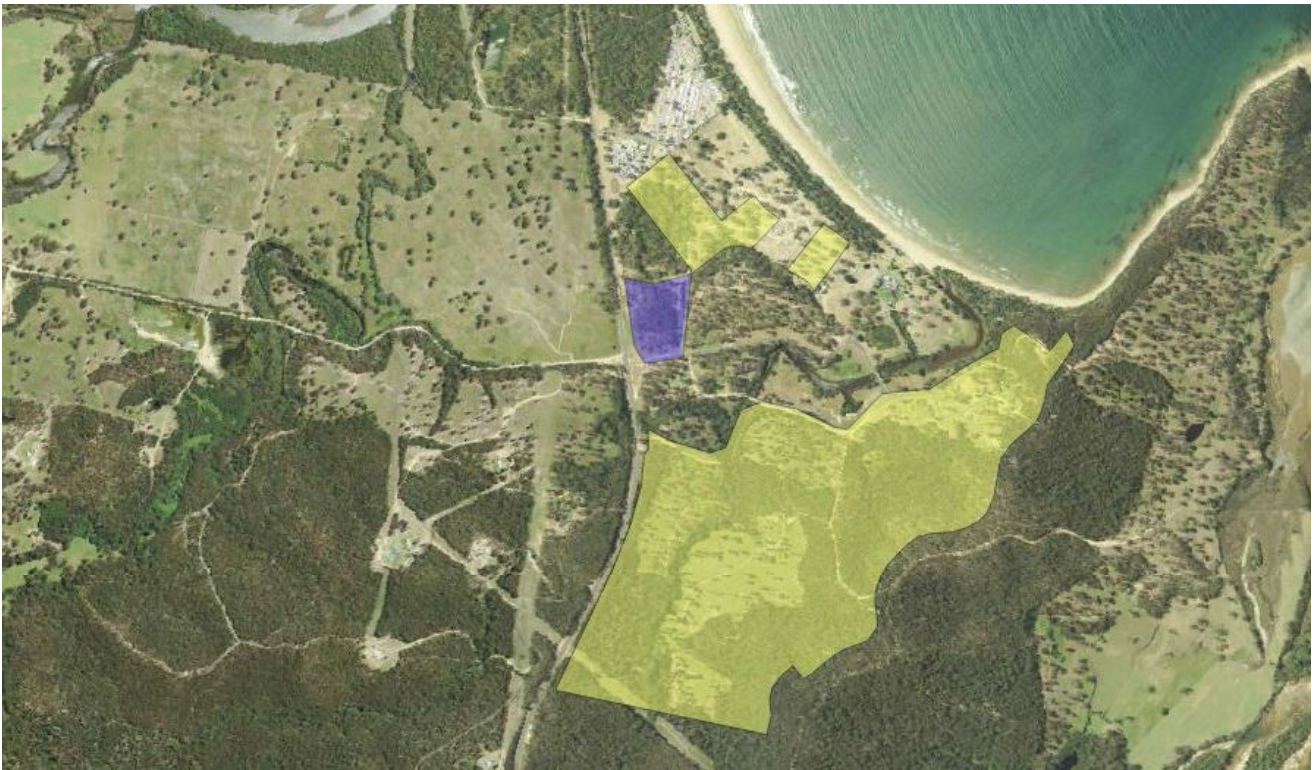
There are some regions of the catchment zoned low density residential and business that are currently undeveloped. These zones are at the downstream end of the catchment, between the Princes Highway and Twofold Bay (refer **Figure 7-1**). The hydrological model was updated to include this development. As it is located at the far downstream end, it had no impact on peak flow through the study areas, and consequently, no impact on peak flood levels. However, development within this region would have implications for the local drainage network, which would need to be assessed as part of the development of this region.

Figure 7-1 Regions of Permissible Future Development (Residential shaded yellow, Business shaded purple)

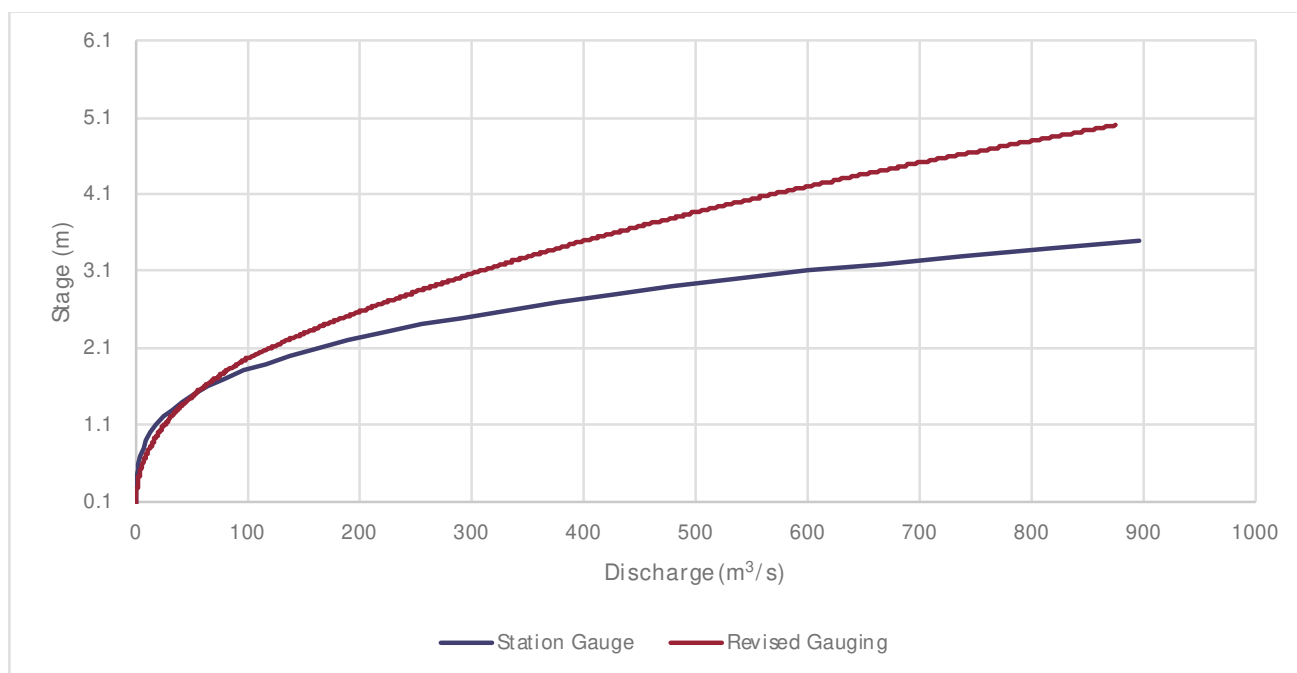
Figure B4 Rocky Hall Rating Curves

Once the roughness values had been calibrated for lower flows, a revised rating curve was established for the higher flows estimating the roughness for the banks and sides of the channel. These new rating curves, as well as the previous, original curves, are shown in **Figures B2 to B4**.

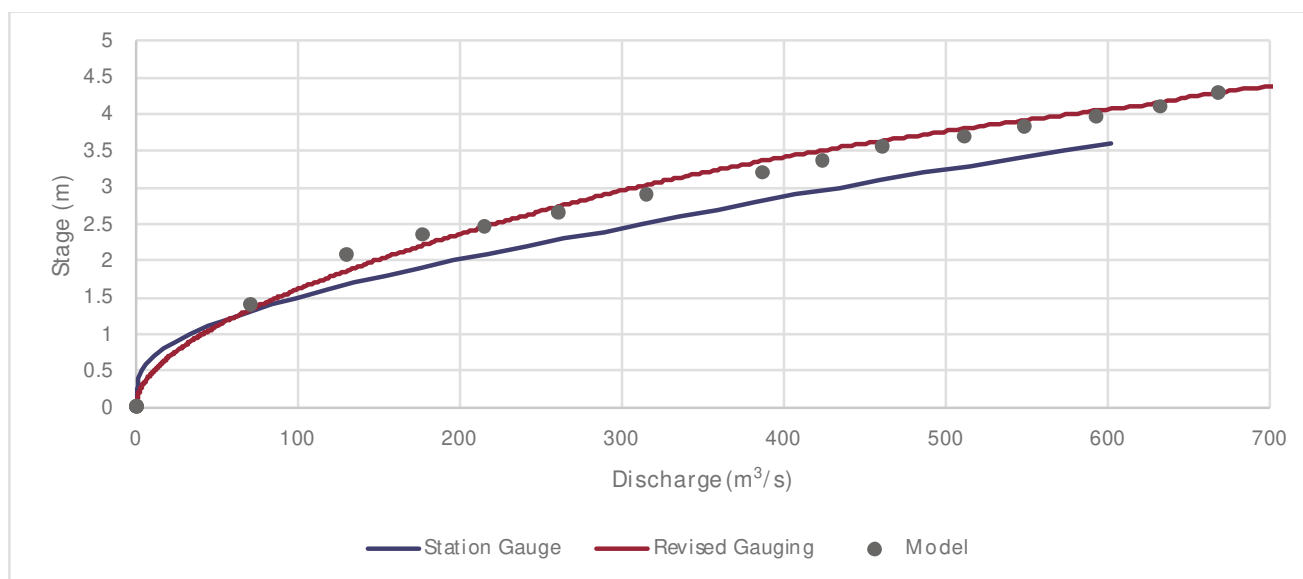
The rating curve extracted from the hydraulic model is shown against the revised and original rating curves in **Figure B5**.

Figure B5 Comparison of Calculated and Modelled Rating Curves at New Buildings

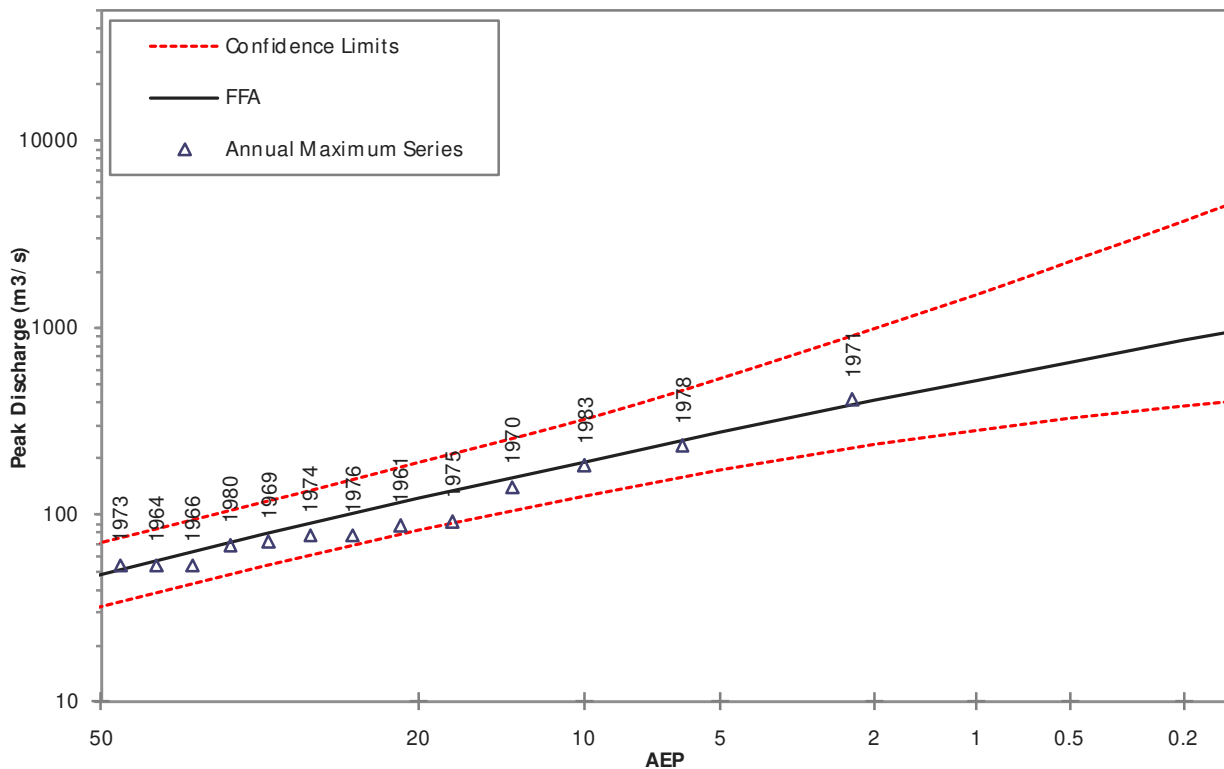
Figure B6 Rocky Hall FFA Comparison

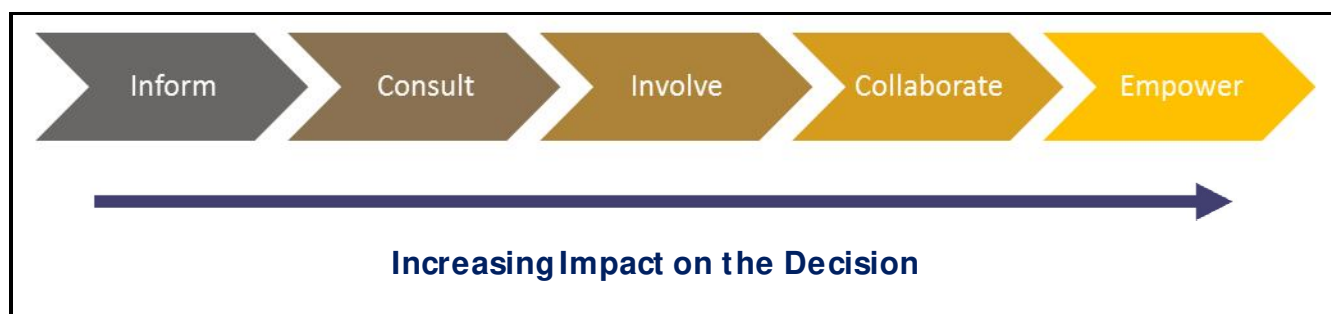
Figure C1 IAP2's Public Participation Spectrum

A stakeholder matrix was developed at the project inception to provide an overview of the different categories of stakeholders, and their relative level of interest, influence and impact on the Flood Study. The type of consultation to be undertaken with each stakeholder was based on the IAP2 consultation spectrum, conceptualised in **Figure C1**.

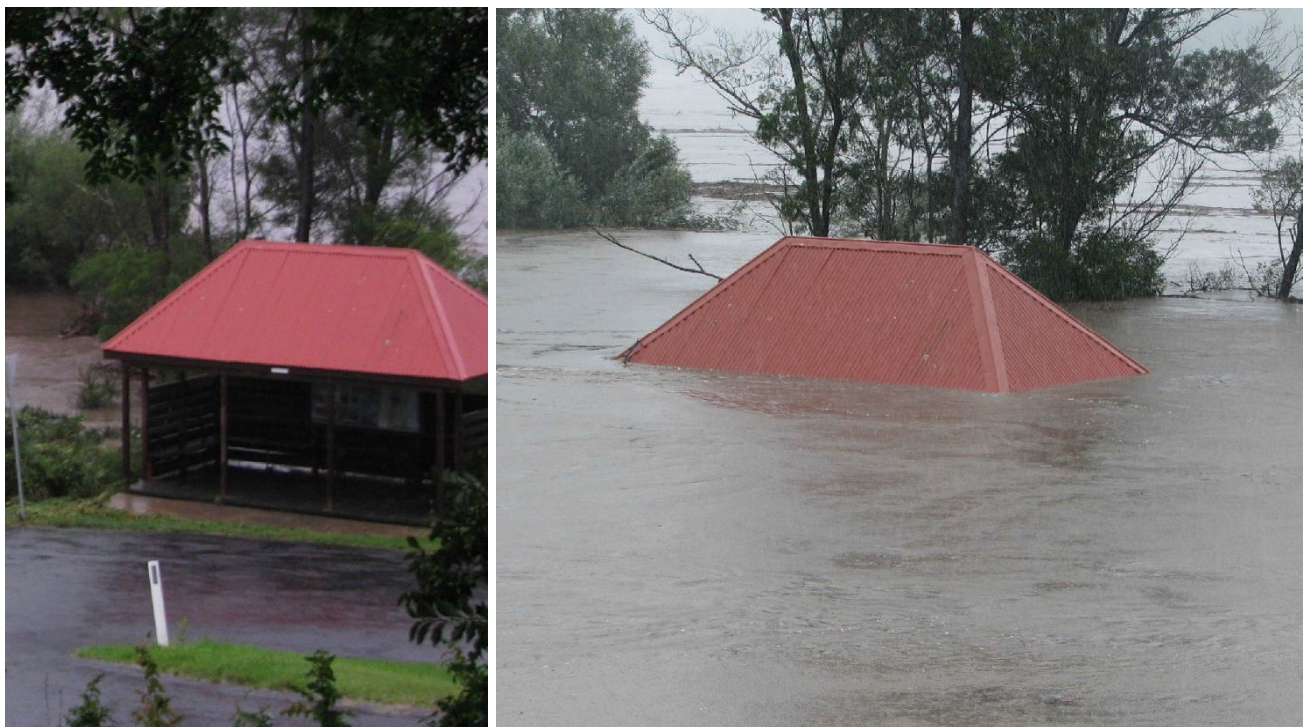
The point surveyed for the 1978 event was marked by a hacksaw on a post near the intersection of Yambulla Road and Towamba Street. The point was surveyed as being at 36.52m AHD. The model at this location has a level of 36.39m AHD, 0.13m lower than the survey mark.

Figure D-12 Towamba Bus Shelter Flooding in 2011
