**Bega Valley Shire Council**  
**Various Works**  
**Aboriginal Cultural Heritage Assessment Report**

**Date:** 23 October 2017

**Author:** Dr Julie Dibden

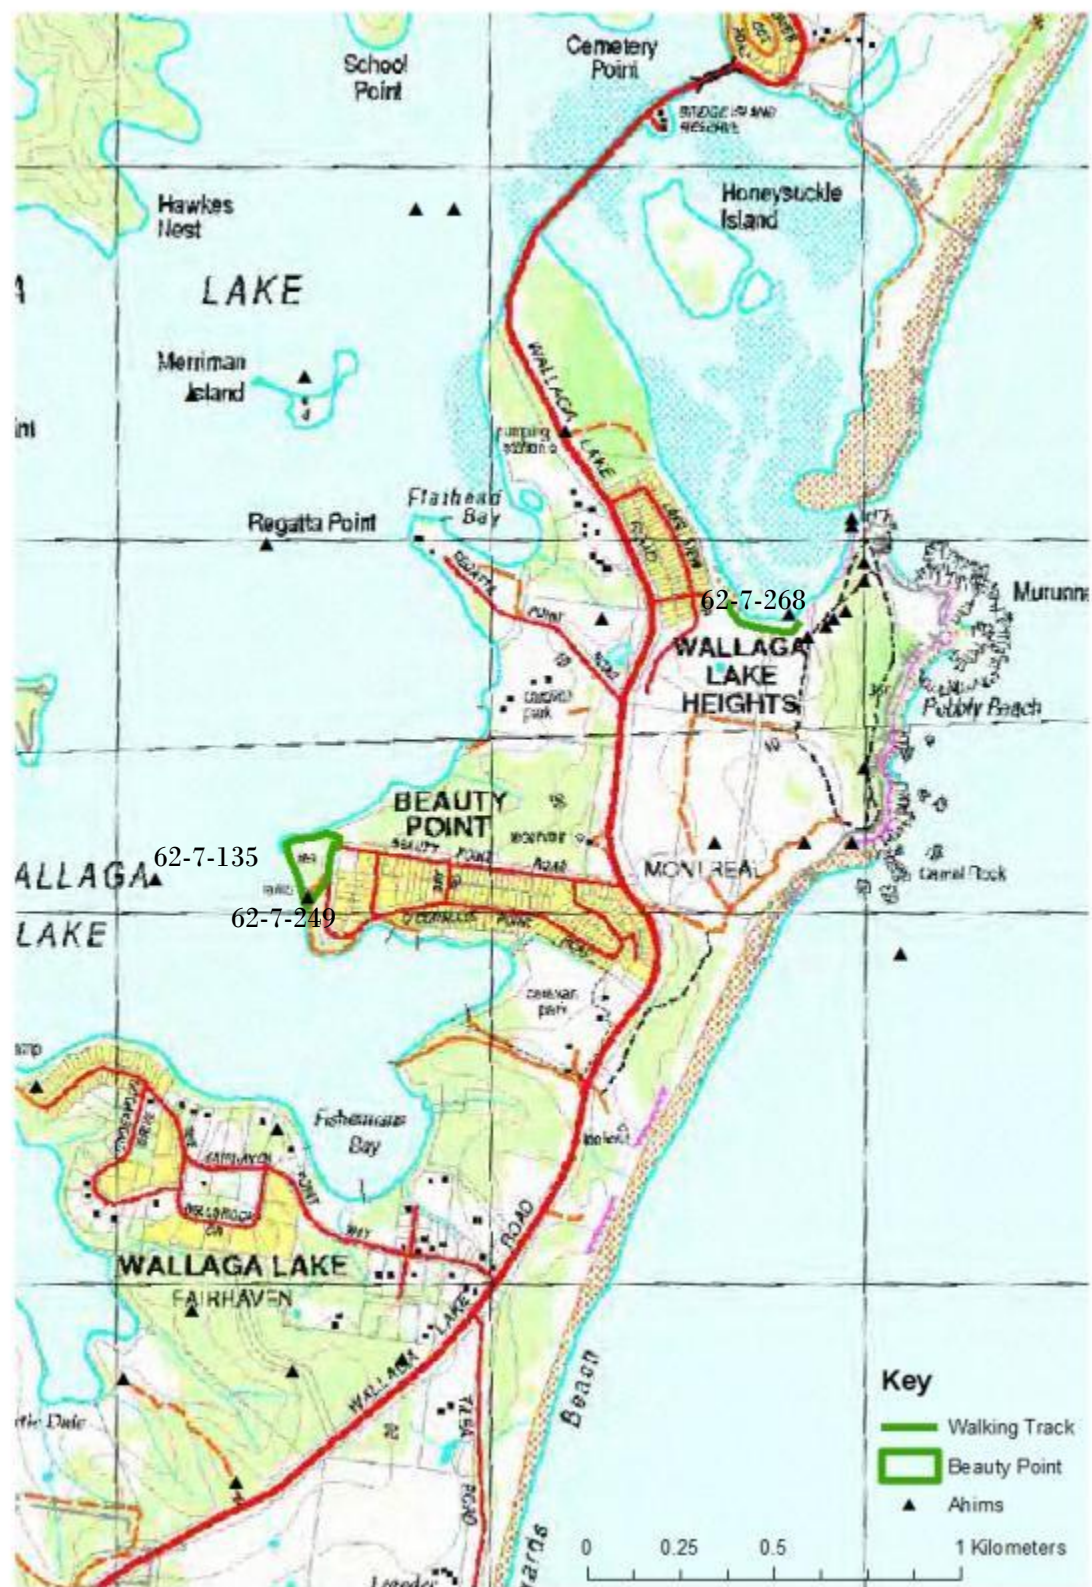
Figure 5 Location of AHIMS sites in respect of the proposed impact areas at Wallaga Lake.

This site consists of artefacts and shell and is located on the bedrock landform outside the area of proposed impact at the eastern end of the proposed walking track (Figure 5). If works are confined to the estuarine sand landform, the AHIMS site would not be impacted.
- Beauty Point Boat Ramp and Carpark      AHIMS #62-7-135 - *Beauty Pt 36/40*

This site is described as a stratified open midden consisting of shell and charcoal, on a rock headland situation, over an area measuring 3000m<sup>2</sup>. This site plots in the lake c. 360 m west of the Beauty Point Headland. It is not certain exactly where it is, but it is likely to be the site (discussed further below in Results) in the proposed carpark (Figure 5).

This site is described as a large, disturbed midden. It is located at the site of the existing boat ramp at the water's edge (Figure 5).
- Tathra Headland      AHIMS #62-6-95 - *Kianniny/Tathra*

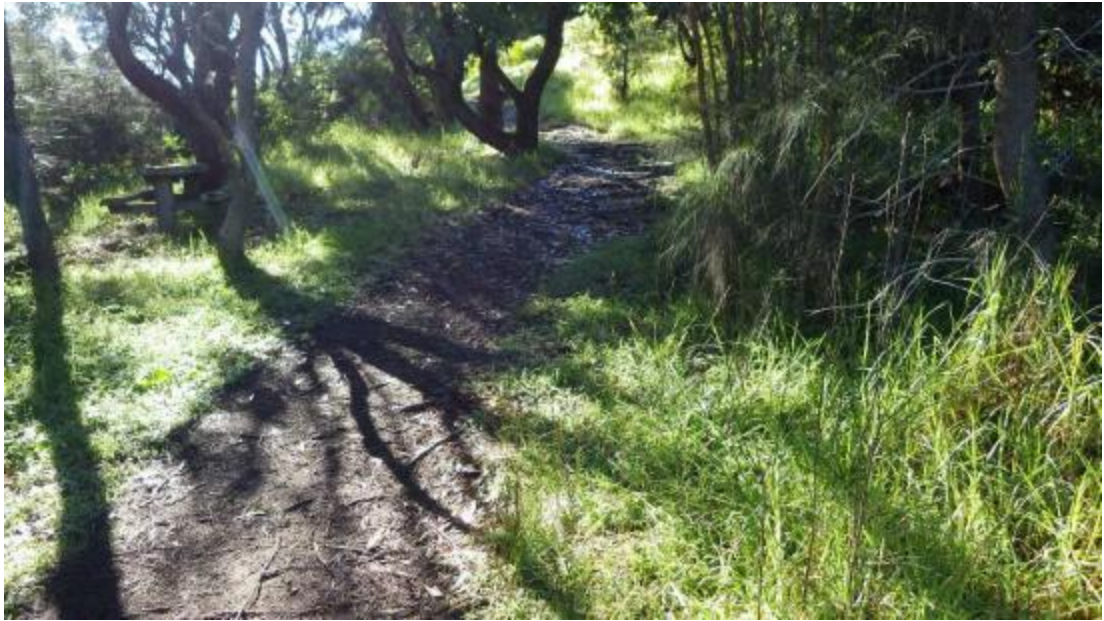
Plate 3 Wallaga Lake. East of the eastern end of the walkway where shell fragments (AHIMS 62-7-268) observed on the sloping landform. Area is outside proposed impact area. Looking 30°.

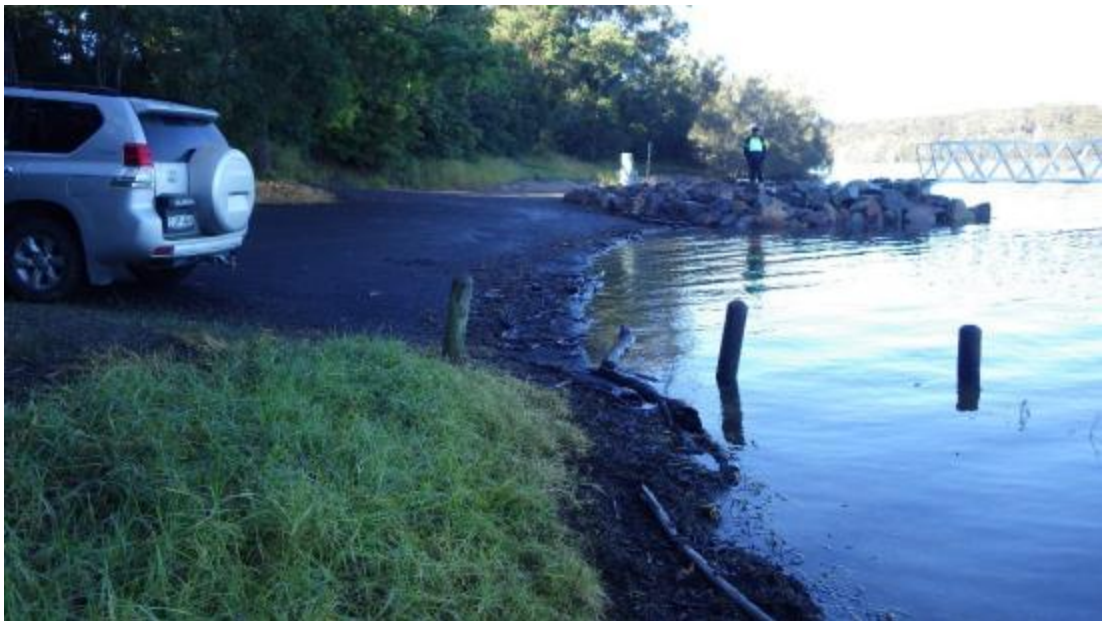
Plate 4 Beauty Point Boat Ramp and location of AHIMS 62-7-249. Looking 140°. The existing boat ramp is the area between the bollards and rock wall.

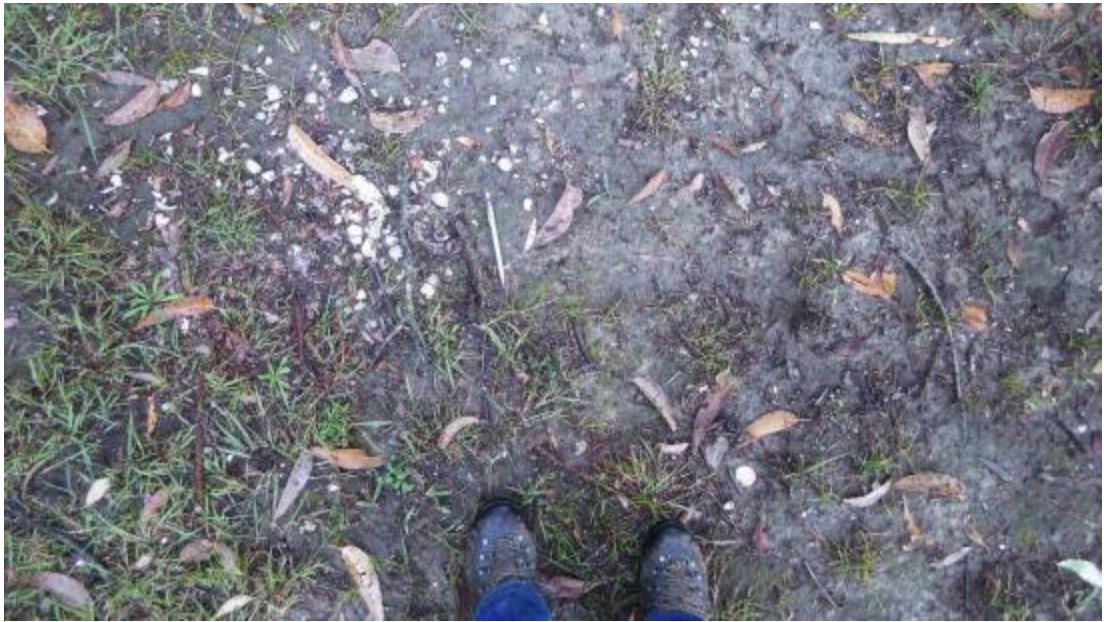
**Plate 5** Beauty Point carpark. An example of exposure and shell fragments in AHIMS #62-7-135. Note, shell and gravels are a lag deposit on an eroded clayey hard packed ground surface.

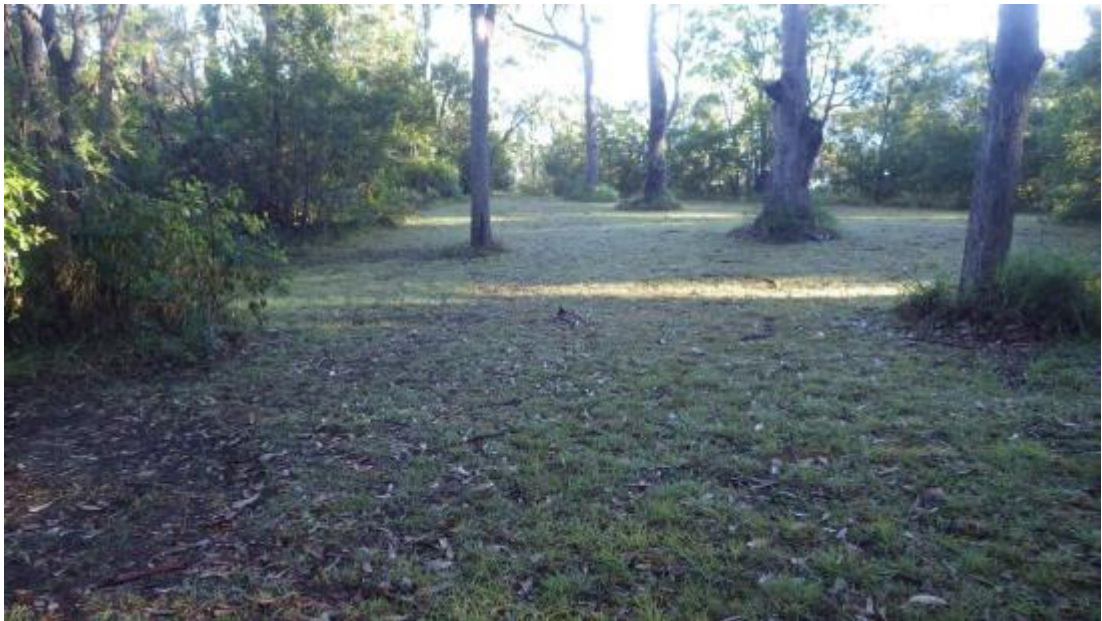
Plate 7 Beauty Point - The northwest area of AHIMS #62-7-135 taken from the edge of the proposed carpark works and showing area which will be excluded from impacts.

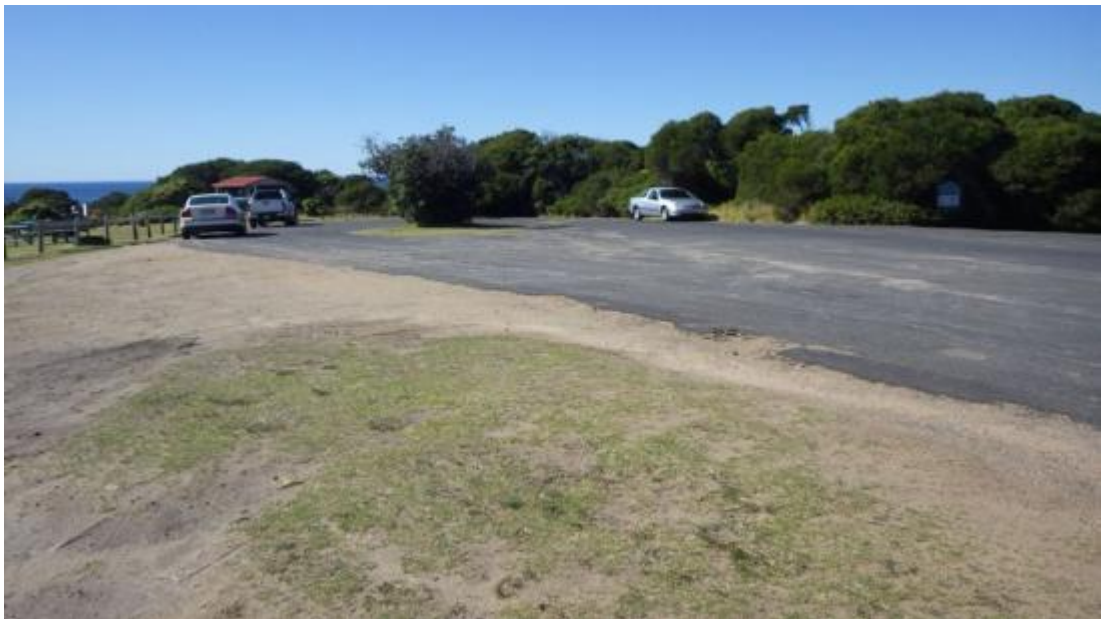
Plate 8 Tathra Headland road terminus and carpark/turning circle; looking 60°. Note the original two-lane wharf road originally continued eastward from the current road terminus (ie beyond the area where the car on the right is parked).

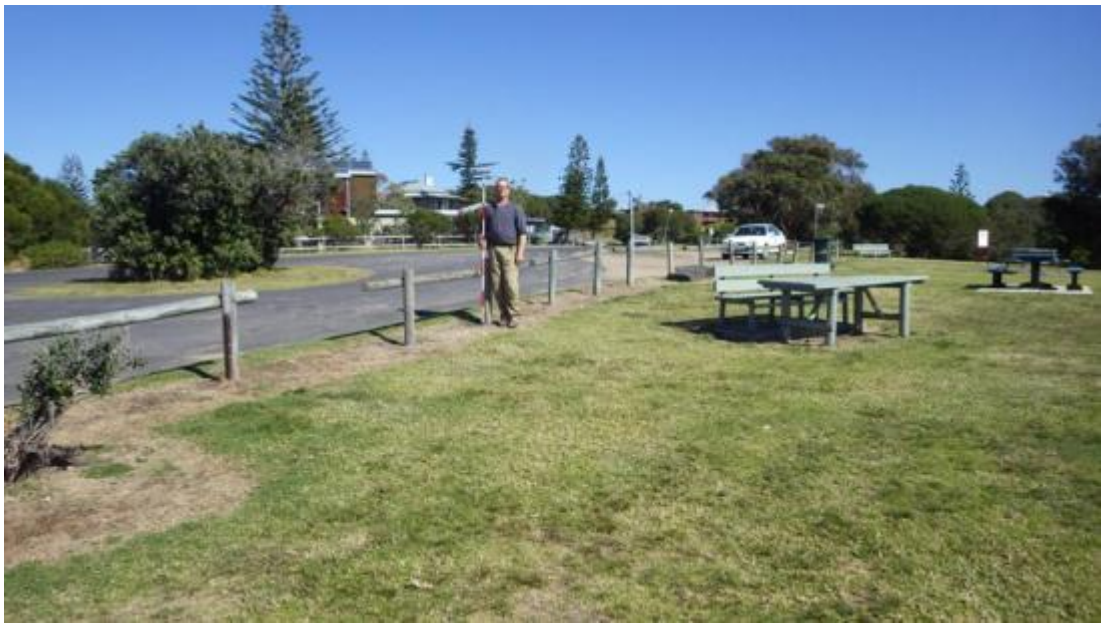
Plate 9 Tathra Headland - The edge of the Lions Park looking 220° along the interface between the road and park where a quartz artefact was found (at man with pole). Note. It is proposed to replace the existing bollards with a sturdier type.

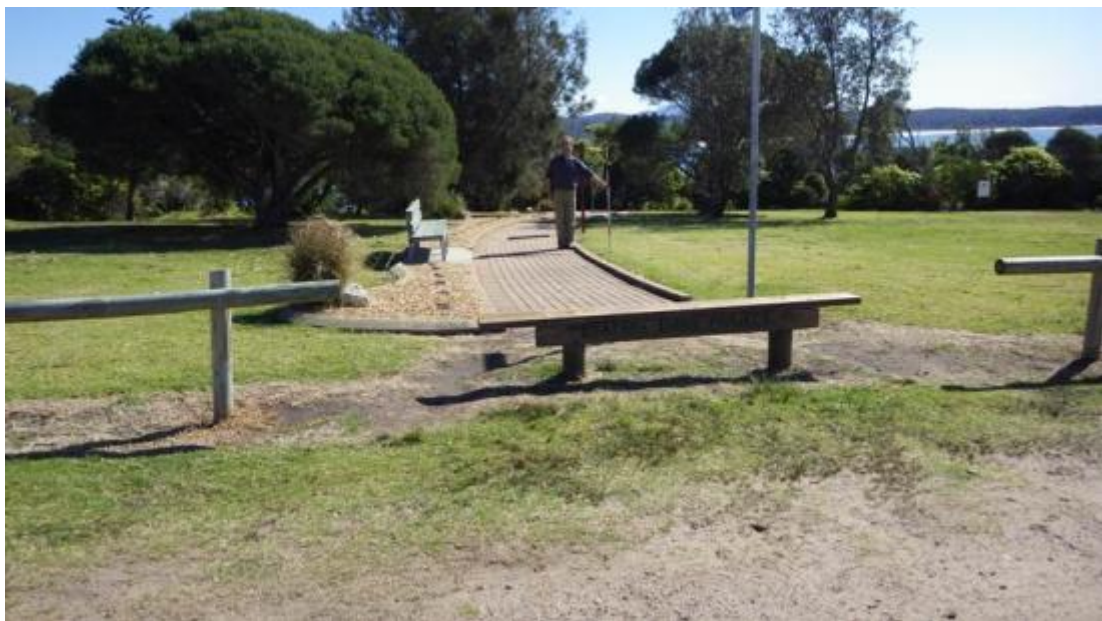
Plate 10 Tathra Headland Lions Park looking 300° from the road along the western section of the existing memorial walk. Note the gravel garden on the west side of the path with memorial plaques.

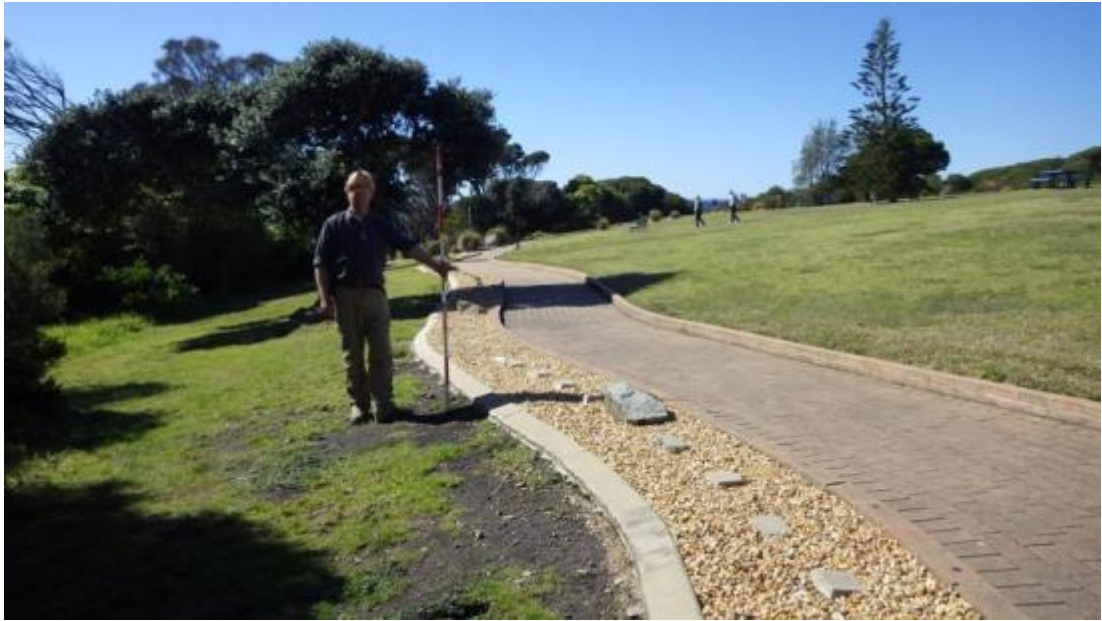
Plate 11 Tathra Headland Lions Park looking 60° along the northern section of the existing memorial walk. Note the gradient and erosional context. The exposed ground is highly compacted and eroded with nil topsoil and hence no subsurface archaeological potential

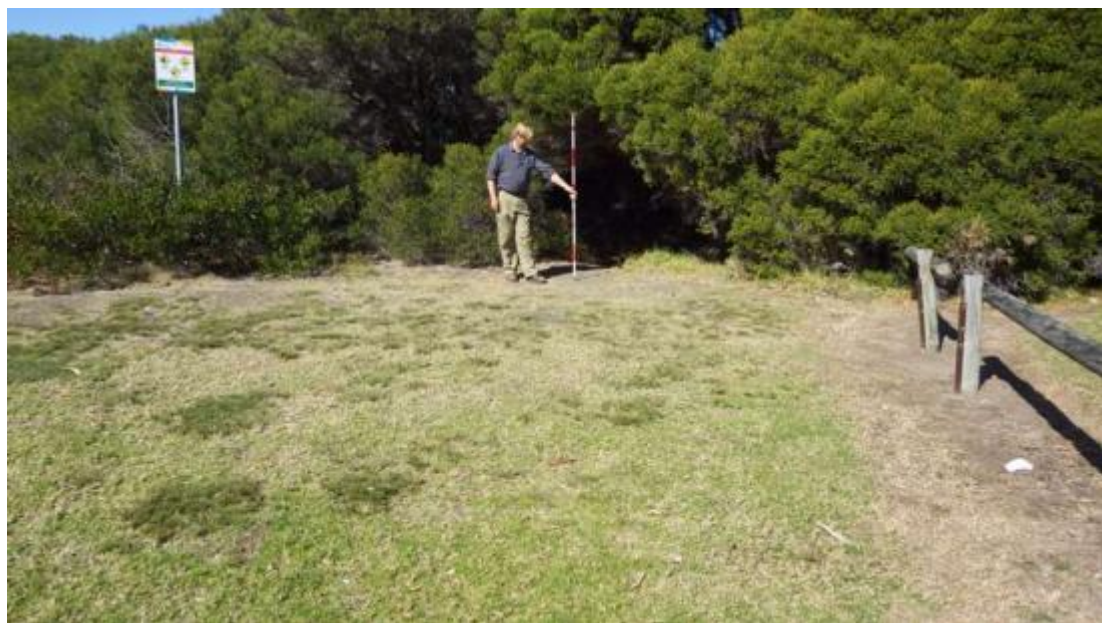
Plate 12 Tathra Headland - The edge of the Lions Park looking 130° to the entrance to the current informal walkway on the old road where a possible quartz artefact was found (at man with pole).

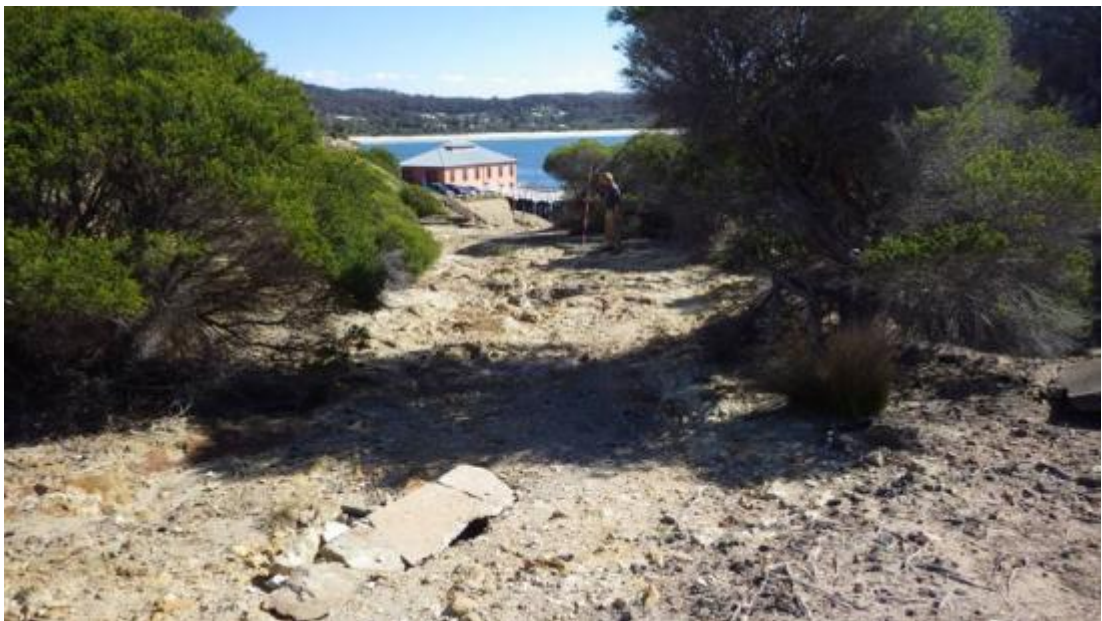
Plate 14 Tathra Headland - The old, eroded two-lane Tathra Wharf road; looking west.

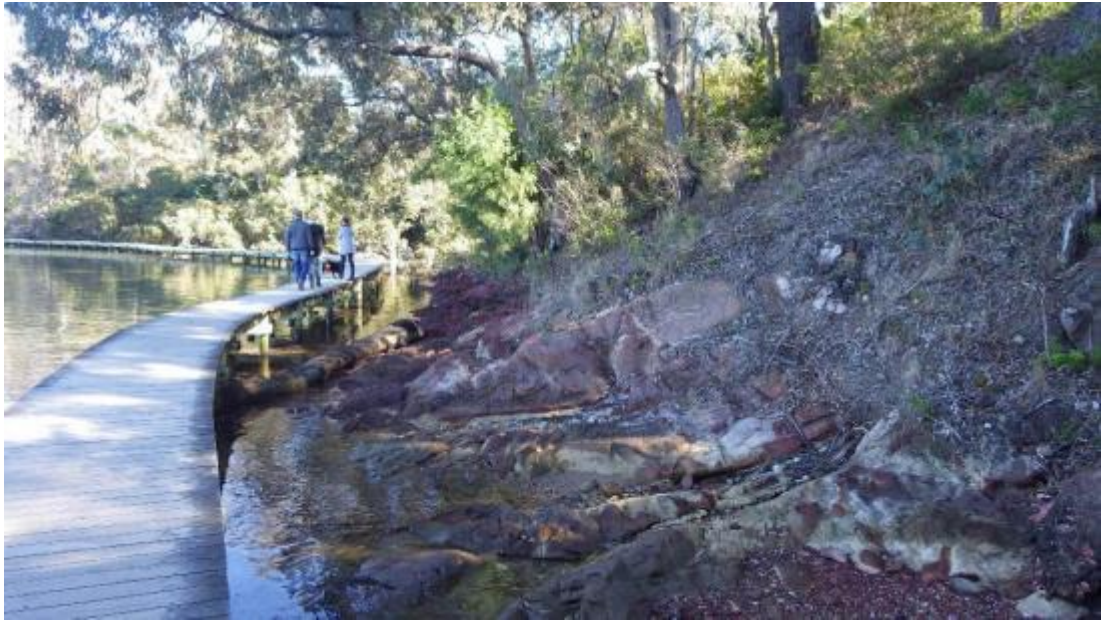
**Plate 17 Merimbula Lake Walkway - Merimbula boardwalk - east end; looking 250°.**  
Note steep cliff and erosion to bedrock at lake edge.

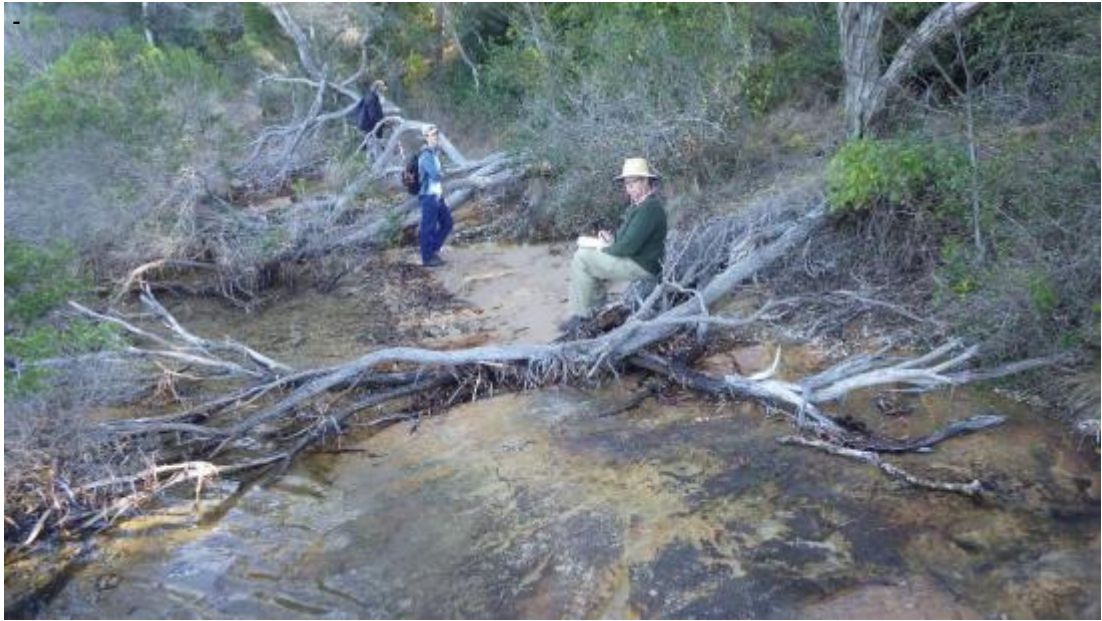
Plate 19 Merimbula Lake Walkway - Area of shell at the shoreline in AHIMS 62-6-98; looking west.

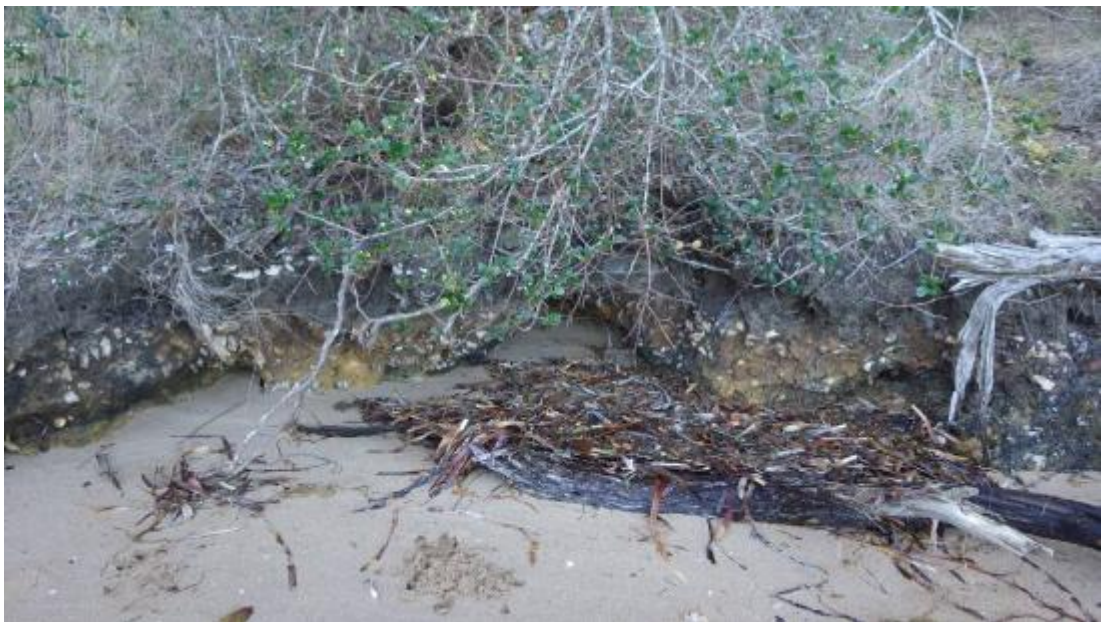
Plate 20 Merimbula Lake Walkway - Lens of shell at the shoreline in AHIMS 62-6-98.

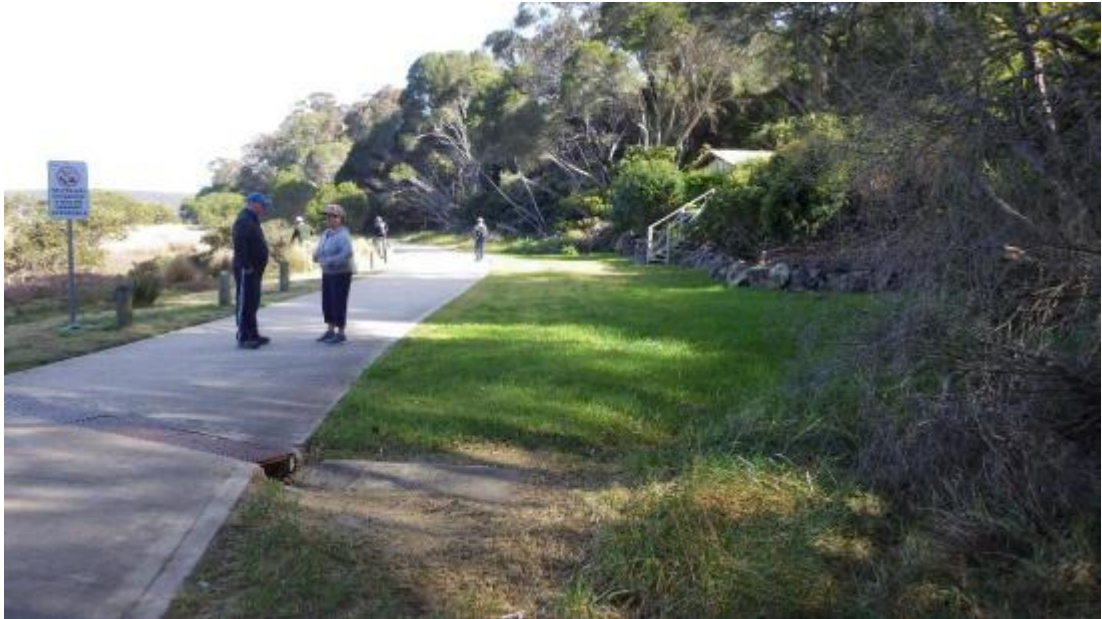
**Plate 21 Merimbula Lake Walkway - Looking towards AHIMS site 62-6-100. Note landscaped and developed area.**

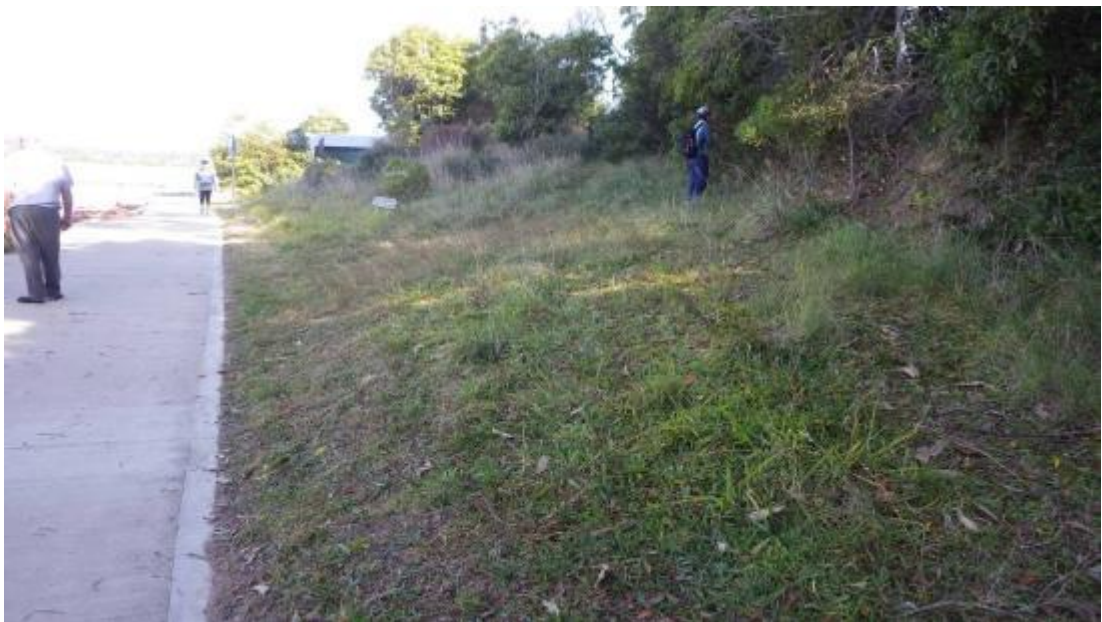
**Plate 22 Merimbula Lake Walkway - Looking 200° towards the point where the main midden deposit of AHIMS 62-6-138 is visible behind the boat shed (green building in distance).**

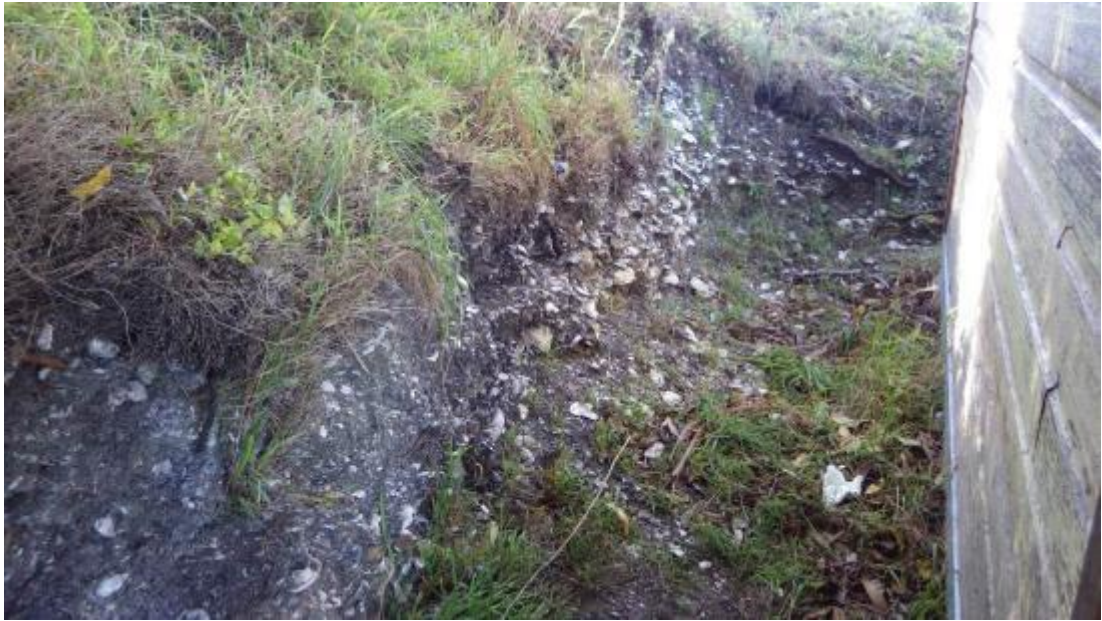
**Plate 23 Merimbula Lake Walkway - The main midden deposit of AHIMS 62-6-138 visible in the cutting behind the boat shed.**

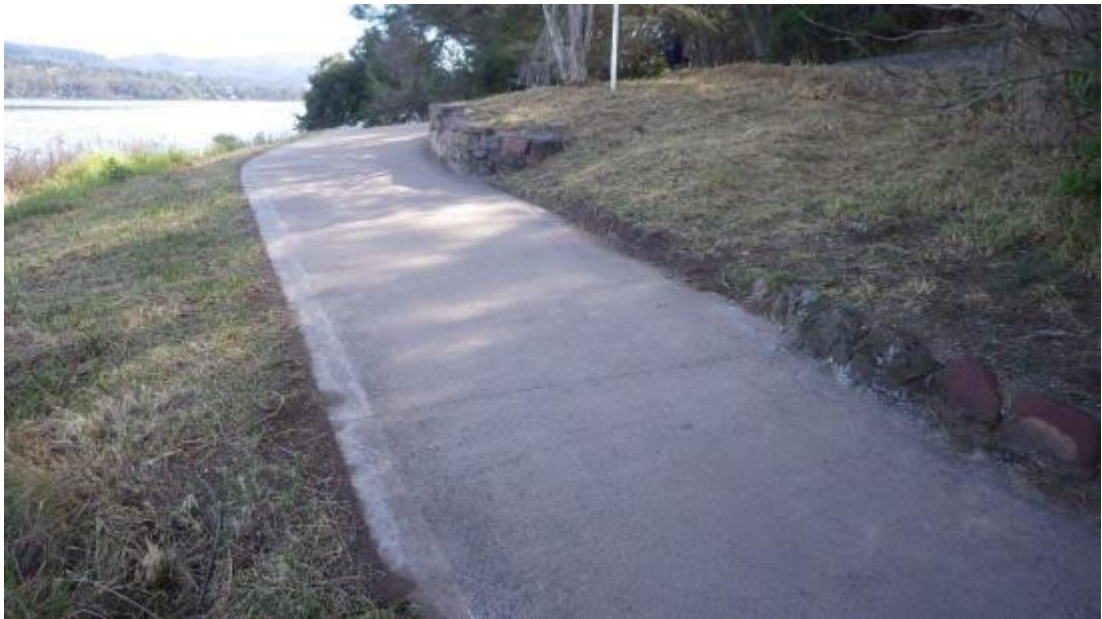
**Plate 24 Merimbula Lake Walkway - AHIMS site 62-6-135; looking 290°.**

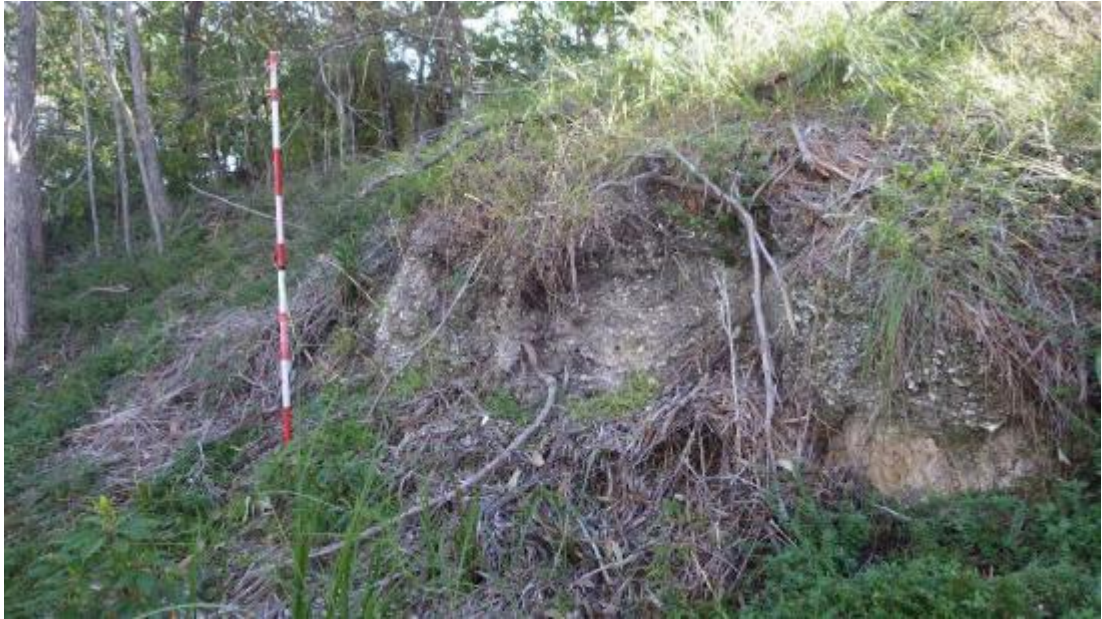
Plate 25 Merimbula Lake Walkway - A section of AHIMS site 62-6-135 in a deep road cutting behind the walkway; looking 290°.

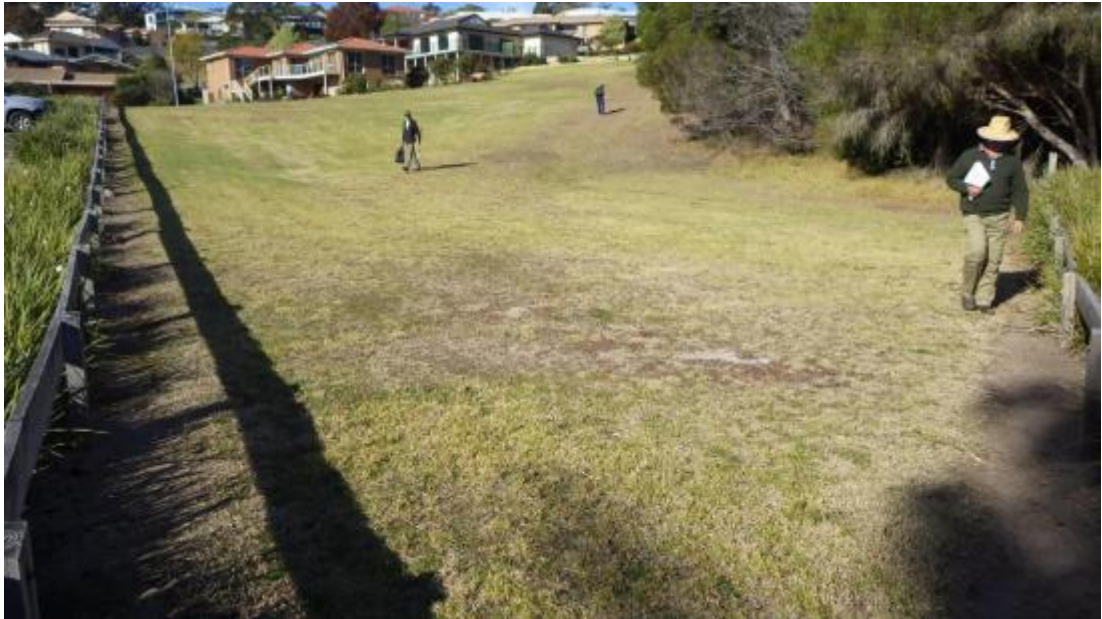
Plate 29 Merimbula Lake Walkway - *Merimbula 4*; looking 90°; artefact at figure at top right.

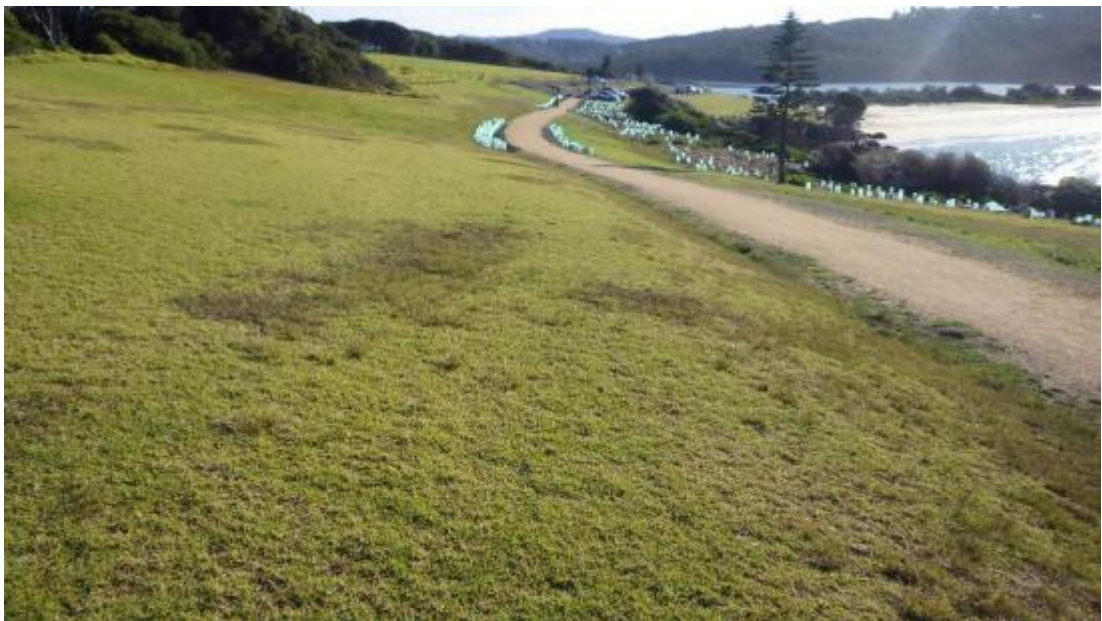
Plate 32 Short Point - New Walkway and area in which stone artefacts were previously retrieved, looking 270°.

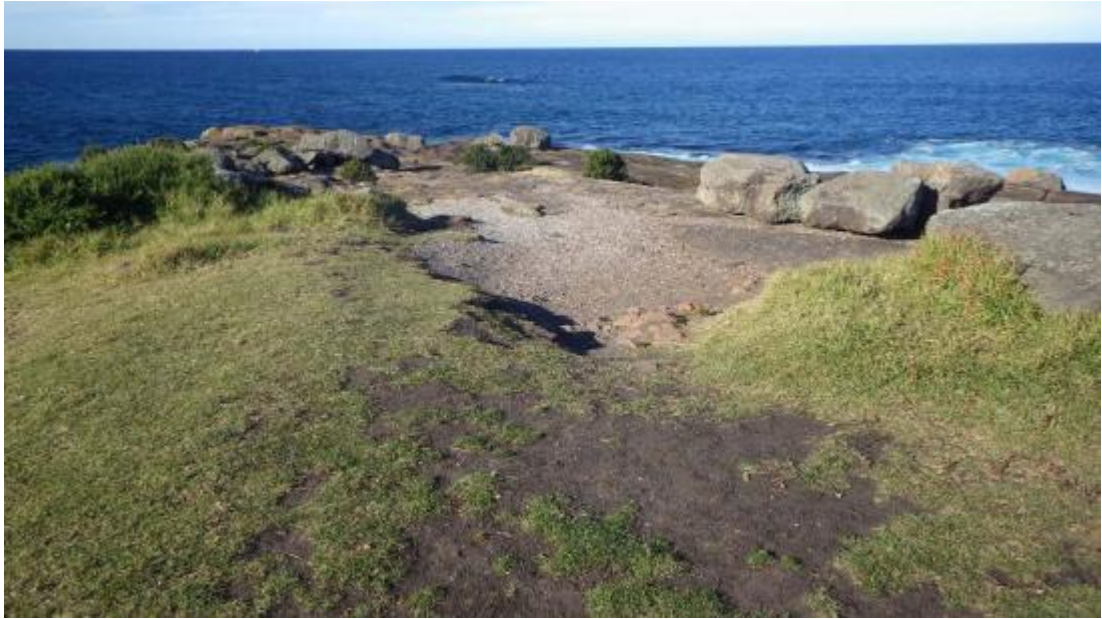
Plate 33 Short Point - The midden at the east end of the point, looking 90°.

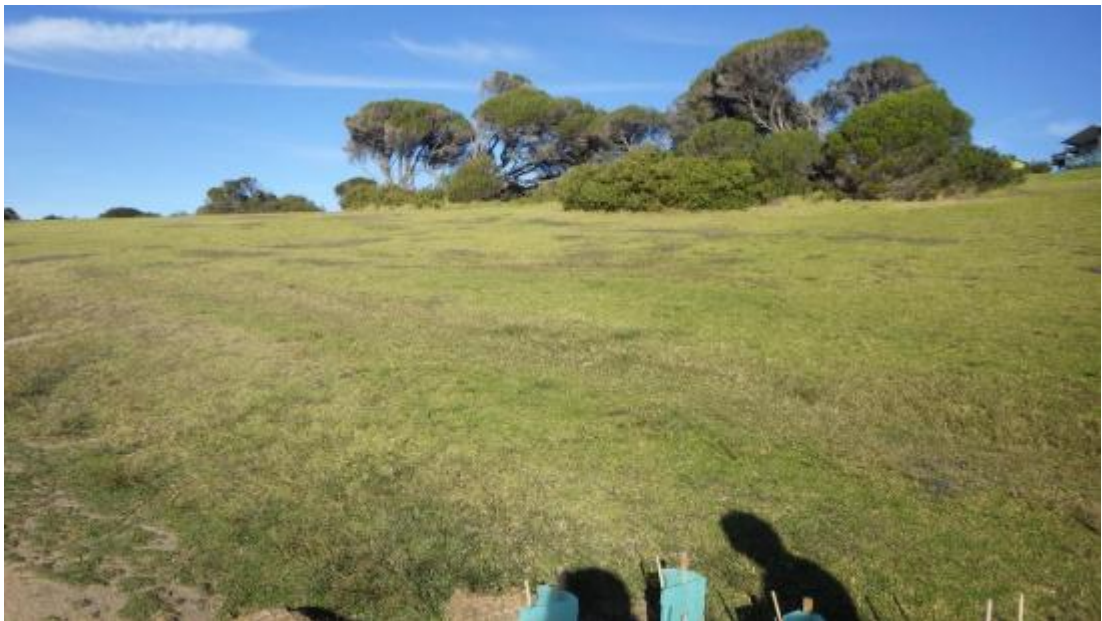
Plate 34 Short Point - Clump of tree where artefacts re-located: looking 40°.

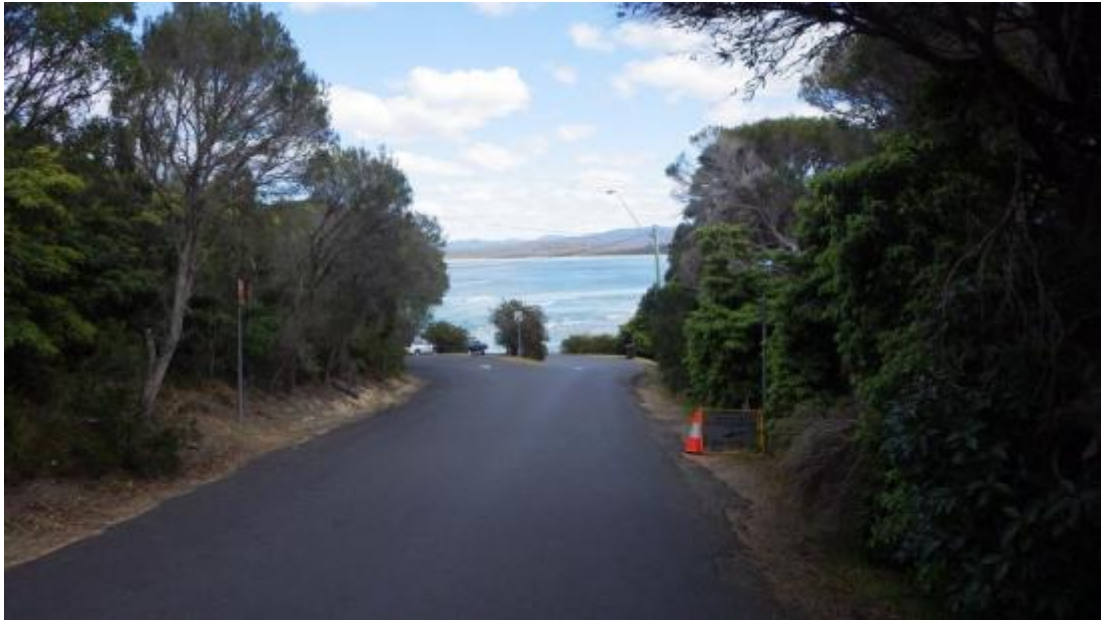
**Plate 35 Merimbula Bar Beach** - The road into the area looking 210°. Note road cut and benched.

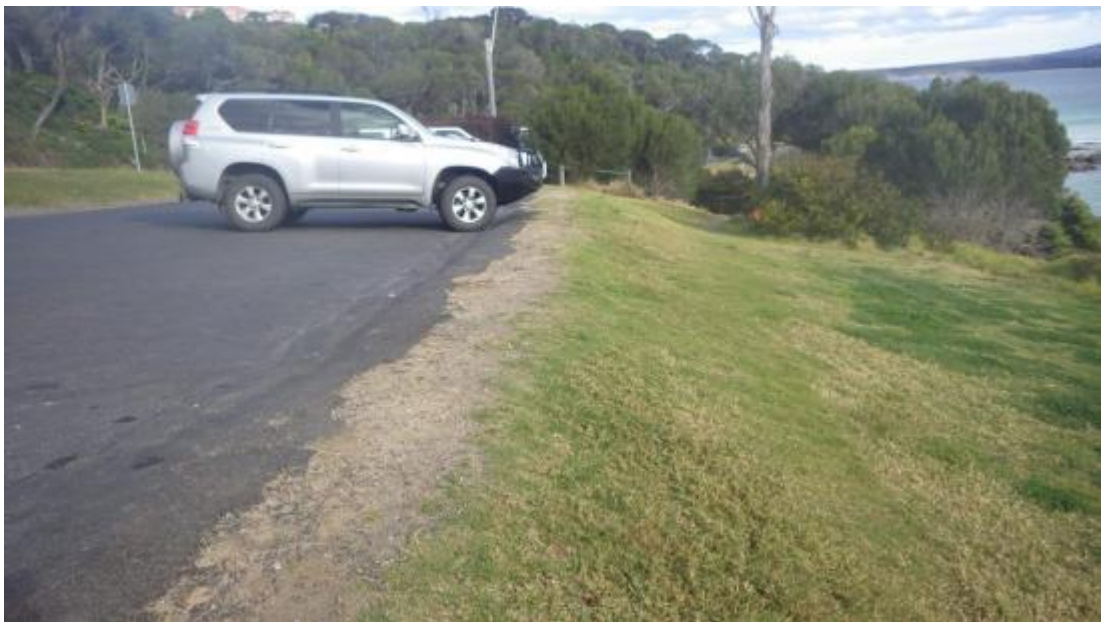
**Plate 36 Merimbula Bar Beach** - Upper carpark area at north end. Note cut and benching. *Bar Beach 2* - Sparse, highly fragmented shell present in area between bitumen and grass.

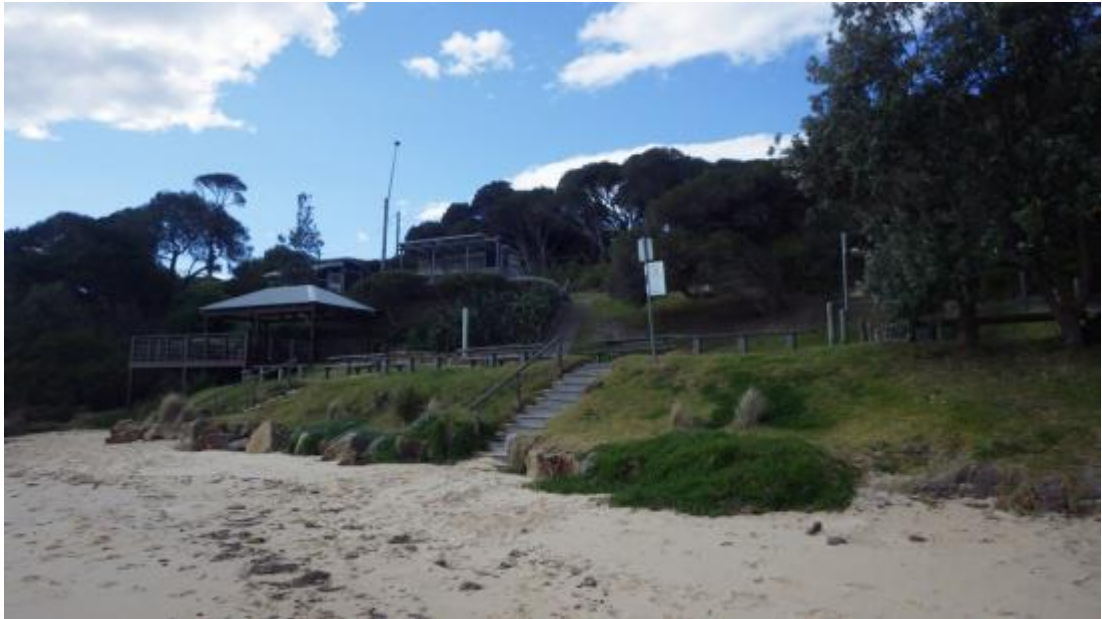
**Plate 37 Merimbula Bar Beach - Recreational area with kiosk and toilets above; looking north. Note the recreation area beyond the stairs is composed of fill.**

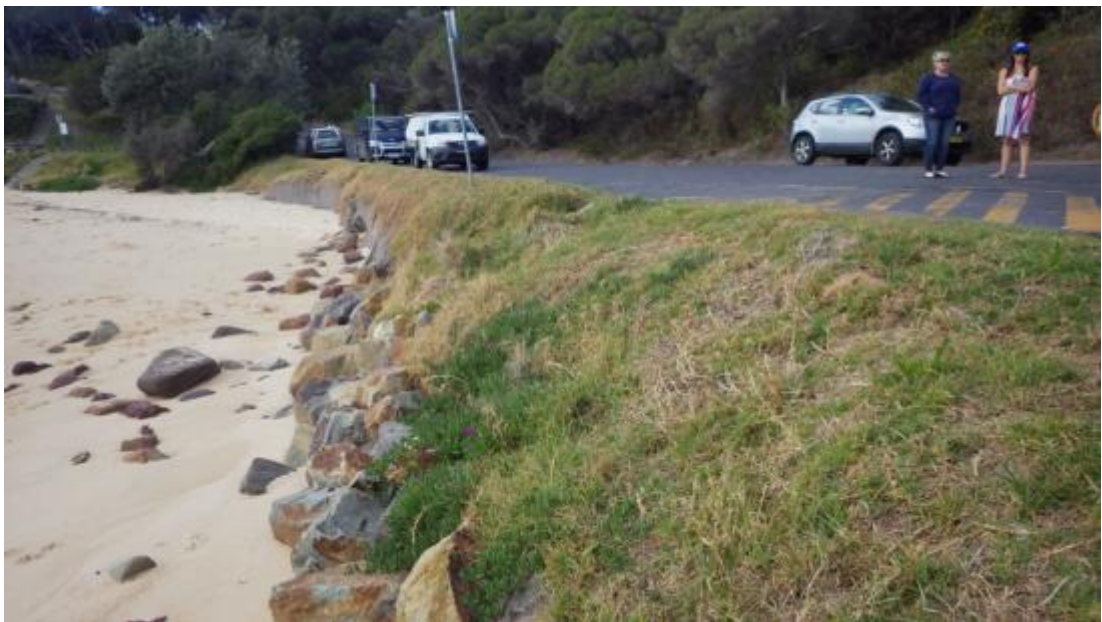
**Plate 38 Merimbula Bar Beach - Southern bit of road and carparking with recreational area at top left; looking 20°. Note the road appears to be composed of fill.**

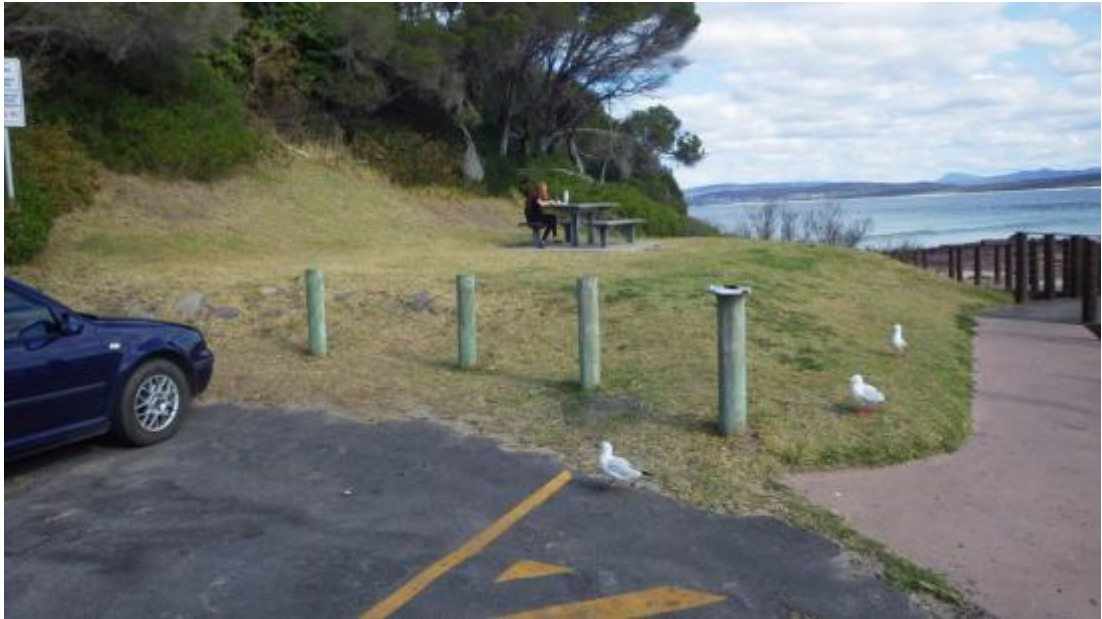
Plate 39 Merimbula Bar Beach - Southern recreational area and location of AHIMS 62-6-496/540; looking south.

**AHIMS #62-6-496 – Bar Beach 1/AHIMS #62-6-540 – Bar Beach Rd.** Note. This is a duplicate recording (Figure 7).

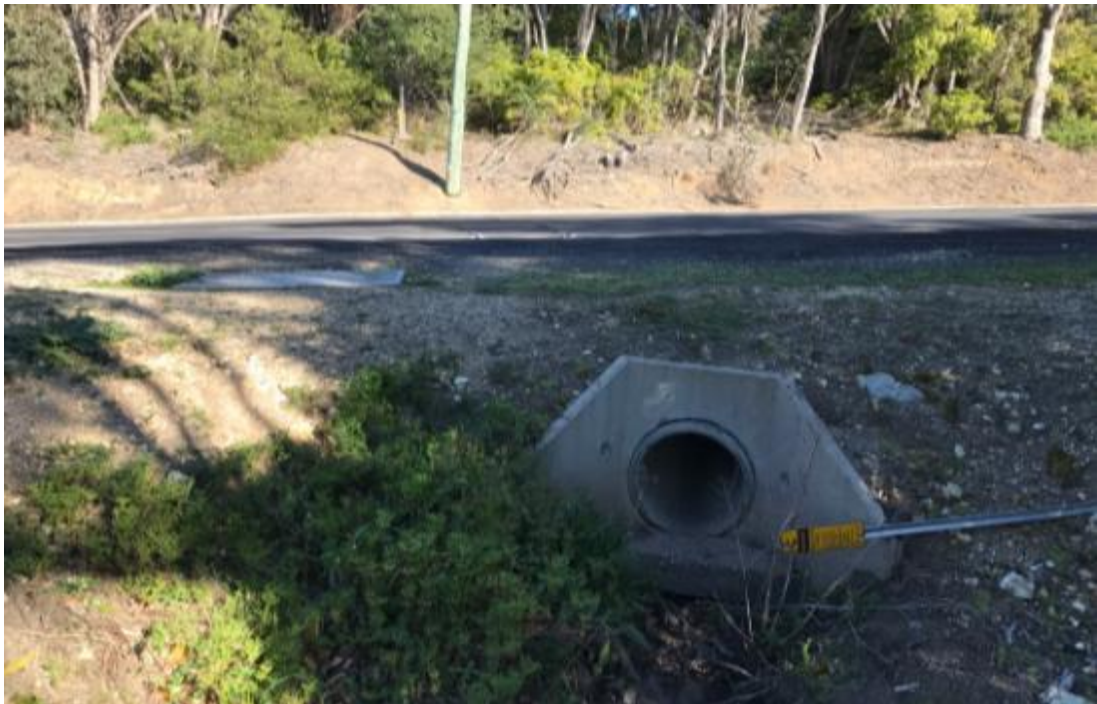
**Plate 41 Eden - Example of extensive disturbance along Albert Terrace, looking west.**

Site	Assessment	Results
	include culverts and underground services. Introduced gravels dominated all areas of surface exposure (Plates 41 & 42).	
Albert Terrace-Museum Street pathway and viewing platform	The entire Lions Park, on the corner of Museum Street and Albert Terrace, was inspected. This was the only portion of the Albert Terrace upgrade area that afforded any archaeological visibility. A shallow sandy topsoil was observed with bedrock and gravelly subsoils exposed in some isolated areas of bare earth. Prior impacts at Lions Park include topsoil removal (earthworks and erosion), embankment fill, underground services and installation of picnic table and power poles (Plate 43).	No AHIMS sites are present. No Aboriginal objects were recorded. The impact area is disturbed and assessed to be of generally low archaeological potential.
Imlay Street-Albert Terrace intersection upgrade	All areas of proposed impacts around the Albert Terrace-Imlay Street-Museum Street intersections were inspected. The existing land surface through this area is generally highly modified with archaeological visibility largely restricted by sealed surfaces (roads and paths) or existing cuttings and introduced fill (Plates 44 & 45). A few areas of more intact land surface with ground exposure were observed around the corner of Imlay Street and Cocora Street. Archaeological visibility in this area was reasonable to good; no	No AHIMS sites are present. No Aboriginal objects were recorded. The impact area is disturbed and assessed to be of generally low to very low archaeological potential.
