**Bega Valley Shire Council**  
**Various Works**  
**Aboriginal Cultural Heritage Assessment Report**

**Date:** 23 October 2017

**Author:** Dr Julie Dibden

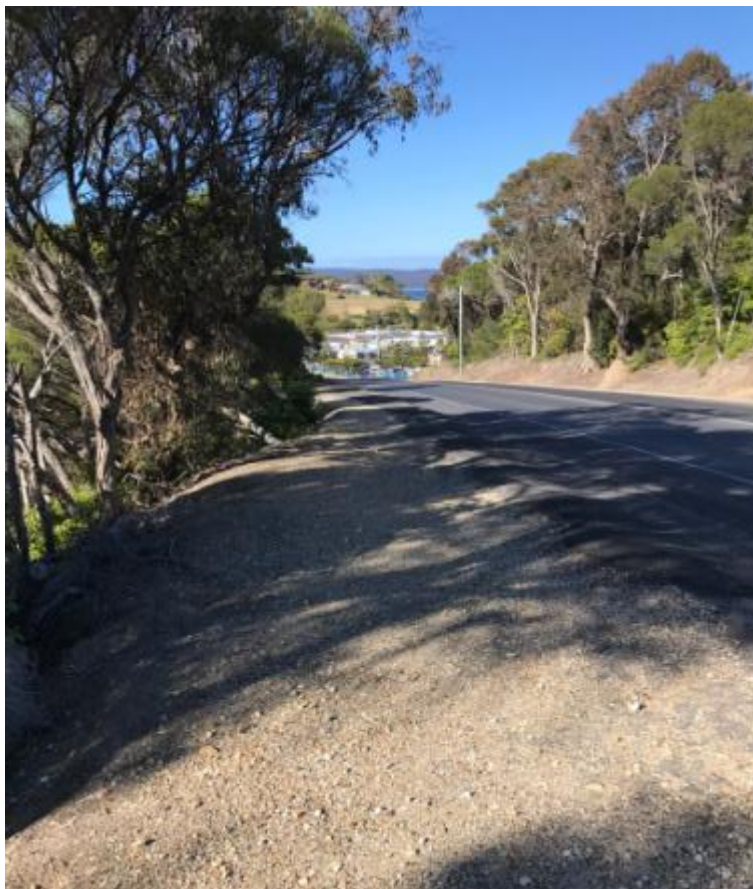
**Plate 42 Eden - General view of proposed pathway along eastern margin of Albert Terrace, looking south.**

Site	Assessment	Results
	include culverts and underground services. Introduced gravels dominated all areas of surface exposure (Plates 41 & 42).	
Albert Terrace-Museum Street pathway and viewing platform	The entire Lions Park, on the corner of Museum Street and Albert Terrace, was inspected. This was the only portion of the Albert Terrace upgrade area that afforded any archaeological visibility. A shallow sandy topsoil was observed with bedrock and gravelly subsoils exposed in some isolated areas of bare earth. Prior impacts at Lions Park include topsoil removal (earthworks and erosion), embankment fill, underground services and installation of picnic table and power poles (Plate 43).	No AHIMS sites are present. No Aboriginal objects were recorded. The impact area is disturbed and assessed to be of generally low archaeological potential.
Imlay Street-Albert Terrace intersection upgrade	All areas of proposed impacts around the Albert Terrace-Imlay Street-Museum Street intersections were inspected. The existing land surface through this area is generally highly modified with archaeological visibility largely restricted by sealed surfaces (roads and paths) or existing cuttings and introduced fill (Plates 44 & 45). A few areas of more intact land surface with ground exposure were observed around the corner of Imlay Street and Cocora Street. Archaeological visibility in this area was reasonable to good; no	No AHIMS sites are present. No Aboriginal objects were recorded. The impact area is disturbed and assessed to be of generally low to very low archaeological potential.

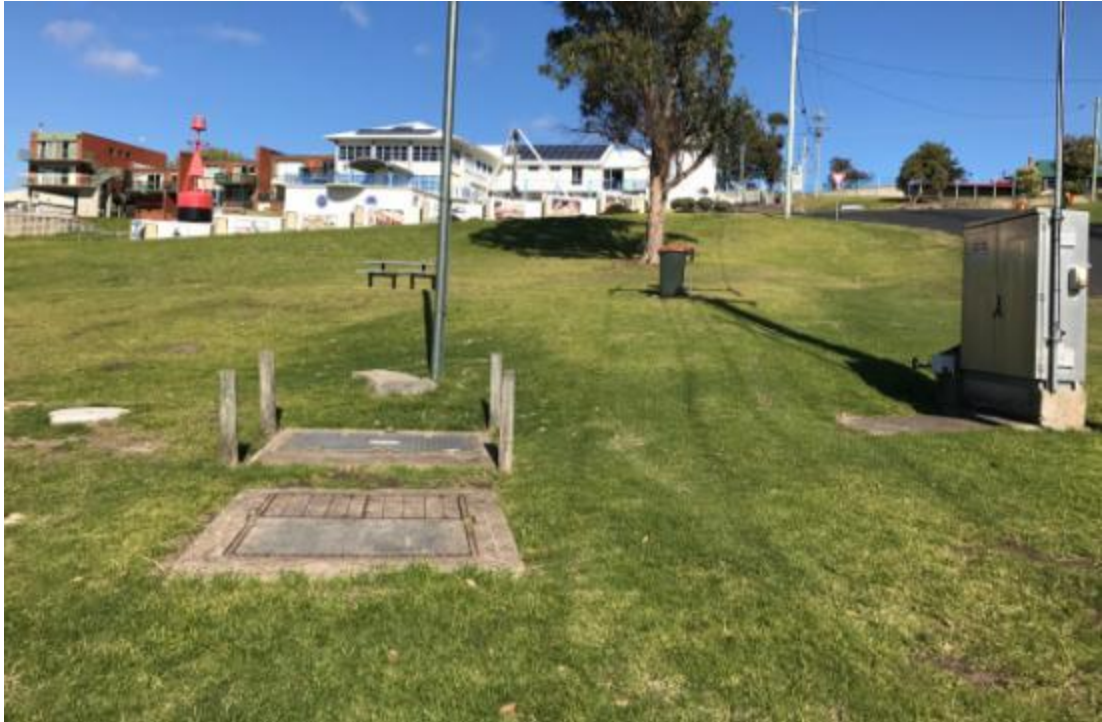
Plate 43 Eden - View to west across Lions Park showing prior impacts.

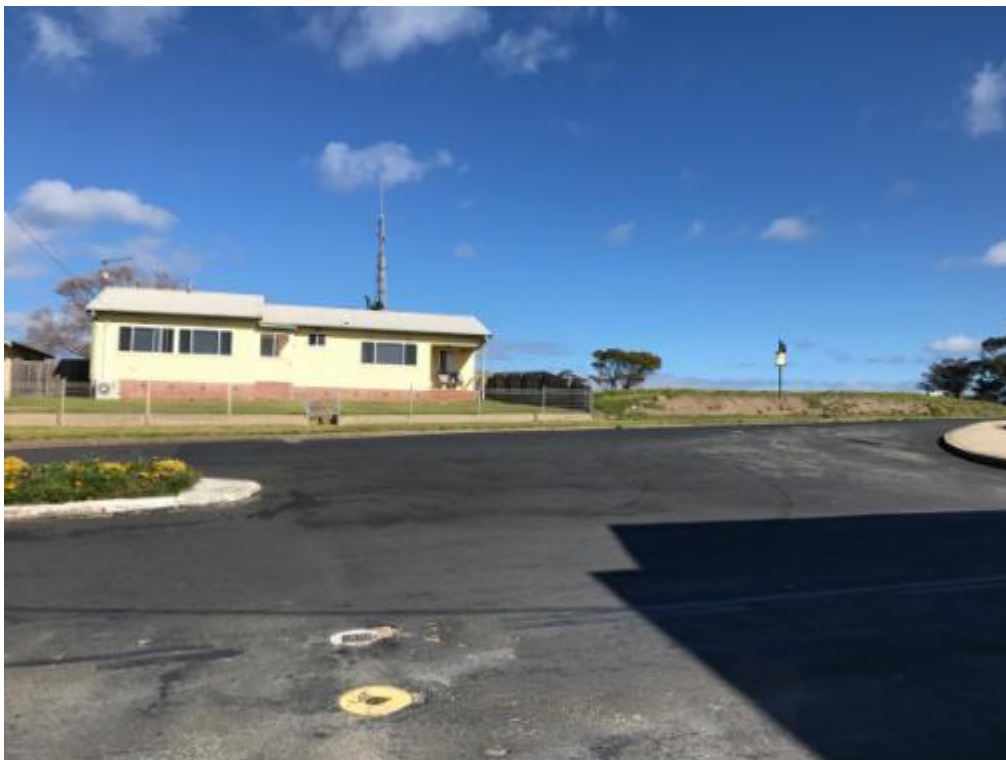
Site	Assessment	Results
	artefacts were visible.	
Imlay Street bus stop and pathway	The impact area is an existing footpath, road verge and road. This area has been cut down into the spur crest and as such is very highly disturbed (Plates 46). The only areas of ground exposure were to the west, outside the proposed impact area. No artefacts were visible in these areas of exposure.	No AHIMS sites are present. No Aboriginal objects were recorded. The impact area is highly disturbed and assessed to be of very low to negligible archaeological potential.

Plate 46 Eden - Proposed location of bus stop on Imlay Street, looking west.

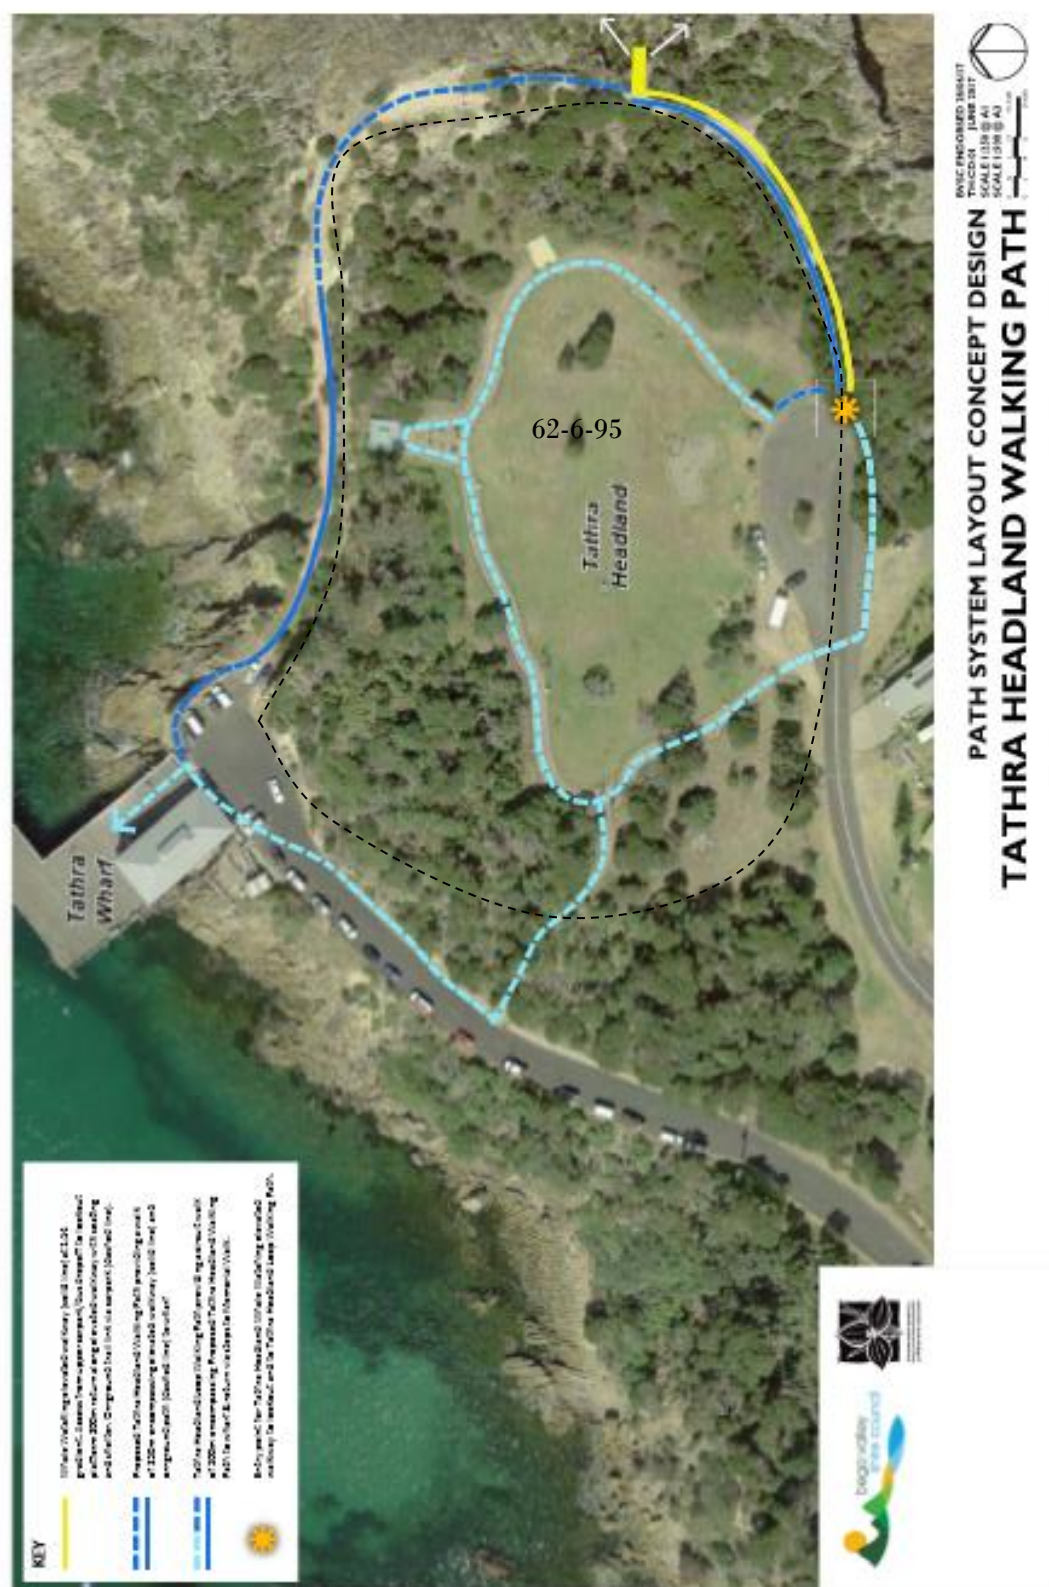
Figure 10 The proposed works at Tathra Headland. Dashed line delineates the extent of the AHIMS site.

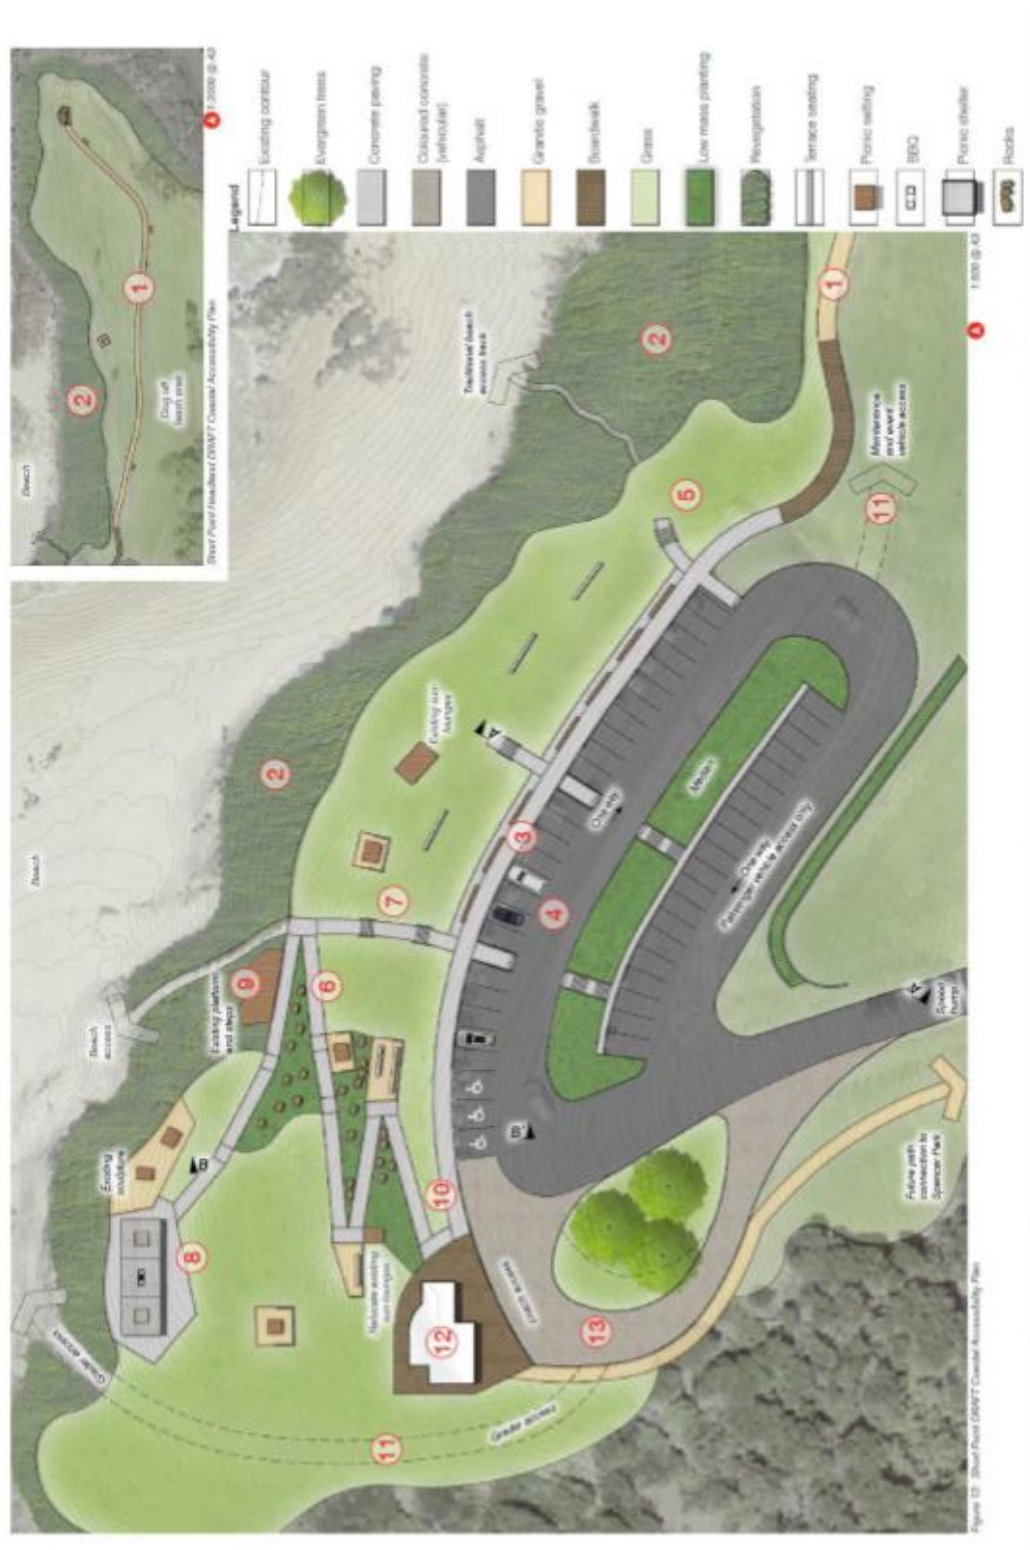
Figure 11 The proposed works at Short Point carpark area. Note the exact location of the AHIMS site 62-9-40 in respect of the carpark is uncertain.

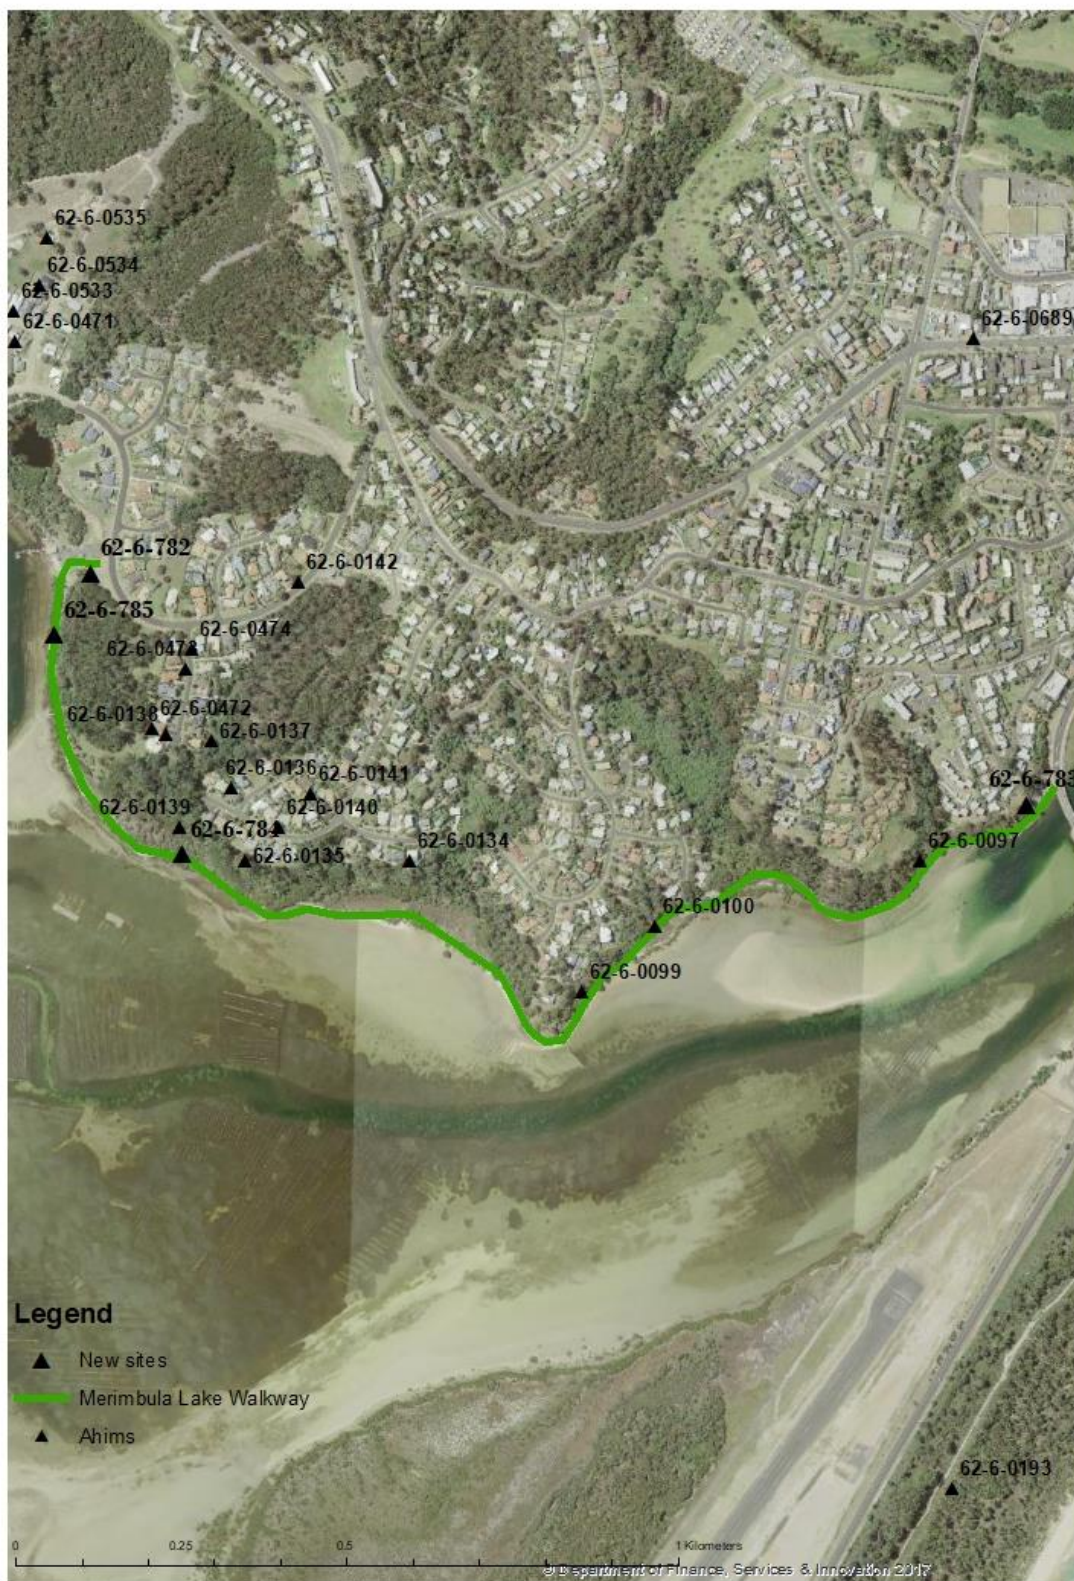
Figure 12 Location of AHIMS sites in the vicinity of the proposed impacts at the Merimbula Boardwalk/Walkway.
