# APPENDIX A

# Rainfall and Flow Data

**EDEN, TWOFOLD BAY AND  
TOWAMBA RIVER FLOOD  
STUDY**

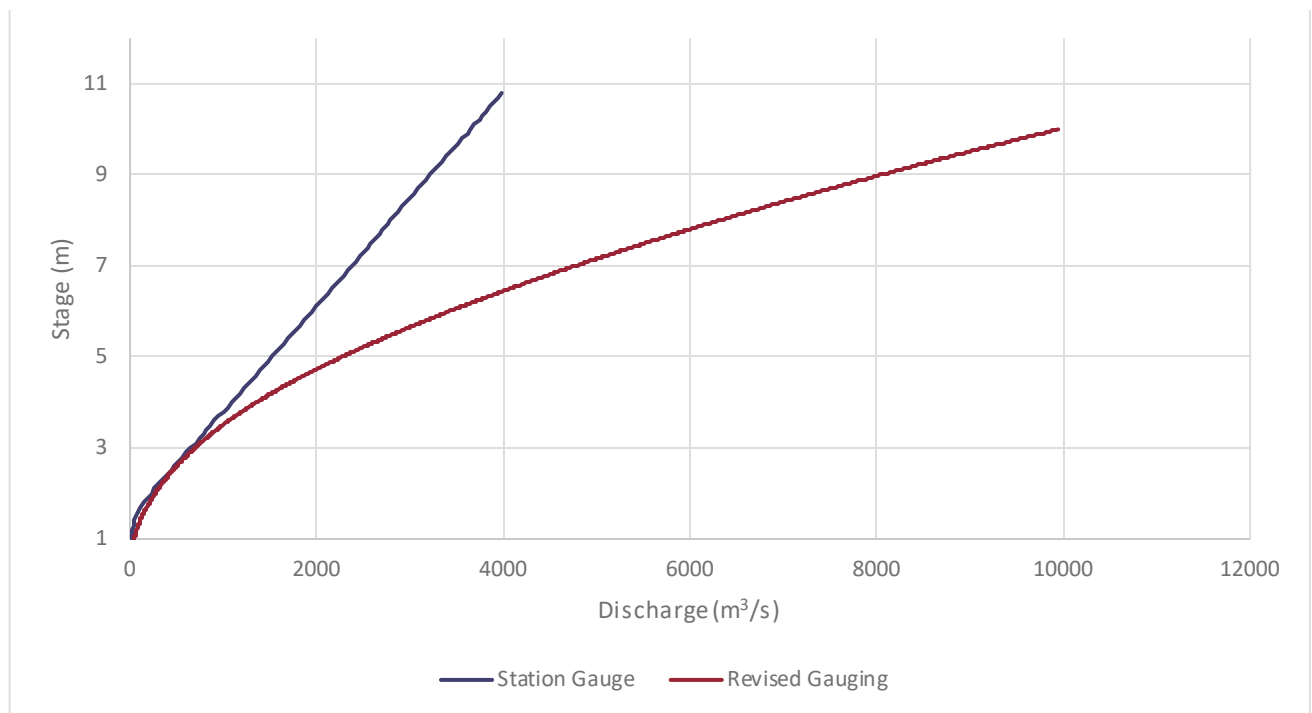
**Figure B2** Towamba Rating Curves

Once the roughness values had been calibrated for lower flows, a revised rating curve was established for the higher flows estimating the roughness for the banks and sides of the channel. These new rating curves, as well as the previous, original curves, are shown in **Figures B2 to B4**.

It can be seen that there were varying degrees of difference for the gauges.

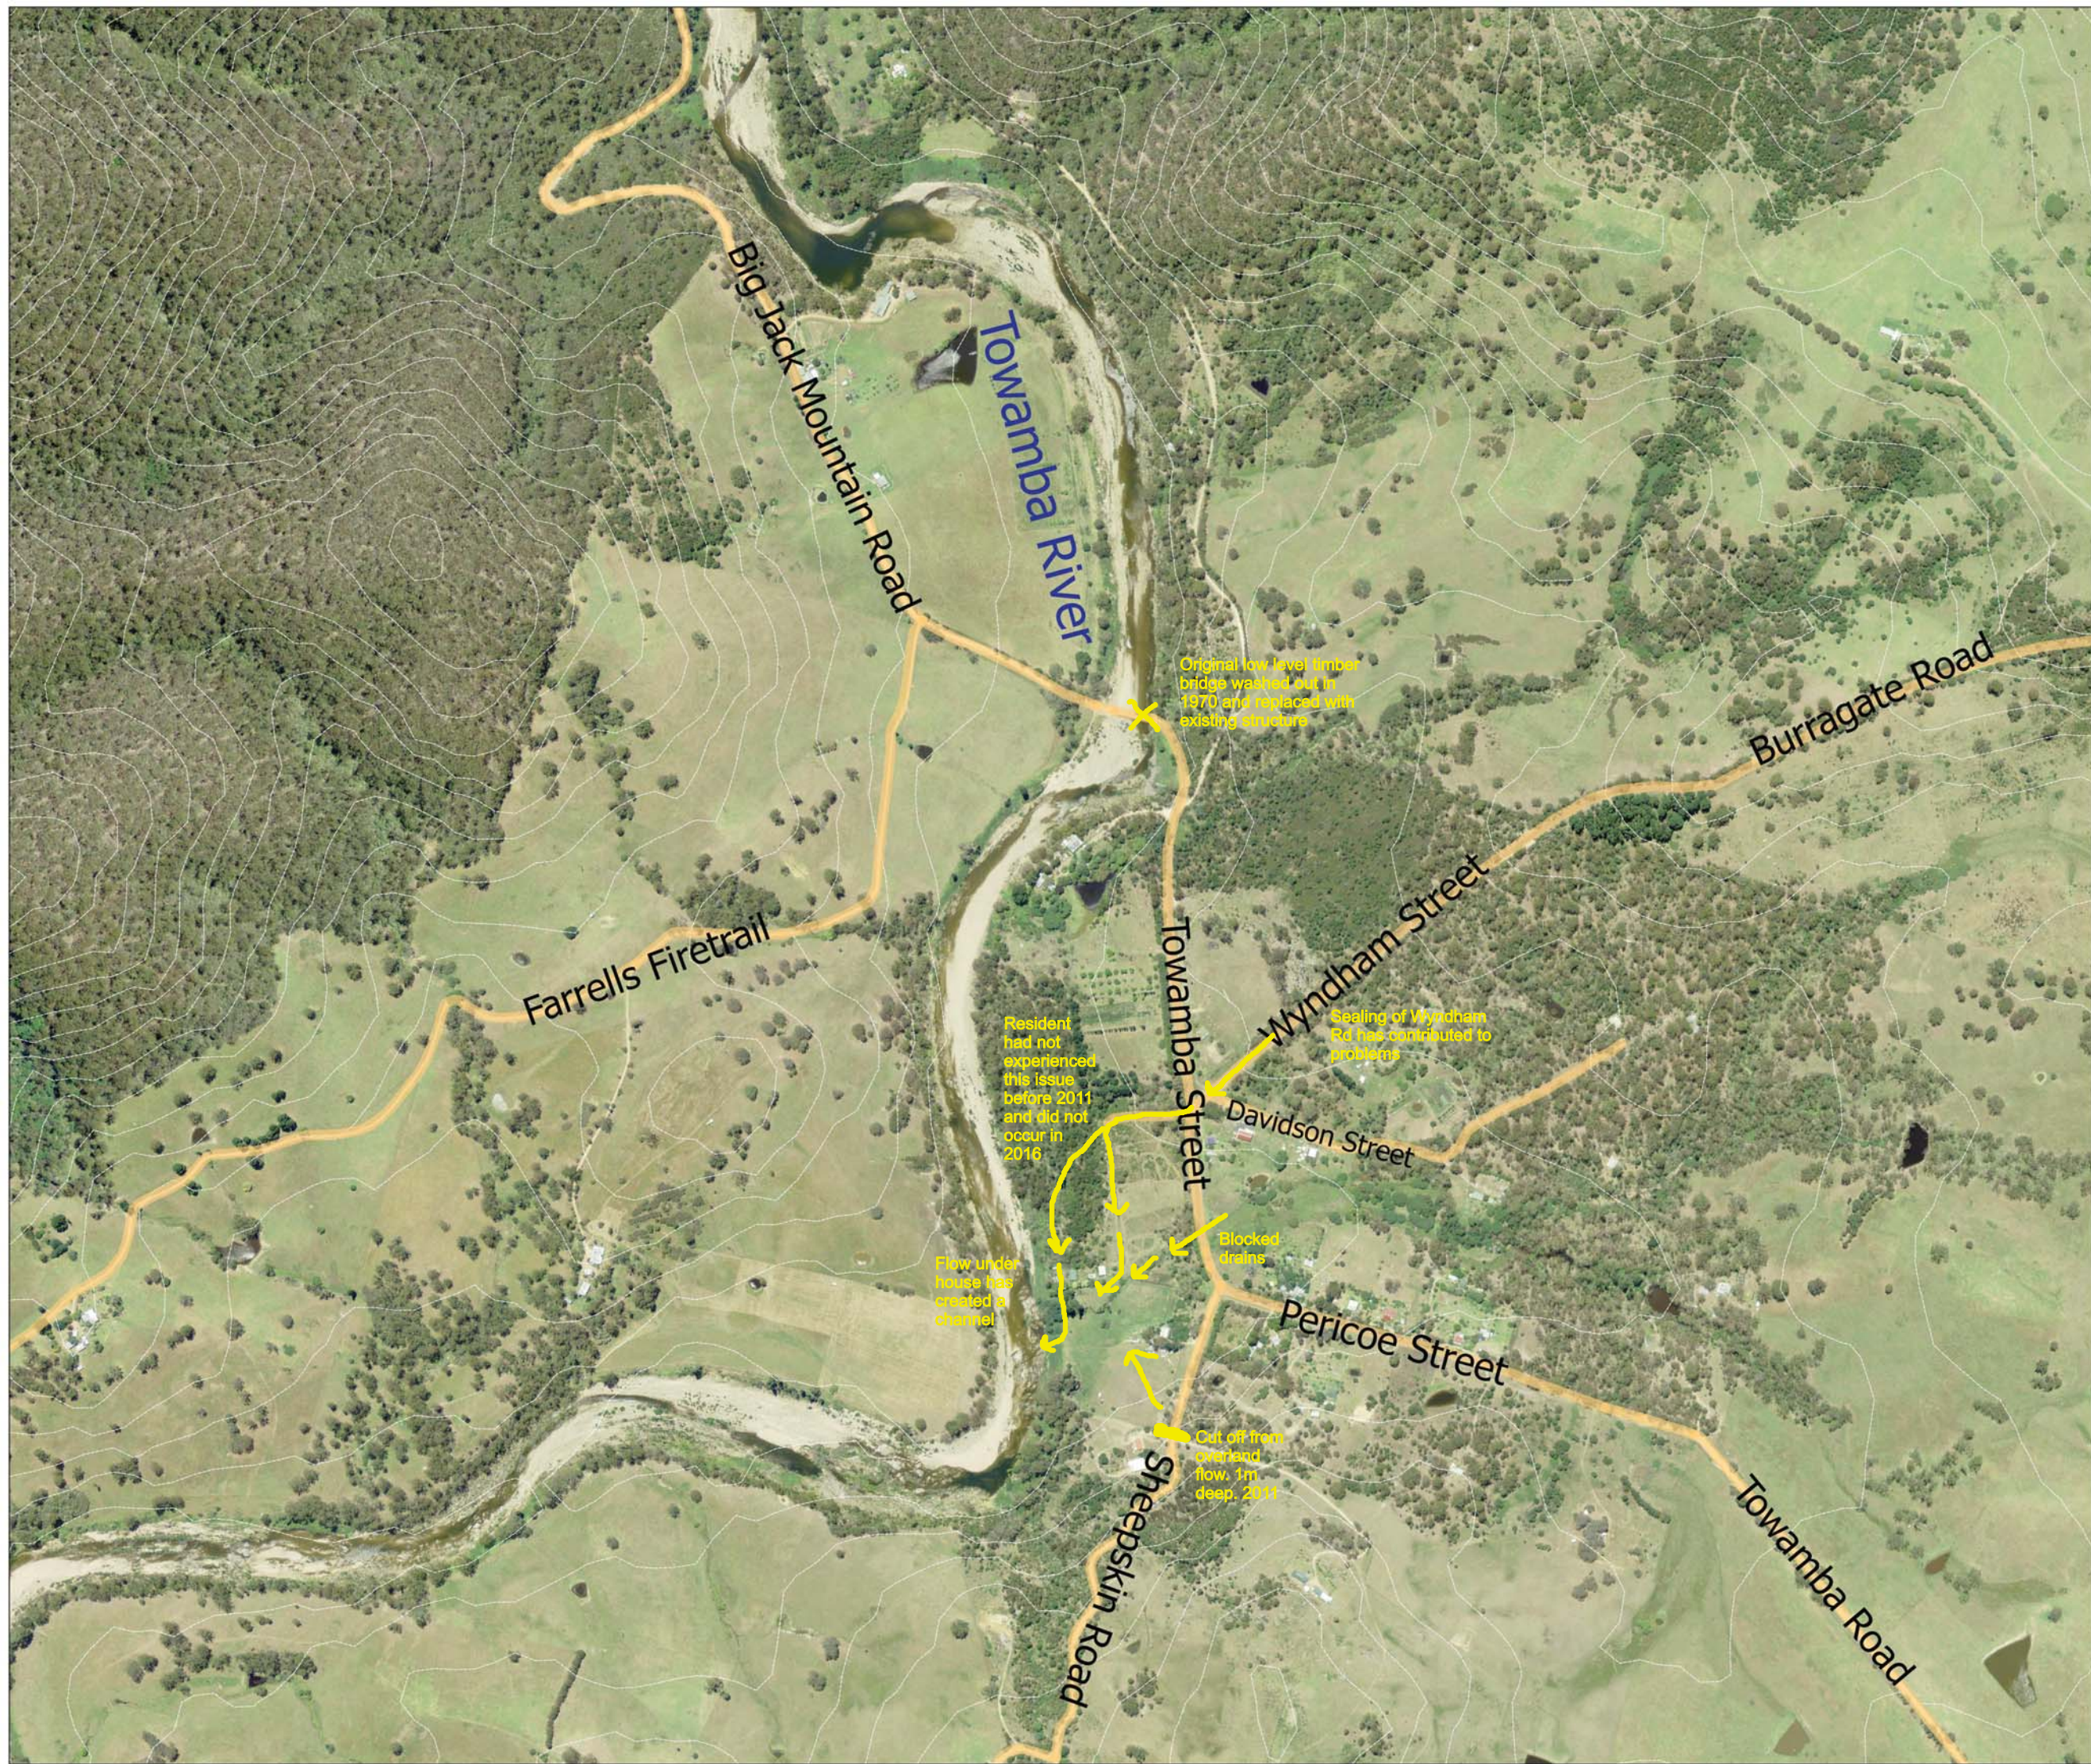
**BURRAGATE  
MAP FOR CONSULTATION**

File: G0024-ConsultationMap\_Burragate  
Scale : 1:4000@A1  
Date : 21 November 2017  
Revision : 0  
Created by : ERM  
Coordinate System : Map Grid of Australia 94

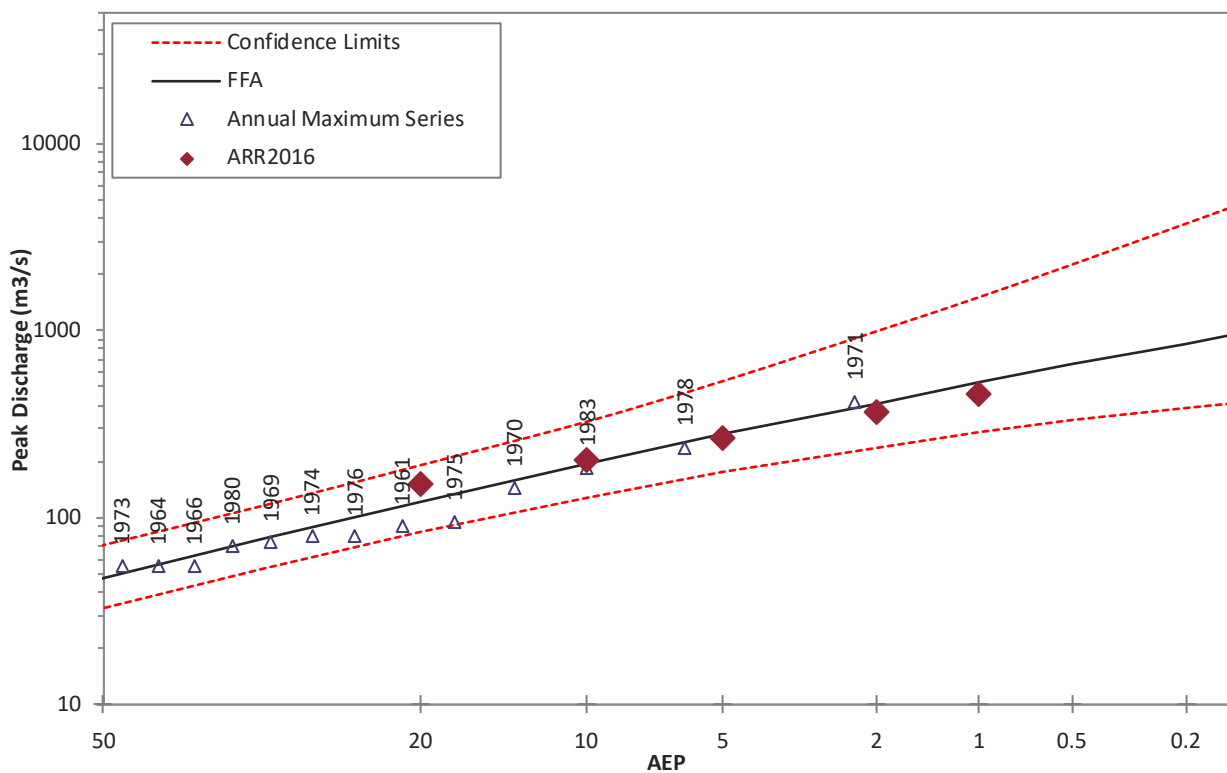
Figure D-5 Rocky Hall FFA Comparison

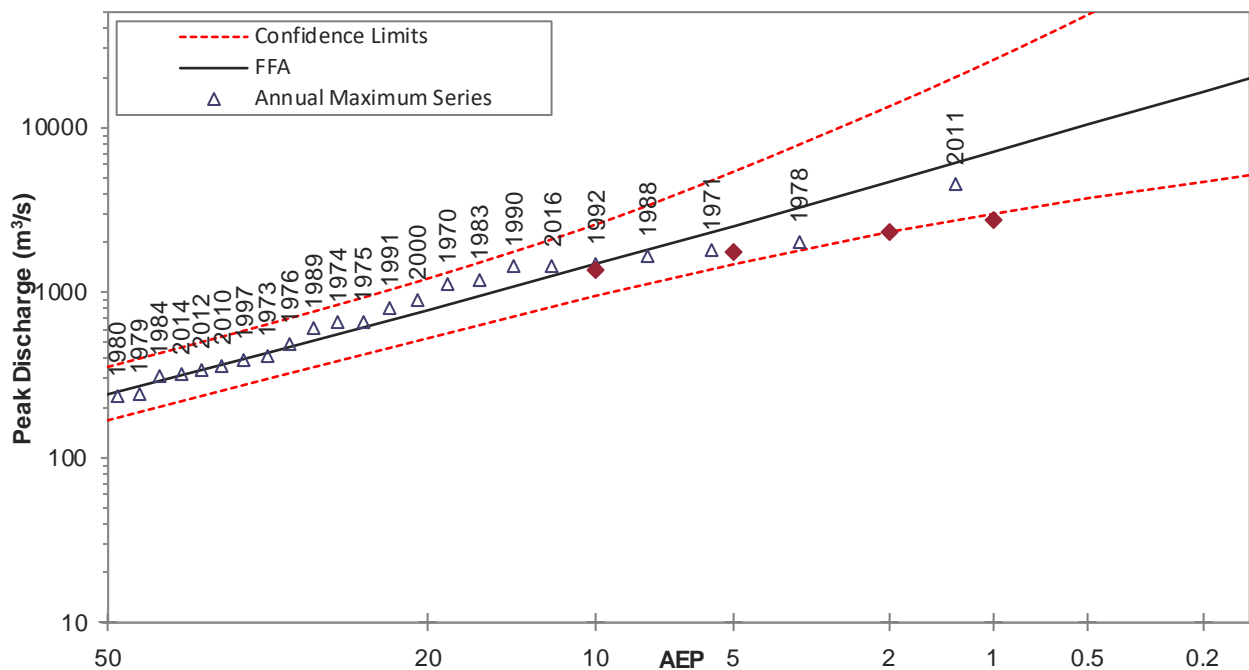
**Figure D-7 Towamba FFA Comparison**

The Towamba gauge does not show as good a match as the other two gauges. The 10% AEP estimate has a reasonable match against the FFA. However, the larger flows increase at a much slower rate than the FFA probability curve. It is interesting to note that the design flow estimates trend in the same way as the observed flood flows, with the exception of the 2011 event, which sits noticeably higher.

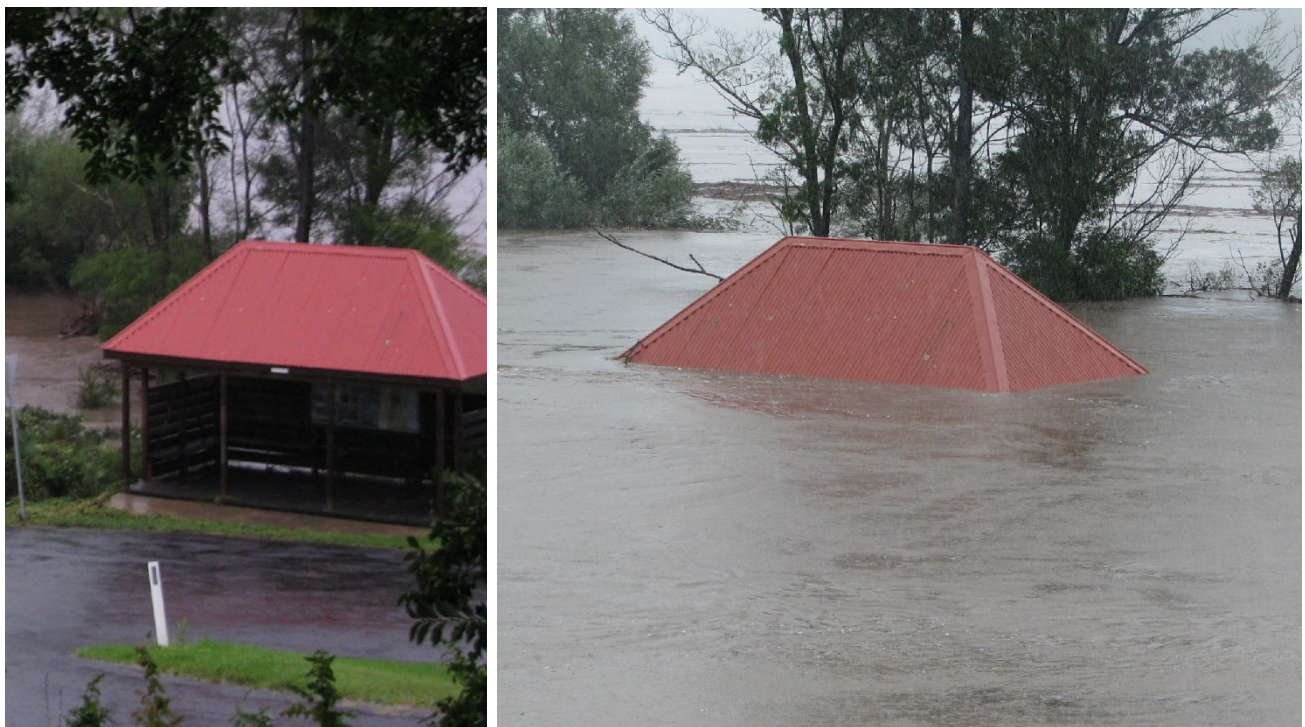
**Figure D-12** Towamba Bus Shelter Flooding in 2011

The point surveyed for the 1978 event was marked by a hacksaw on a post near the intersection of Yambulla Road and Towamba Street. The point was surveyed as being at 36.52mAHD. The model at this location has a level of 36.39mAHD, 0.13m lower than the survey mark.
