Catchment Management Plan

REPORT

Bega Valley Shire Council

11 August 2016 PROJECT REFERENCE: JN15115

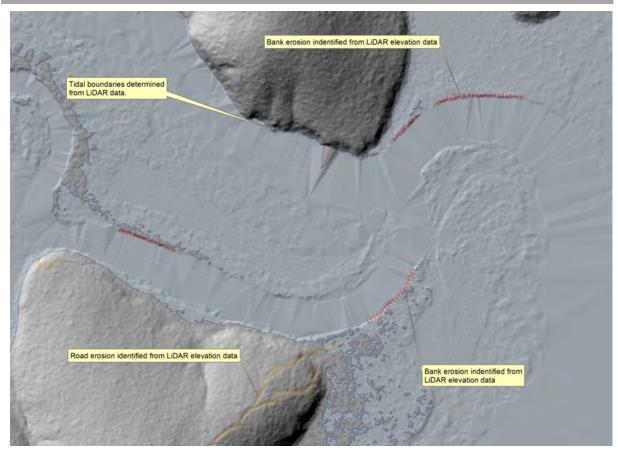
- In general, majority of potential erosion sites in the catchment were located in the hillslope areas directly adjacent the estuary and lower freshwater reaches, which had been subject to historical logging operations. These areas are now administered by National Park. Many of these were located in vicinity of old logging roads and snig tracks.
- Potential bank erosion was identified in the lower freshwater reaches of Nelson Creek and these were subject to field inspections (see Section 6.3).

Figure 14. Potential erosion sites in the mid-estuary area identified from LiDAR elevation data and DEM.

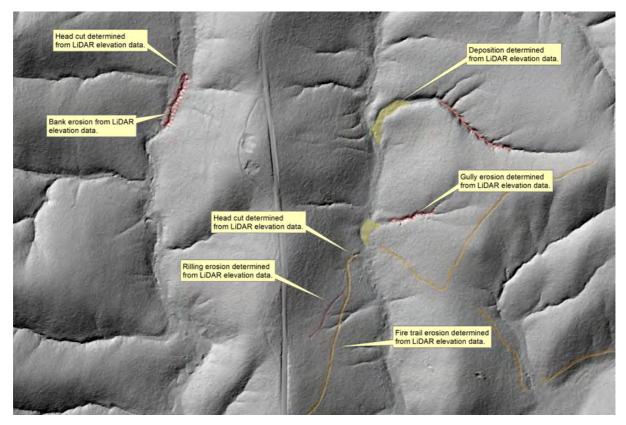
The potential erosion assessment identified the many logging roads and snig tracks that have been constructed in the catchment from historical forestry operations (Figure 16). Soils in the Nelson Creek catchment are classified as erosional soil landscapes (DLWC 1999). This means that soils are extremely sensitive to disturbance and are particularly prone to erosion when they are disturbed and or burnt. Constructed logging roads, tracks, and snig tracks are vulnerable to erosion, especially when runoff concentrates in these depressions, and without appropriately functioning runoff controls, begin to behave like first order drainage lines. Sediments may be mobilised from the surfaces of unsealed roads in even low to moderate rainfall events. These areas are likely to continue to erode until they reach the underlying bedrock or dense clays.

Erosion of logging roads and snig tracks has likely supplied some sediment to the upper estuary, particularly the main channel of Nelson Creek. Although most of the sediment eroded from logged hillslopes was likely still trapped in deposition fans at the base of 1st order drainage lines. The dispersible fraction of sediment eroded from logged hillslopes has likely been transported to the lower estuary.

Figure 16. Example of forestry logging roads (now fire trails) and rilling of old snig tracks identified on the enhanced DEM and slope analysis.

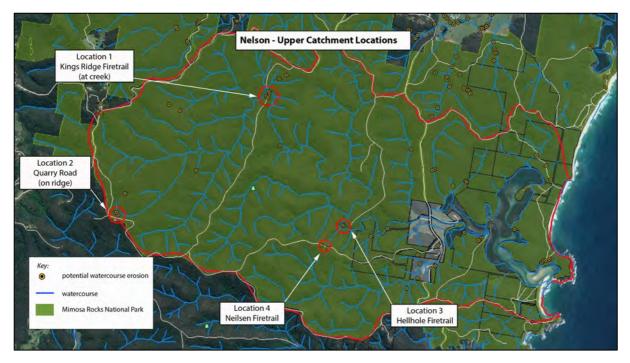
A limited assessment of the unsealed road network was undertaken in accordance with the *Managing Urban Stormwater - Soils and Construction Volume 2C Unsealed Roads* (DECC 2008). Four sites identified in the potential erosion assessment that were accessible and adjacent to watercourses were inspected (**Figure 17**). A summary of the assessment of upper catchment locations is provided in **Table 10**.

Figure 17. Upper Catchment locations and unsealed road areas inspected for erosion issues.

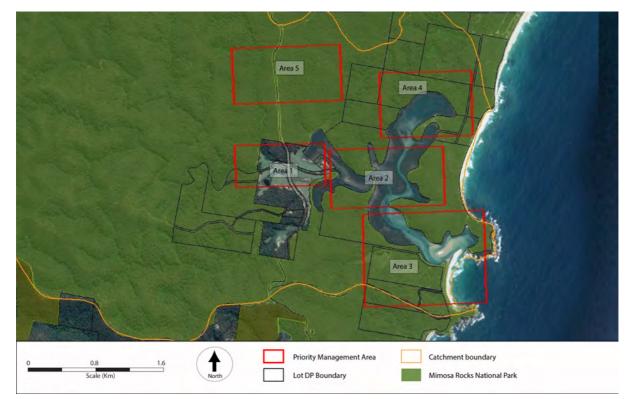
Five (5) priority management areas have been identified, all situated around the lower Nelson catchment as shown in **Figure 18**. Within each management area, at least one or more of the following issues is currently occurring - road erosion, natural stream bank erosion, degradation of riparian zone and/or sensitive coastal saltmarsh areas, estuary foreshore erosion, and excessive sedimentation.

Figure 18. Overview of priority management area locations for Nelson catchment.

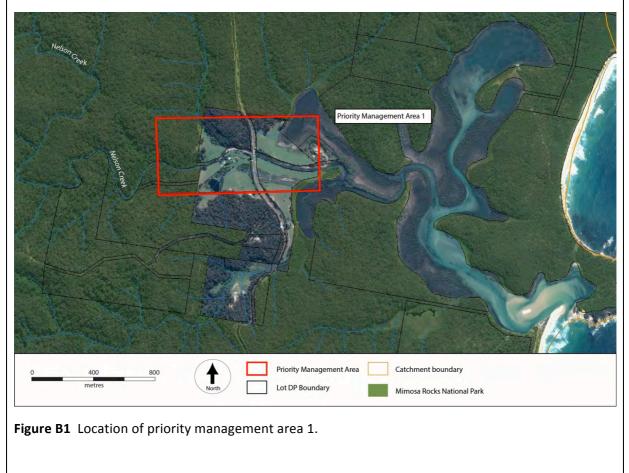
The landholder has been pro-active towards protection of high conservation value areas fencing off a large area of saltmarsh community and preventing cattle access to mangrove community. However, erosion issues affect the stability of the streamside zone along freshwater and upper estuary reaches of Nelson Creek and protective measures are required to mitigate further degradation and loss of land.

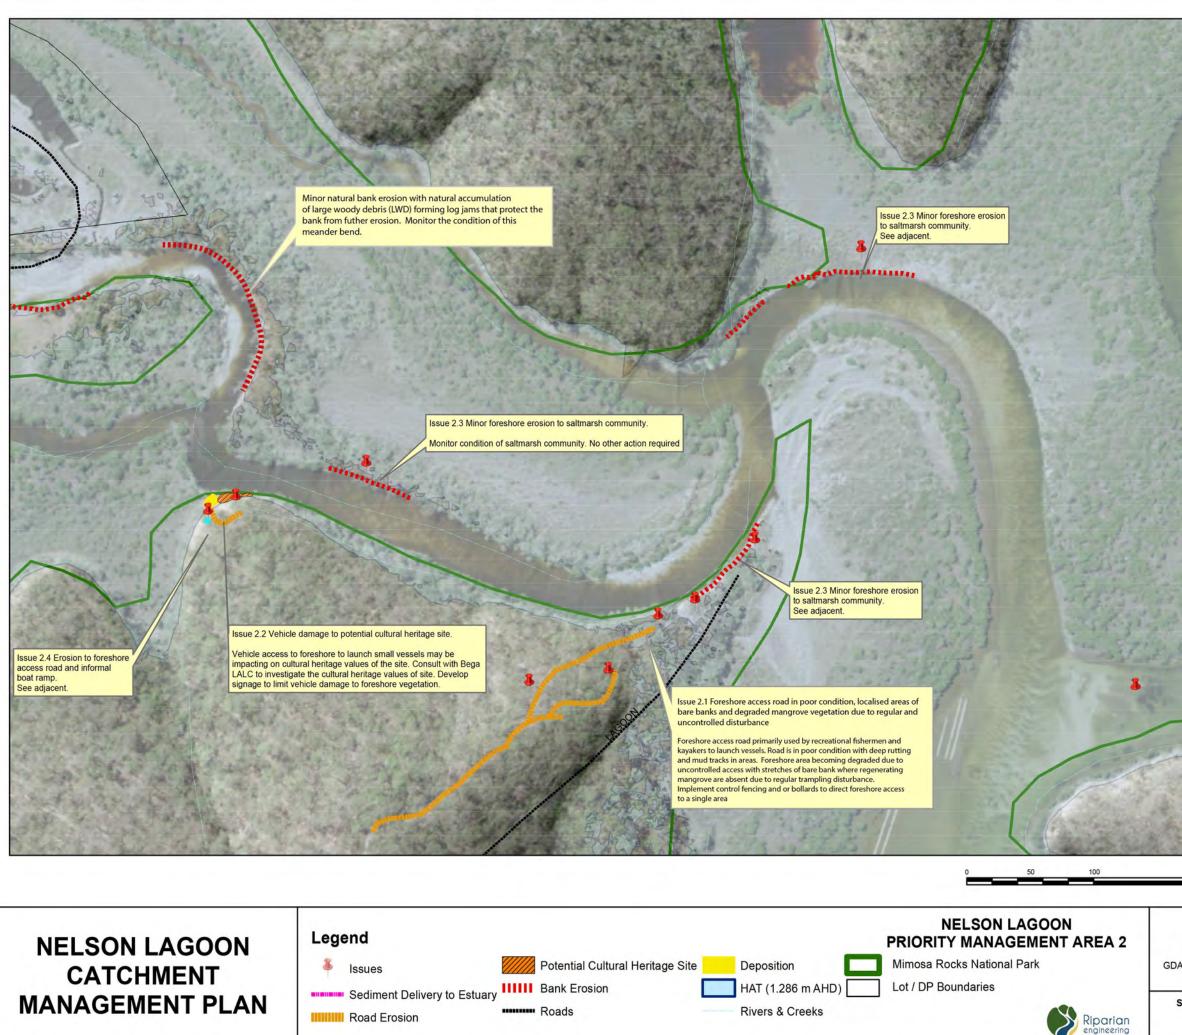
Figure B12. Vehicle access to the foreshore from Cowdroys road with moderate erosion and wheel rutting evident (*left image*). Current road condition is relatively stable with majority of dispersible sediment already eroded (*right image*).

Issue 2.4 Erosion to foreshore access road and informal boat ramp.

Road and informal boat ramp off Cowdroys Road providing vehicle access to foreshore to launch small boats. Current usage of this foreshore access road is not known. The road is relatively stable with majority of dispersible sediment already delivered to estuary. Consult with NPWS to determine whether foreshore access at this location is to be maintained. Monitor road condition and implement repair is condition deteriorates.

- Consult with NPWS to determine whether foreshore access at this location is to be maintained.
- Monitor road condition and implement repair should road condition deteriorate further.

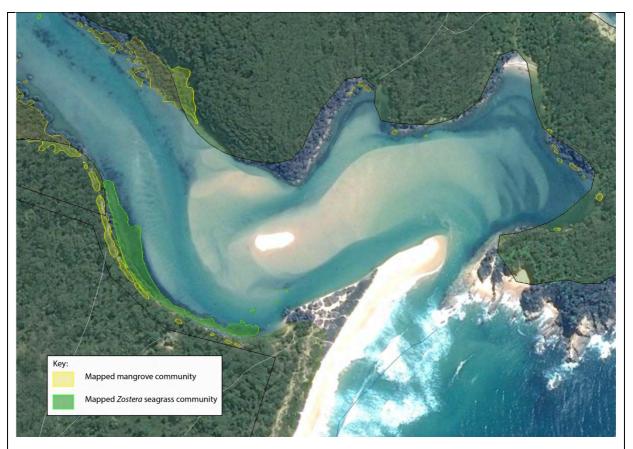
Issue Description: Estimated that >70% loss of seagrass has occurred from Nelson Lagoon over 20year period between 1985 to 2006 (Creese et al. 2009) with the current condition of the seagrass community rated as being in very poor condition (DECCW 2011). This estimate of seagrass loss may not be accurate due to differences in mapping techniques applied in the 1985 and 2006 assessments. However, the potential issue of seagrass loss in Nelson Lagoon is worthy of further investigation through additional seagrass mapping utilising methodology similar to that applied by NSW DPI in 2006. The largest continuous patch of seagrass community mapped in Nelson Lagoon occurs in the lower estuary where recreational activity is most popular and rates of human disturbance perhaps also greatest. Minimising potential loss of seagrass is an ongoing issue that will have broader implications for the ecological condition of the estuary.

Figure B14 Mapped distribution and extent of seagrass and mangrove community in the lower estuary area of Nelson Lagoon.

- Erect educational signage to illustrate the ecological importance of seagrass meadows and role they play in stabilising estuarine sediments. Recommend that signage be erected at all boat launching areas as outboard engines at low-tide represent a high potential threat of damage to seagrass community.
- Update seagrass mapping to ascertain changes in seagrass community over the last 10-year period and implement program to monitor condition of seagrass community.

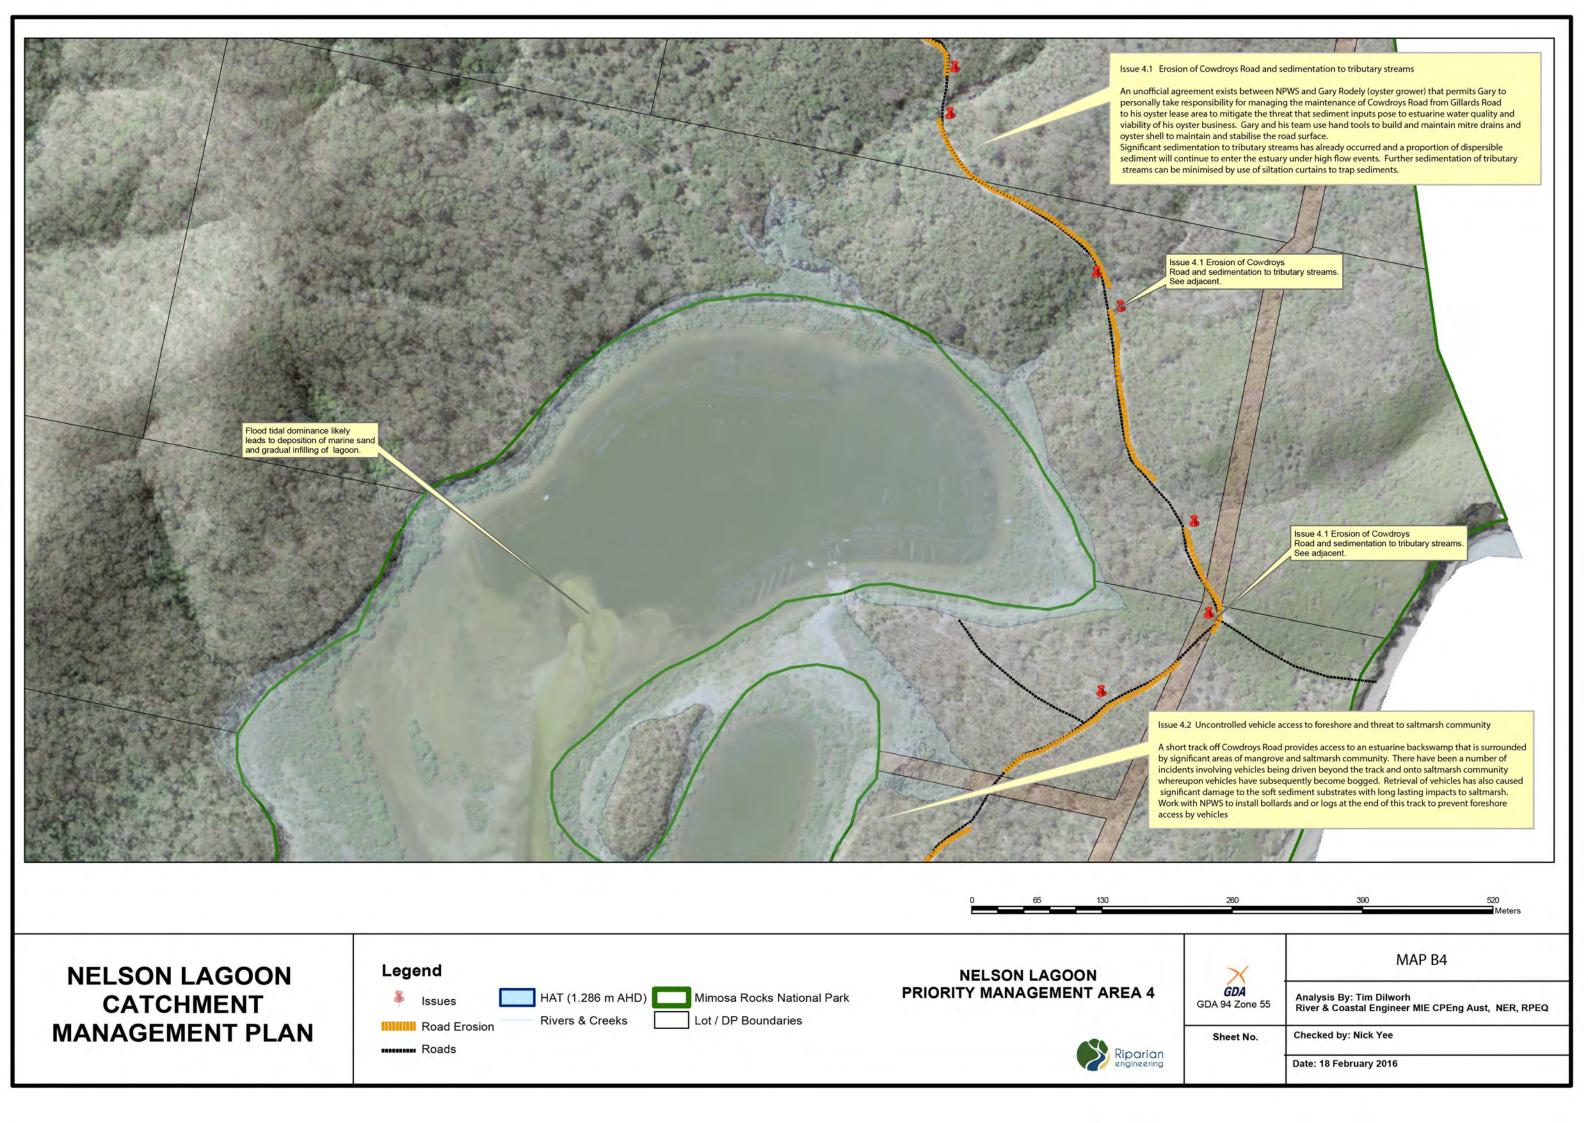
Issue Description: A number of informal tracks provide access to the foreshore of Nelson Lagoon from Cowdroys Road. These tracks are primarily used by recreational fishermen to access the waterway. While it is important to maintain foreshore access to permit the continuation of recreational user experience, vehicle access via some of these informal tracks needs to be restricted to protect the foreshore and saltmarsh community from degradation.

A short track off Cowdroys Road provides access to an estuarine backswamp that is surrounded by significant areas of mangrove and saltmarsh community. There have been a number of incidents involving vehicles being driven beyond the track and onto saltmarsh community whereupon vehicles have subsequently become bogged. Retrieval of vehicles has also caused significant damage to the soft sediment substrates with long lasting impacts to saltmarsh.

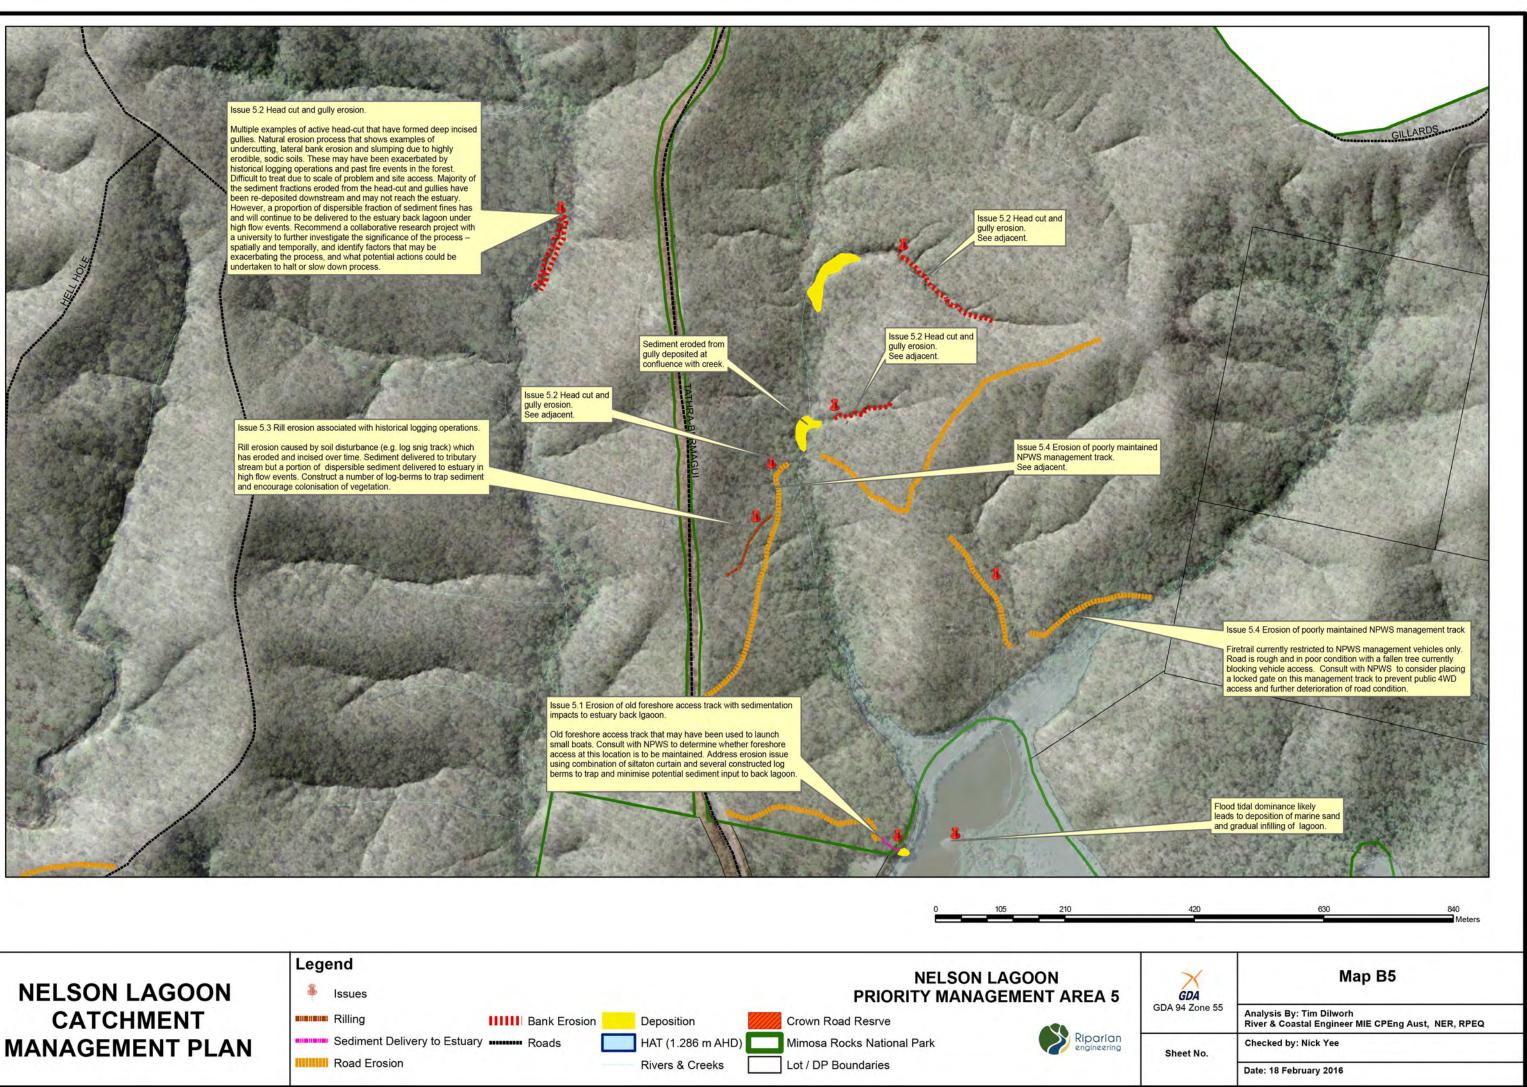
Issue Description: Firetrail currently restricted to NPWS management vehicles only. Road is rough and in poor condition with a fallen tree currently blocking vehicle access. Multiple examples of poor surface runoff controls with road erosion causing sedimentation impacts to tributary streams.

Figure B24 Example of NPWS management track showing minor to moderate erosion (*left image*). Localised areas of road erosion include nick-points with potential to develop into gullies if left unaddressed (*right image*).

• Consult with NPWS to consider placing a locked gate on this management track to prevent public 4WD access and further deterioration of road condition.
