# **Review of Environmental Factors:**

Lighting upgrade- Berrambool Sporting Field, Merimbula

Report Prepared for:
Bega Valley Shire Council

September 2019

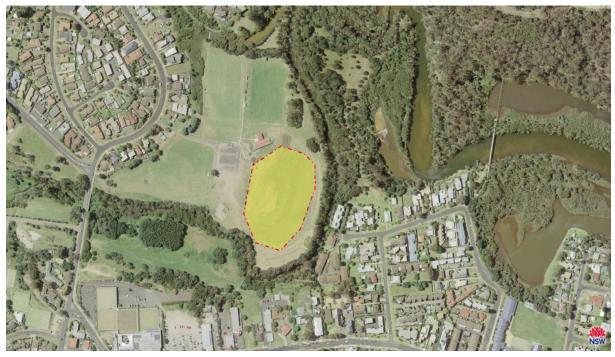
Figure 1-1 – Works location.

Southeast Engineering and Environmental (SOUTHEAST) was commissioned by Brendan Read of Affinity Electrical, on behalf of Bega Valley Shire Council (BVSC) to prepare a Review of Environmental Factors (REF) for the proposed installation of four lighting towers and associated infrastructure at the Berrambool Playing Fields, Merimbula (Figure 1-1).

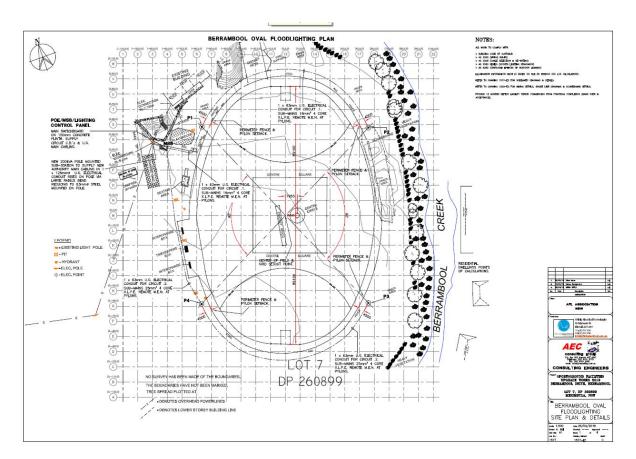
Figure 2-1 Berrambool Lighting site plan- Affinity Electrical 2019.

The main switchboard will be mounted on a cement pad and emerging out from this will be a 50mm electrical conduit which runs to a new electrical pit installed adjacent the oval. From this pit the conduit branches out running a 50mm conduit clock wise around the oval and anti-clockwise as well to a new electrical pit installed at the back of each pole. From each pit at a 50mm a conduit will be installed running from pit to pole. Contained within this conduit will be 2 x 3phase circuits with conductor size of 25mm<sup>2</sup>.

The removal of four existing light poles on the north-west and western side of the oval will also be required. The area will be levelled and turfed or seeded with appropriate grasses. Design plan is shown in Figure 2-1 highlighting the proposed works.

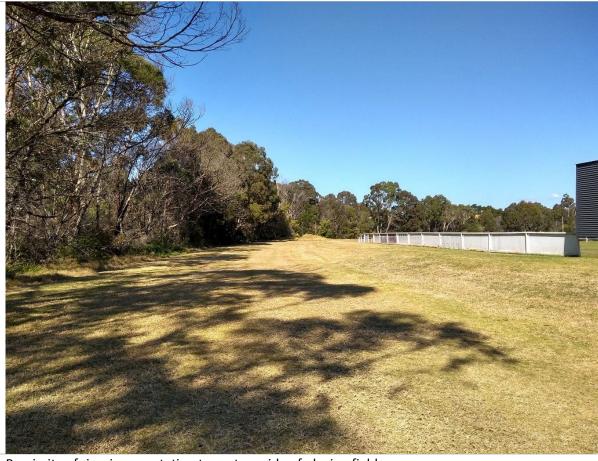
Proximity of riparian vegetation to eastern side of playing field.

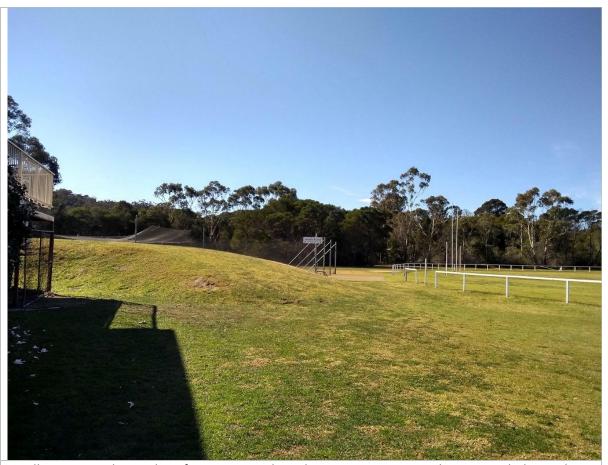
Small rise on northern edge of existing grandstand, riparian vegetation along Merimbula Creek in background.

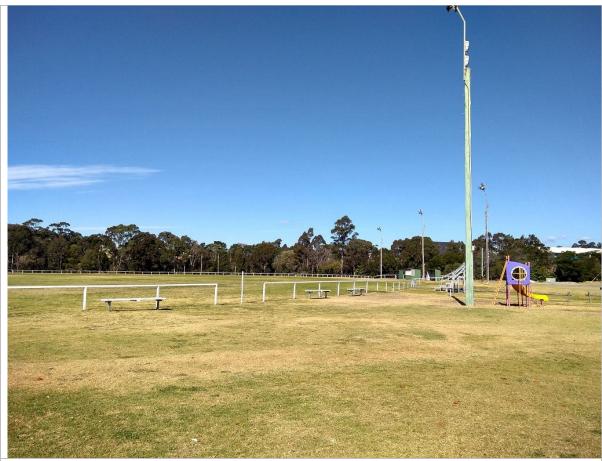
Existing lighting poles to be removed on west and south-west side of playing field.

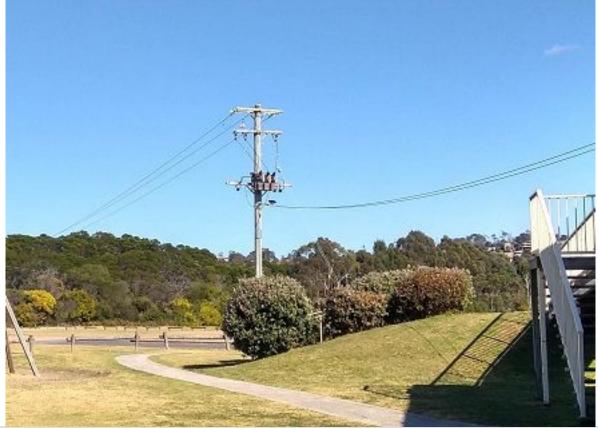
Current power connection to be upgraded to new sub-station.

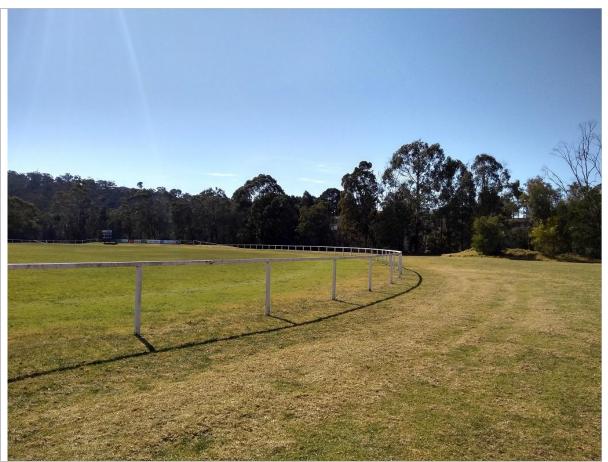
Steel rail fence along perimeter of playing field. Electrical conduit to be placed underground 4500mm from fenceline.

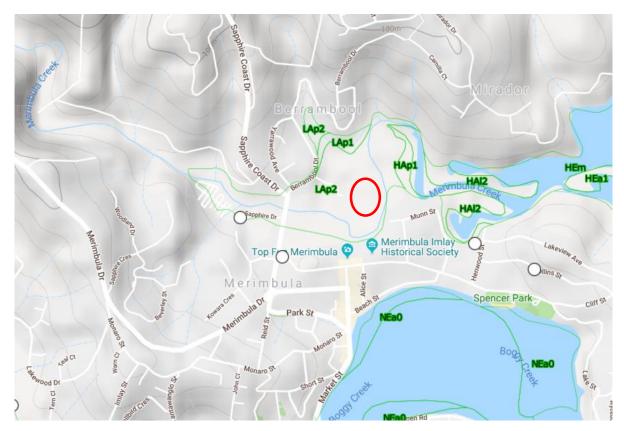
Acid Sulfate Soils Mapping (extract from eSPADE accessed 24/09/2019). Red line indicative of oval perimeter.

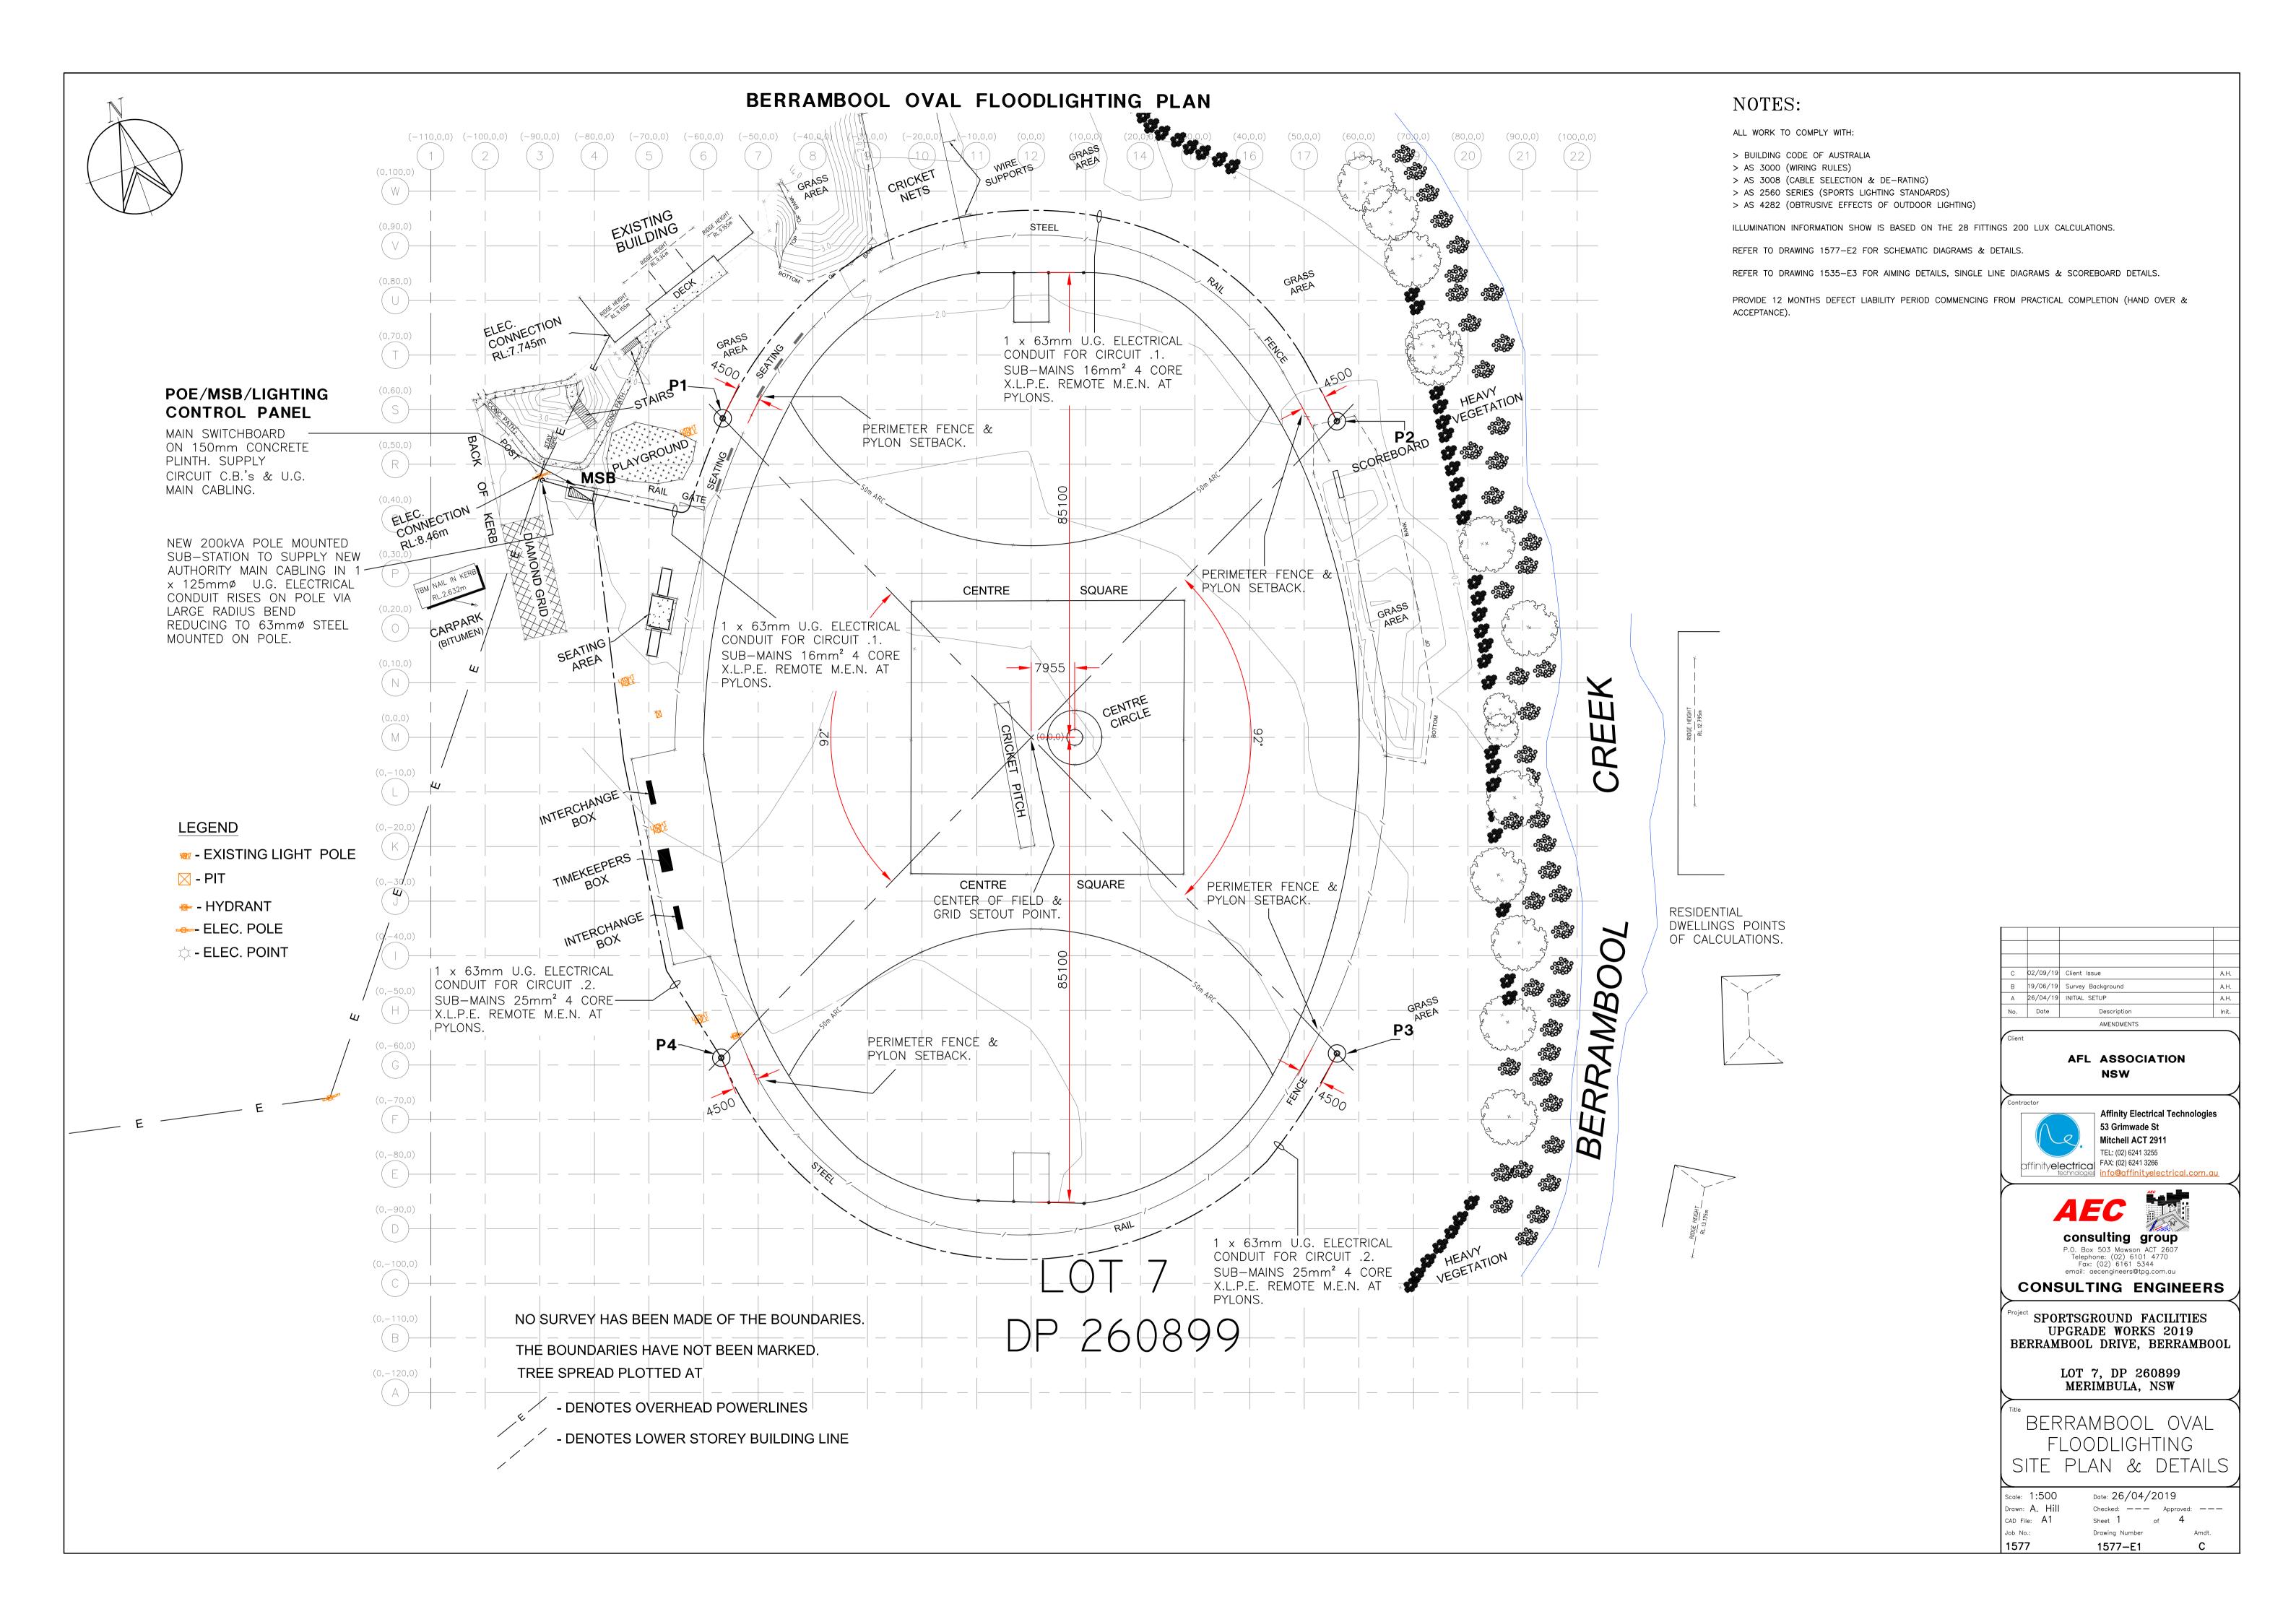
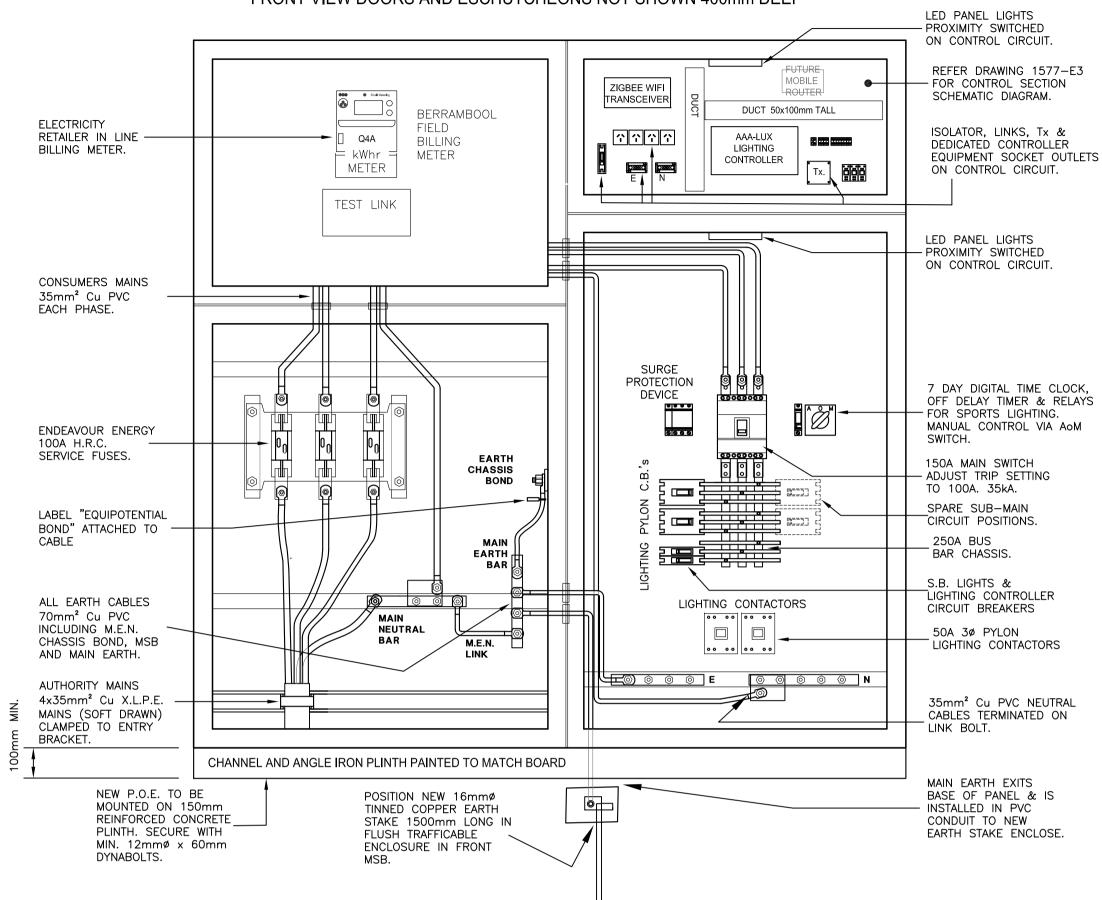
# P.O.E. / M.S.B. PANEL INDICATIVE ARRANGEMENT

REFER TO SWITCHBOARD MANUFACTURE'S APPROVED DRAWINGS FOR MAIN SWITCHBOARD

# ARRANGEMENT. FRONT VIEW DOORS AND ESCHUTCHEONS NOT SHOWN 400mm DEEP

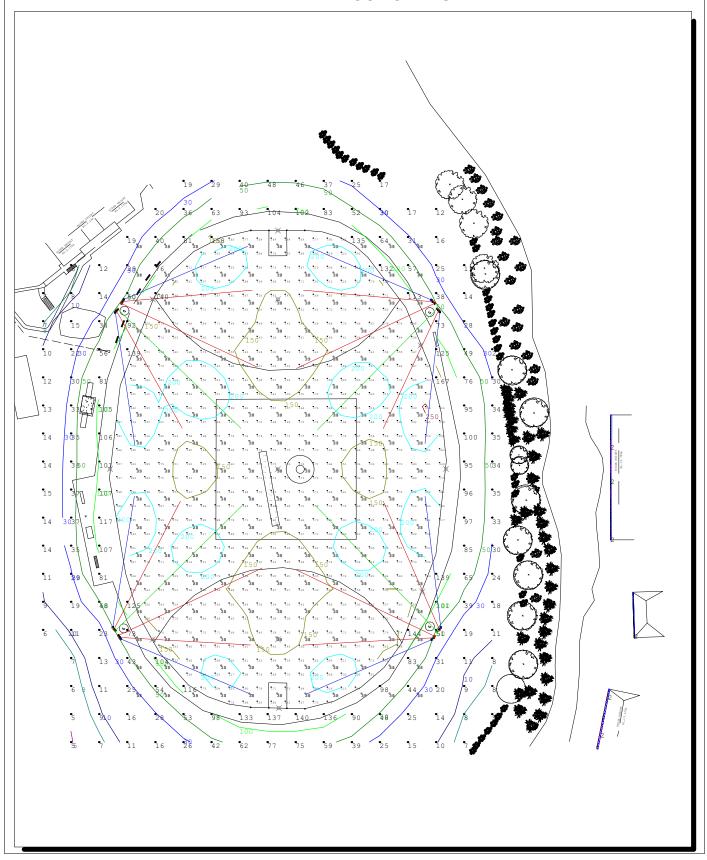
## **BERRAMBOOL OVAL SITE PLAN**

Details: 150 lux - 24 Fittings Ilumination Calculations

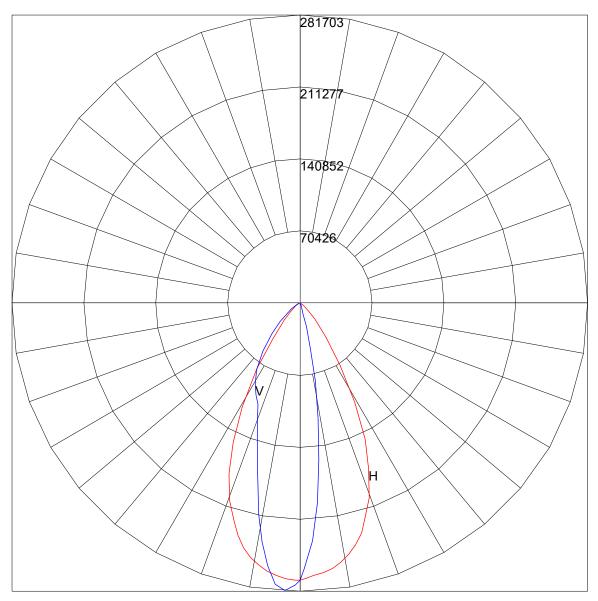
#### **AXIAL CANDELA DISPLAY**

Maximum Candela = 281703 Located At Horizontal Angle = 0, Vertical Angle =-3

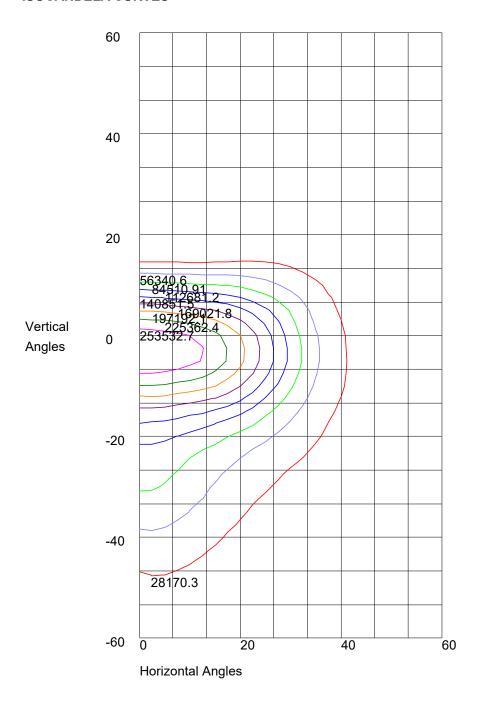
#### **ISOCANDELA CURVES**

Maximum Candela = 281703 Located At Horizontal Angle = 0, Vertical Angle =-3 50% Maximum Candela = 140851.5 10% Maximum Candela = 28170.3

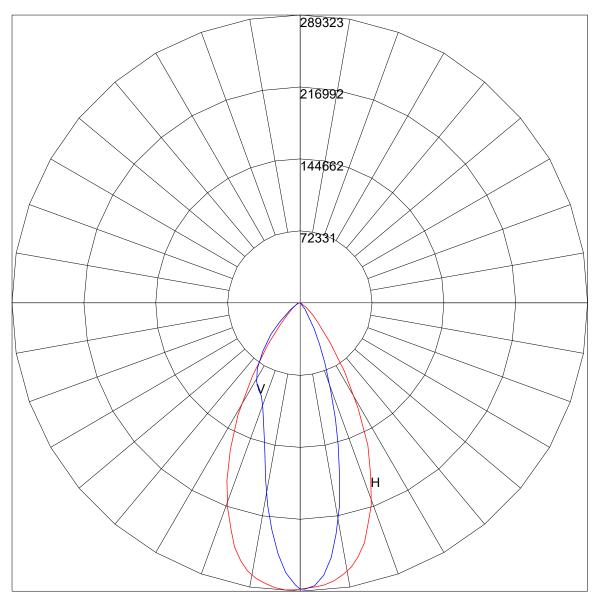
#### **AXIAL CANDELA DISPLAY**

Maximum Candela = 289323 Located At Horizontal Angle =-3, Vertical Angle = 1

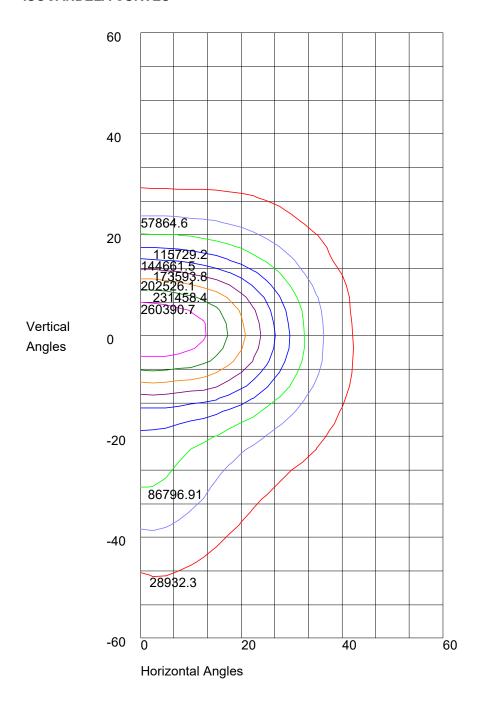
#### **ISOCANDELA CURVES**

Maximum Candela = 289323 Located At Horizontal Angle =-3, Vertical Angle = 1 50% Maximum Candela = 144661.5 10% Maximum Candela = 28932.3

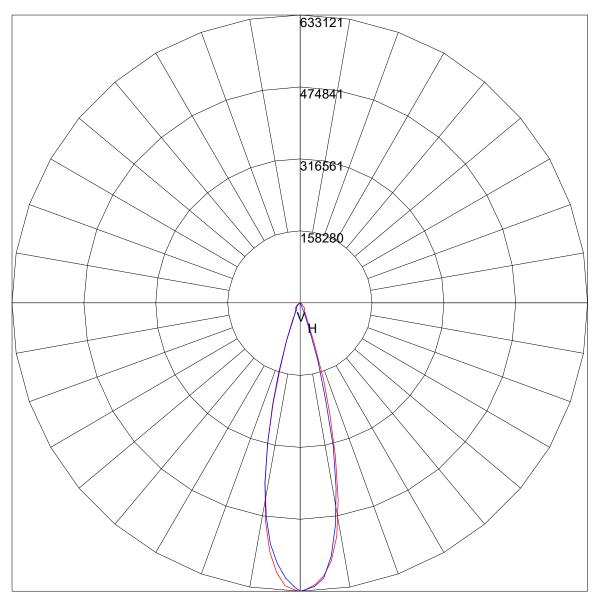
#### **AXIAL CANDELA DISPLAY**

Maximum Candela = 633121 Located At Horizontal Angle = 0, Vertical Angle = 0

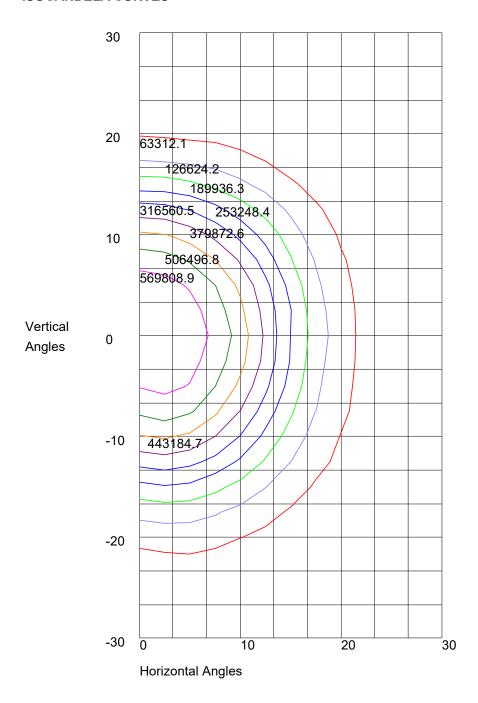
#### **ISOCANDELA CURVES**

Maximum Candela = 633121 Located At Horizontal Angle = 0, Vertical Angle = 0 50% Maximum Candela = 316560.5 10% Maximum Candela = 63312.1

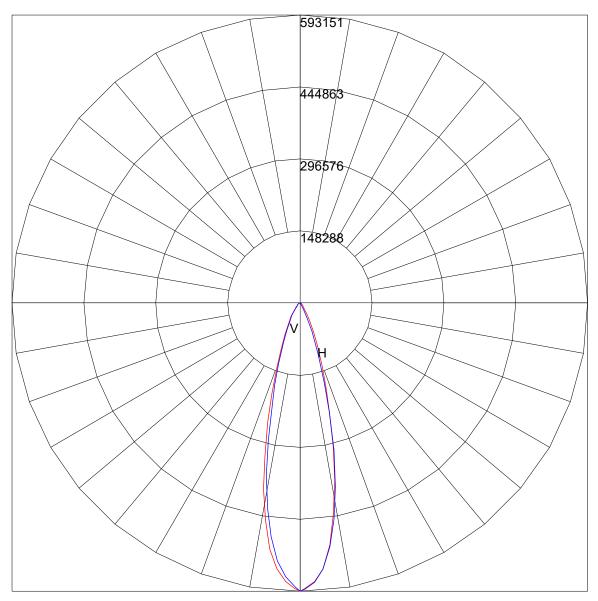
#### **AXIAL CANDELA DISPLAY**

Maximum Candela = 593151 Located At Horizontal Angle = 0, Vertical Angle = 0

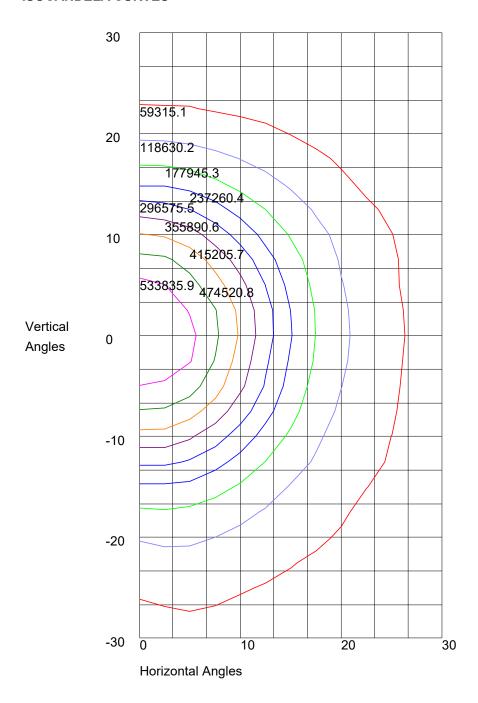
#### **ISOCANDELA CURVES**

Maximum Candela = 593151 Located At Horizontal Angle = 0, Vertical Angle = 0 50% Maximum Candela = 296575.5 10% Maximum Candela = 59315.1

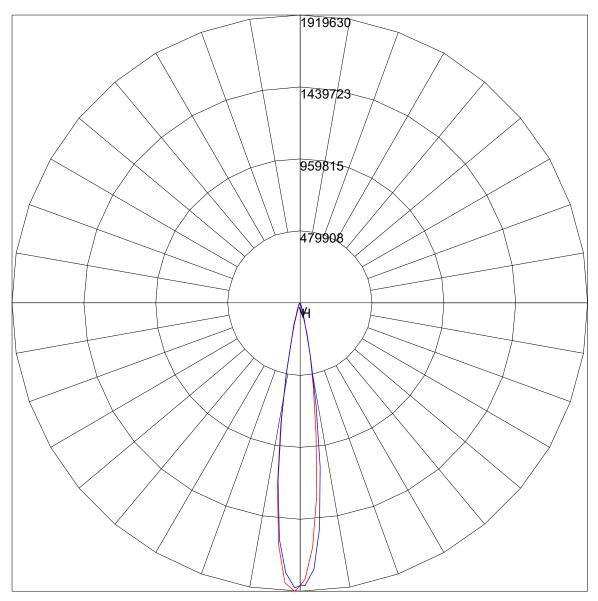
#### **AXIAL CANDELA DISPLAY**

Maximum Candela = 1919630 Located At Horizontal Angle =-1, Vertical Angle = 0

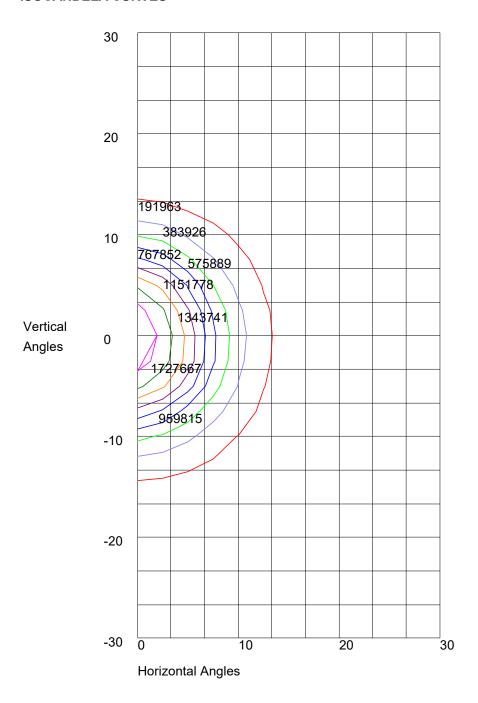
#### **ISOCANDELA CURVES**

Maximum Candela = 1919630 Located At Horizontal Angle =-1, Vertical Angle = 0 50% Maximum Candela = 959815 10% Maximum Candela = 191963
