WALLAGA LAKE URBAN STORMWATER REVIEW

JULY 2004

Peter Spurway & Associates Pty Limited

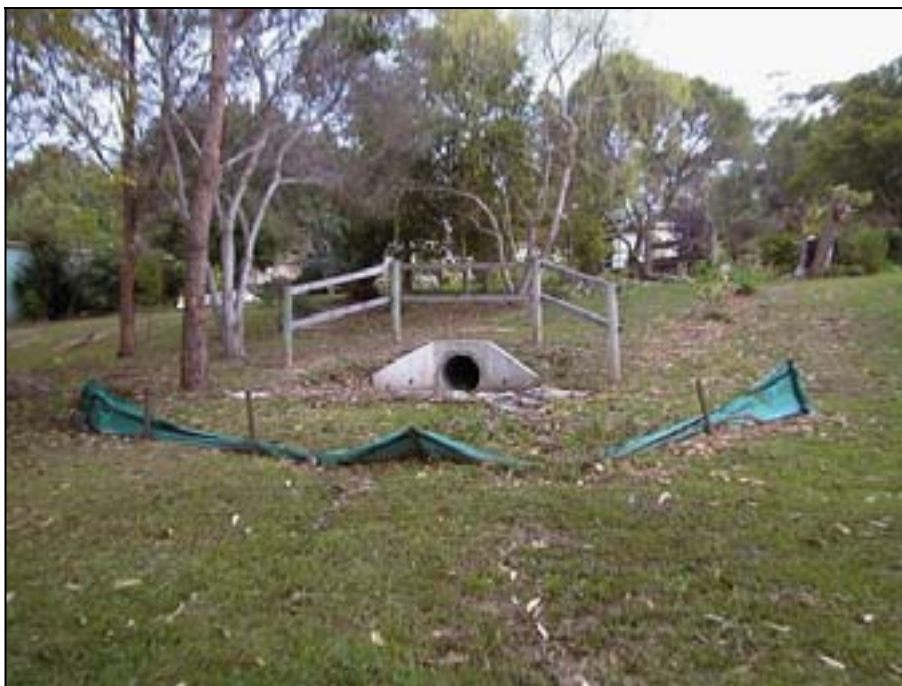
This drainage system runs up to Beauty Point Road and discharges through mostly open channel, crossing O'Connells Point Road in 600mm diameter pipe. A new headwall is sited at the rear of house no. 57, situated some 20 metres from the lake in a moderately steep area. Flow discharge is over a newly-constructed rough concrete dissipater to control exit flow velocities and prevent local scour. The photograph of this headwall (**Photograph 1** overleaf) shows temporary silt fencing remaining from the construction period.

There is evidence of leaf litter and mud in stormwater pits on O'Connells Point Road, which would flow to the estuary under most flow conditions. The combination of open drains and well vegetated forest areas in this catchment are a source of organic material which would be difficult to control.

Photograph 1 - Drainage outlet - No. 57 O'Connells Point Rd, Beauty Point
